Week ending 14 November 2018

This incident summary provides information on reportable incidents and safety advice for the NSW mining industry. To report an incident to the NSW Resources Regulator: phone 1300 814 609 24 hours a day, 7 days a week.

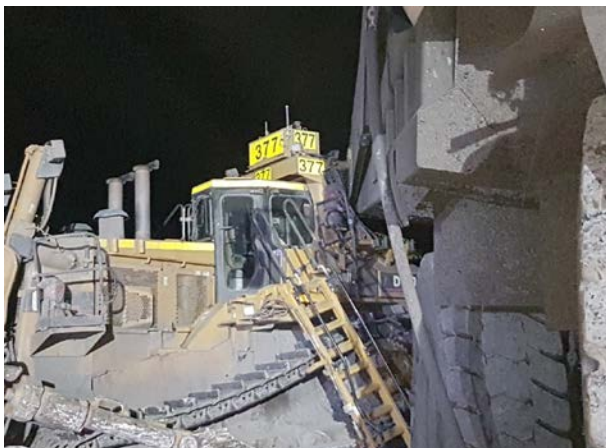
Incident type	Summary	Recommendations to industry
Dangerous incident SinNot-2018/01898	<p>A dump truck and a dozer collided at a dump tip head in an open cut coal mine. The dozer was on the off driver's side of the truck. The dozer's rollover protection canopy and access ladder were damaged and a tyre was deflated.</p>

<p>A S195 notice was issued to the mine arising from this incident.</p> <p>Tip heads must be designed and maintained to enable safe dumping and interaction between plant.</p> <p>Workers must be trained in dump procedures that must include positive communication requirements. The monitoring and verification of compliance with dump procedures must be routinely conducted by statutory officials.</p> <p>Please review the safety bulletin on positive communications SB18-06</p>

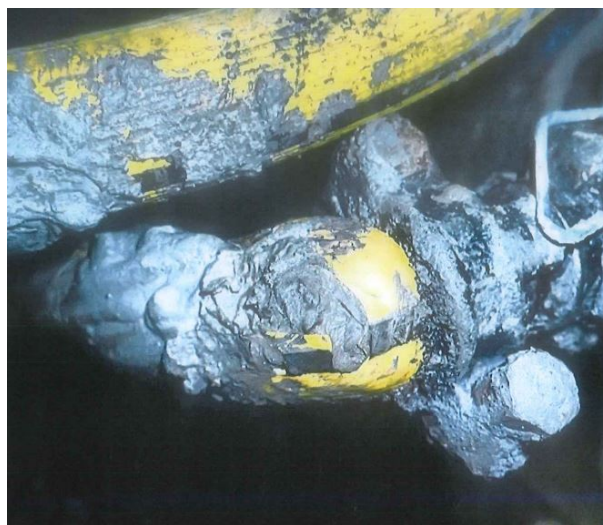
A worker was sprayed with grout at an underground coal mine. The workers were in the process of grouting cable bolts when a worker removed his glasses. A pressure hose burst and sprayed the worker with grout. A similar failure was reported at another mine where a worker was not placed at risk.

Hoses, fittings and attachments used for grouting must be rated to the pump stall pressure. All equipment must be inspected as fit-for-purpose and ready for use before commencing work.
