# WEEKLY INCIDENT SUMMARY

Week ending Friday 30 July 2021

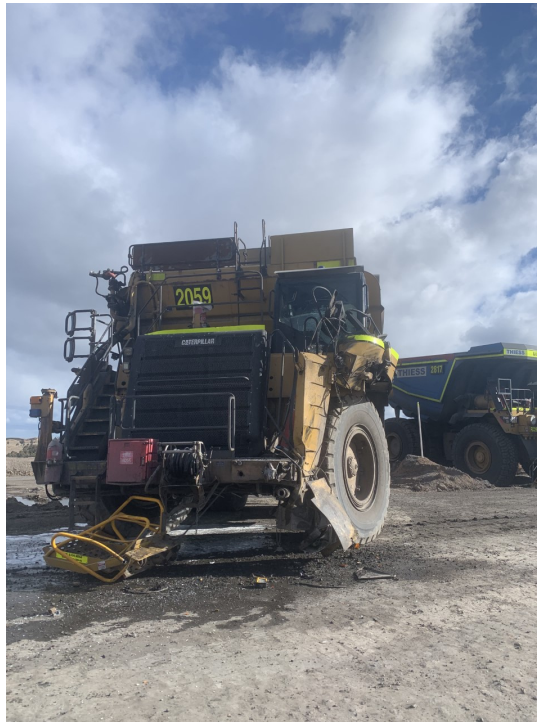
Roads or other vehicle operating areas	A watercart collided with a haul truck while both vehicles were exiting a park up area. The haul truck was travelling along the exit road of the park up area when the watercart drove into the path of the haul truck. The operator stated that they had been distracted by an alarm. The front left corner of the water cart struck the front right tyre of the haul truck.	Operators should remain focused on control of their vehicle and their surrounds and only respond to alarms and other functions when safe to do so. Our recent campaign sought to bring to the attention of operators the risk of collisions involving heavy mining equipment. Refer to: <a href="#">Vehicle incidents – heading in the wrong direction</a> .

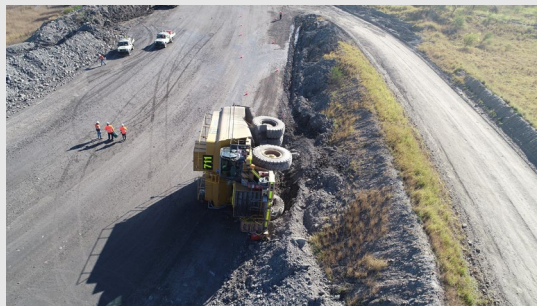
Dangerous incident  
IncNot0040395

A water cart failed to negotiate a corner in a haul road and drove up a windrow, rolling onto its side. The operator was looking at the touch screen, to turn on the water pump and sprays, when he felt the truck climbing the windrow. He stopped the truck and was about to reverse when the truck rolled onto its side. The operator was uninjured and was able to exit the vehicle safely.

Equipment operators must maintain situational awareness and remain vigilant regarding the risk of machine rollovers. This incident underpins the importance of wearing seatbelts as a mitigating control.
