WEEKLY INCIDENT SUMMARY

Week ending Friday 14 January 2022

This incident summary provides information on reportable incidents and safety advice for the NSW mining industry. To report an incident to the NSW Resources Regulator: phone 1300 814 609 24 hours a day, 7 days a week.

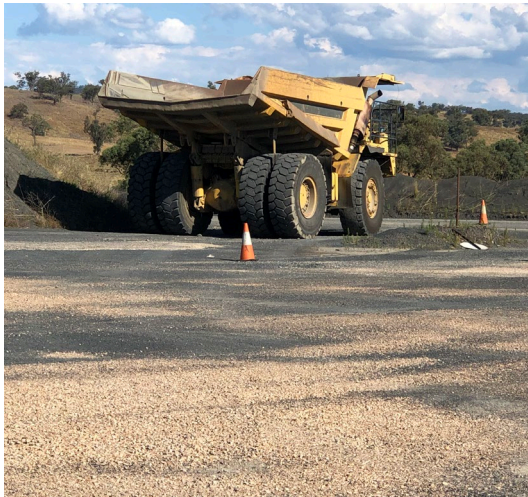
INCIDENT TYPE	SUMMARY	COMMENTS TO INDUSTRY
Dangerous incident IncNot0041395 Quarry	<p>A dump truck with its tray raised hit and pulled down live overhead powerlines. The truck continued to drive forward.</p>

<p>Operators should consider the risks associated with all activities that may occur near overhead power lines, irrespective of the frequency or complexity of the activity.</p> <p>Consideration should be given to all controls to prevent equipment encroaching on safe approach distances for high voltage overhead power lines, including:</p> <ul style="list-style-type: none"> • alternate travel routes or work sites • limits on maximum height for any equipment that may travel, or be transported

below, or work near overhead power lines

- warning signs or barriers (temporary or permanent) for overhead power lines (include safe height limits).

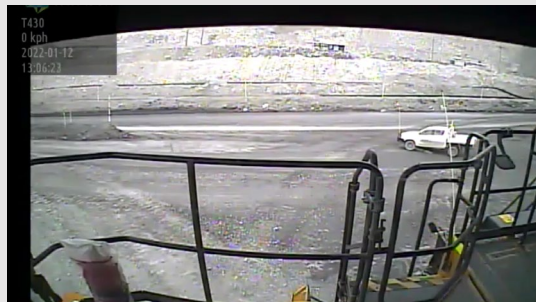
A light vehicle failed to stop and give way to a haul truck at a T-intersection when the truck was turning right. The vehicle and haul truck stopped 18 metres apart. There were no injuries.

Mine operators must ensure they have appropriate controls in place to manage the risks associated with heavy and light vehicle interactions.

Mine operators must ensure all roadways, intersections and park-up areas are designed, constructed, and maintained to safely manage interactions between mobile plant and light vehicles.

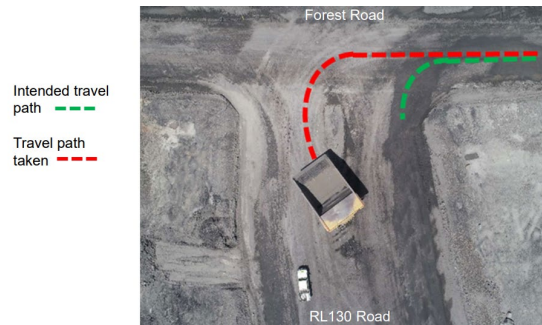
A truck hauling reject incorrectly turned left into an outgoing lane intersection. A light vehicle was approaching the intersection. The operator of vehicle identified the truck and came to a stop before the intersection. The truck identified the vehicle as it began its left-hand turn, at which point the vehicle was about 25 metres away from the intersection.

Mine operators must ensure they have appropriate controls in place to manage the risks associated with heavy and light vehicle interactions.

Mine operators must ensure all roadways, intersections and park up areas are designed, constructed, and maintained to safely manage interactions between mobile plant and light vehicles.
