Safety Alert

Date: August 2023

Serious injury of a Jumbo offsider during drilling work

Safety Alert SA23-02

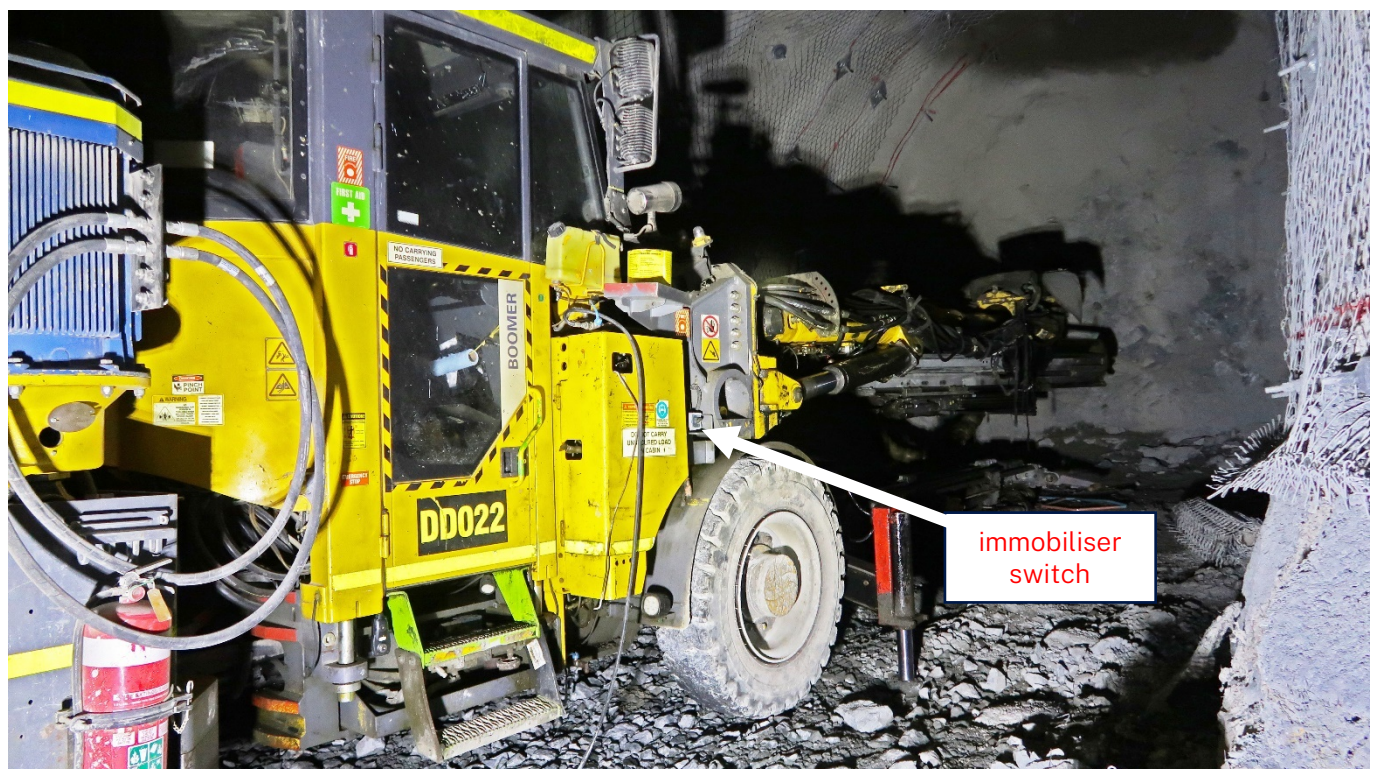
One of the drilling offsider's (nipper's) tasks was changing various drilling consumables on the booms of the Jumbo as the ground support work progressed. Immobiliser switches that were used to isolate the booms' movements were on the left and right sides of the Jumbo (Figure 1).

Figure 1: Jumbo drill rig at the incident scene

1. there was no automatic detection system, such as a laser beam, to immobilise the Jumbo booms when a person entered the operating area where there was a risk of entanglement.
2. existing immobiliser switches on the Jumbo were not used.
3. there were no work instructions for installing drilling consumables on Jumbo booms.
4. there was an accepted work practice amongst operators and nippers of not using immobilisers, and loading the drill steels while the coupling was rotating
5. the exclusion zone created by trailing cable barricading required the supervisor to request permission to enter the work area, impacting on ability to observe real behaviours and standards.

1. there is adequate training of drilling offsiders and operators for activities associated with working on or around drilling consumables
2. supervisors should complete regular inspections of all activities associated with installing ground support
3. controls are fully implemented, remain effective and are verified at a frequency determined by a risk-based approach
4. there is consideration for combining engineering controls to manage entanglement risks associated with drilling consumables. They may include:
 - a. immobilisation switches with inbuilt indication lights visible to the rear of the drill rig, for drilling offsiders
 - b. laser curtains/barriers
 - c. proximity detection devices
 - d. cameras.

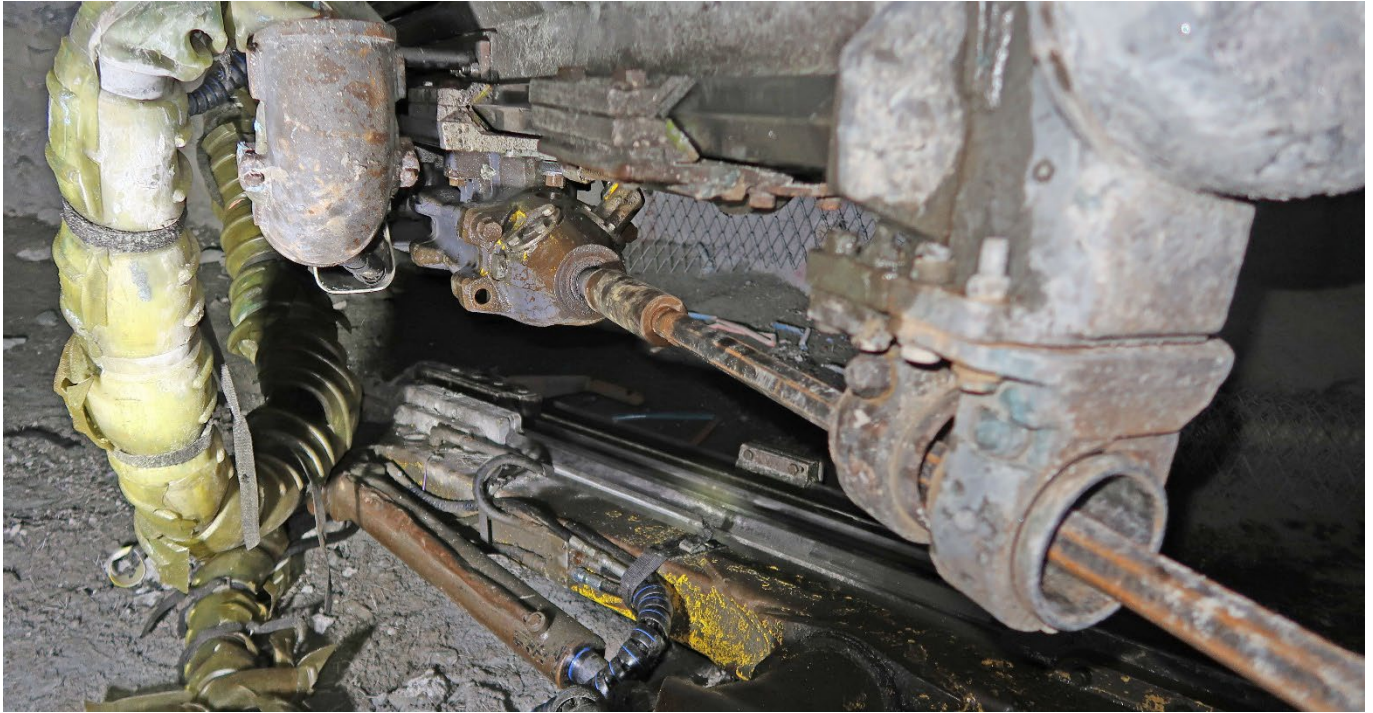
The drilling offsider approached the front of the Jumbo to load a drill rod on the right hand boom when his left arm became entangled. This resulted in the traumatic amputation of his left arm below the elbow. An emergency response was initiated with the drilling offsider being transported to the surface and airlifted to hospital for treatment.

Figure 2: Drill steel inserted into coupling on the right hand drill

The worker inserted a 3.7 metre drill steel into the drifter coupling of the righthand boom while it was rotating.

The NSW Resources Regulator is giving clear direction to the NSW mining industry that effective immobilisation controls must be in-place for personnel entering the implement operating zone of a Jumbo.

- a. Immobilisation switches with inbuilt indication lights, for drilling offsiders.
 - b. Laser curtains/barriers.
 - c. Proximity detection devices.
 - d. Cameras.
