Leadville Mine Remediation Action Plan

Final

15 April 2024

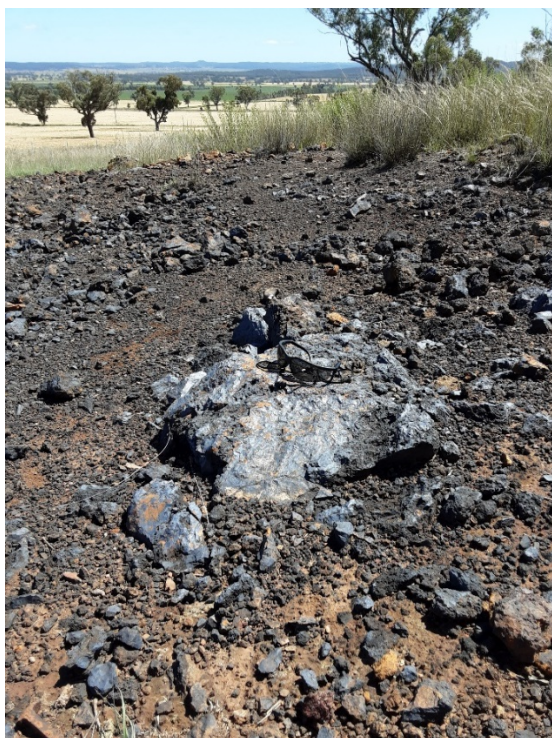
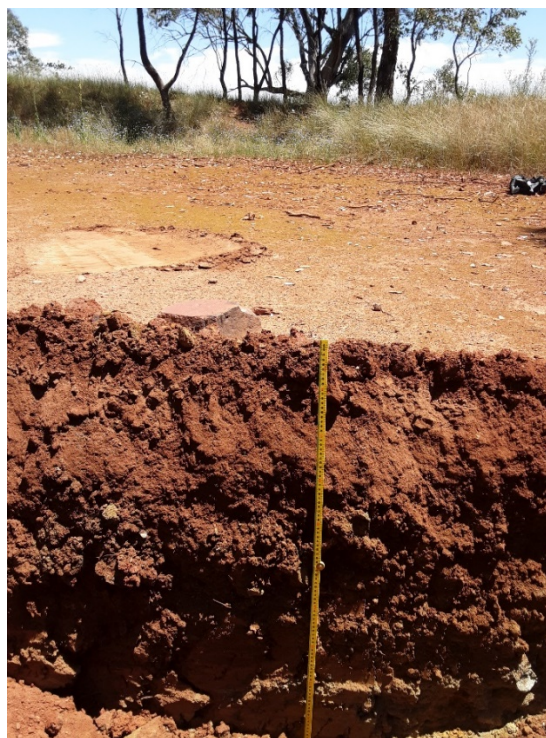
Figure 6 Naturally Mineralised Surface Outcrops at Grosvenor and Silty Contaminated Material in Grosvenor Dam

The presence of the stamper battery upstream of the Western dam implies that ore milling activities occurred in this area, suggesting that fine ore and waste in the dam likely originated from milling activities upstream. Sediment analysis through calibrated XRF readings and 4-acid digest assays returned a value of 4.8% Lead. The material is interpreted to extend from surface to around 0.5m (see Figure 6 and Test Pit 8 – Appendix D of Okane, 2022).

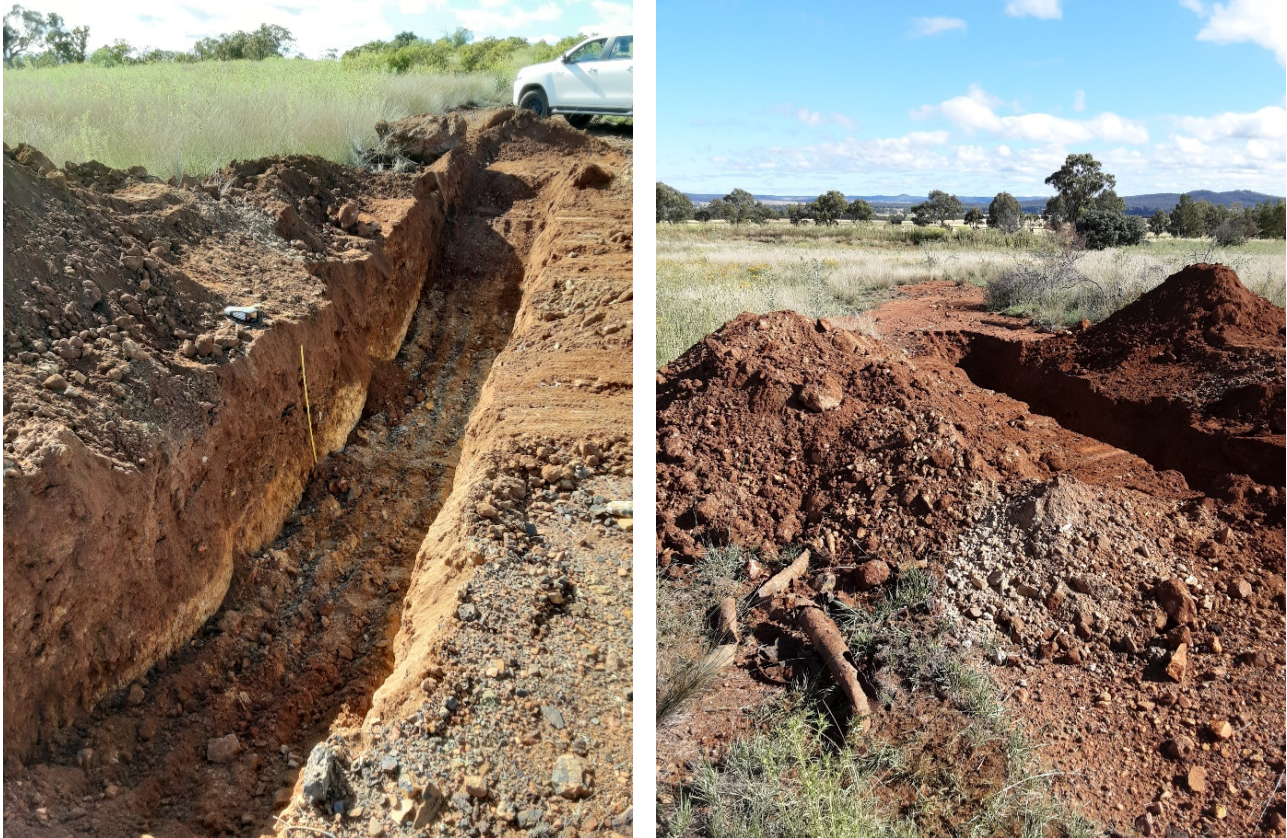
Figure 8 Backfilled contaminated material in areas devoid of vegetation (Mt Stewart Drainage)

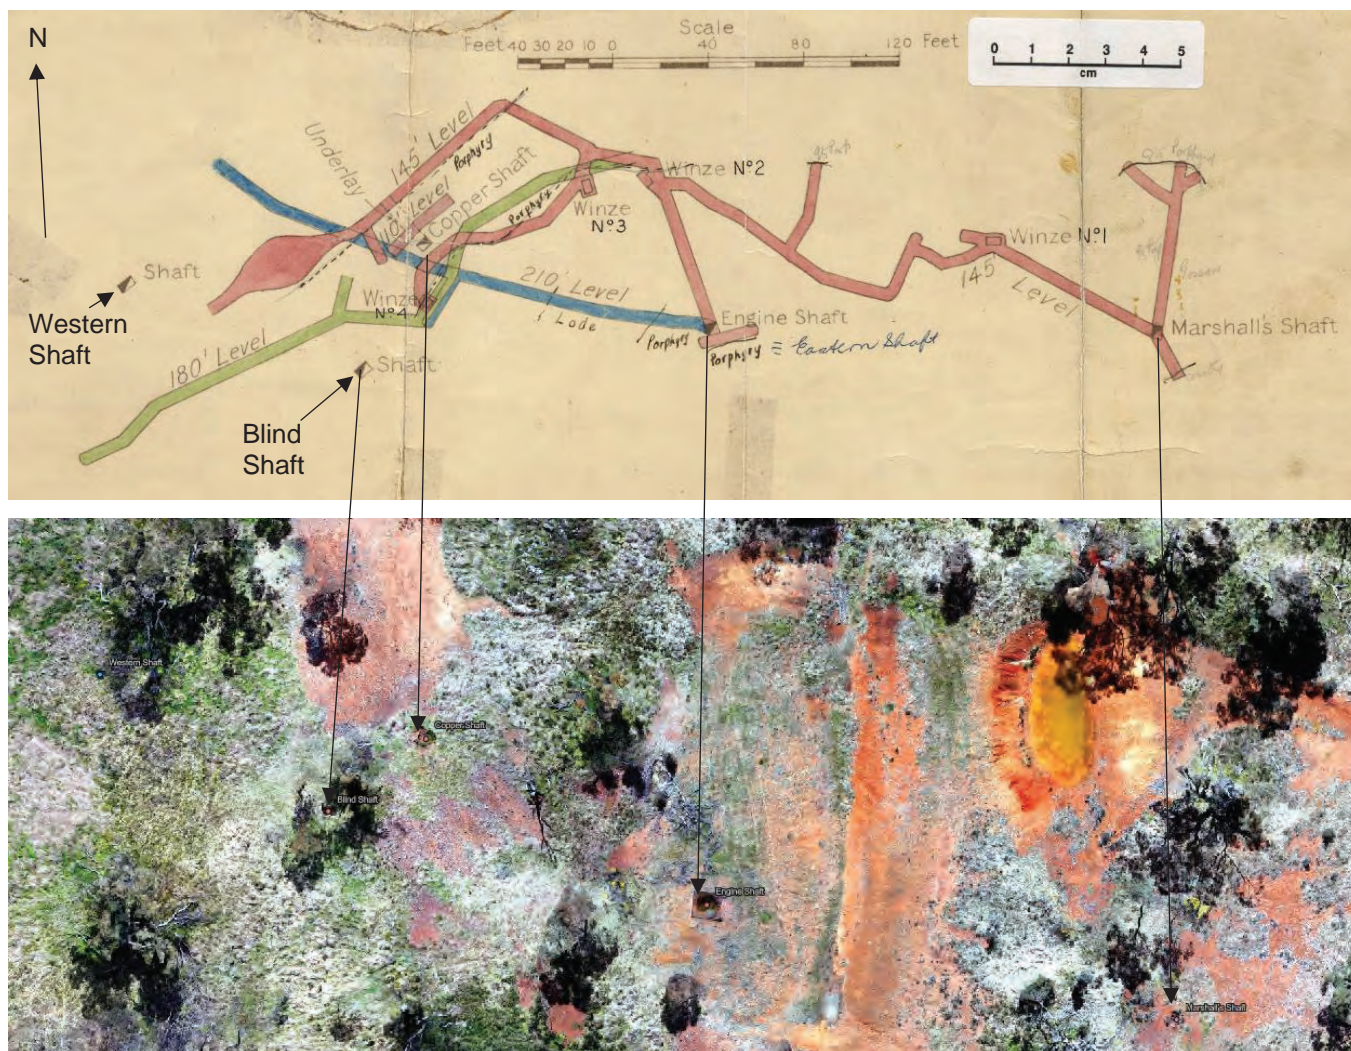
Figure 3.13 Mount Stewart Extended workings from 1922. In GS1922/016 (DIGS Ref. D003796360) and orthophoto

- ‘Engine Shaft’ – also known as “Eastern Shaft”
- ‘Blind Shaft’
- ‘Copper Shaft’ – also known as “Old Copper Shaft”
- ‘Marshall’s Shaft’

The above shafts are matched to visible features as shown in Figure 3.13. The Western Shaft is probably marked by a mound of rocks beside a tree.

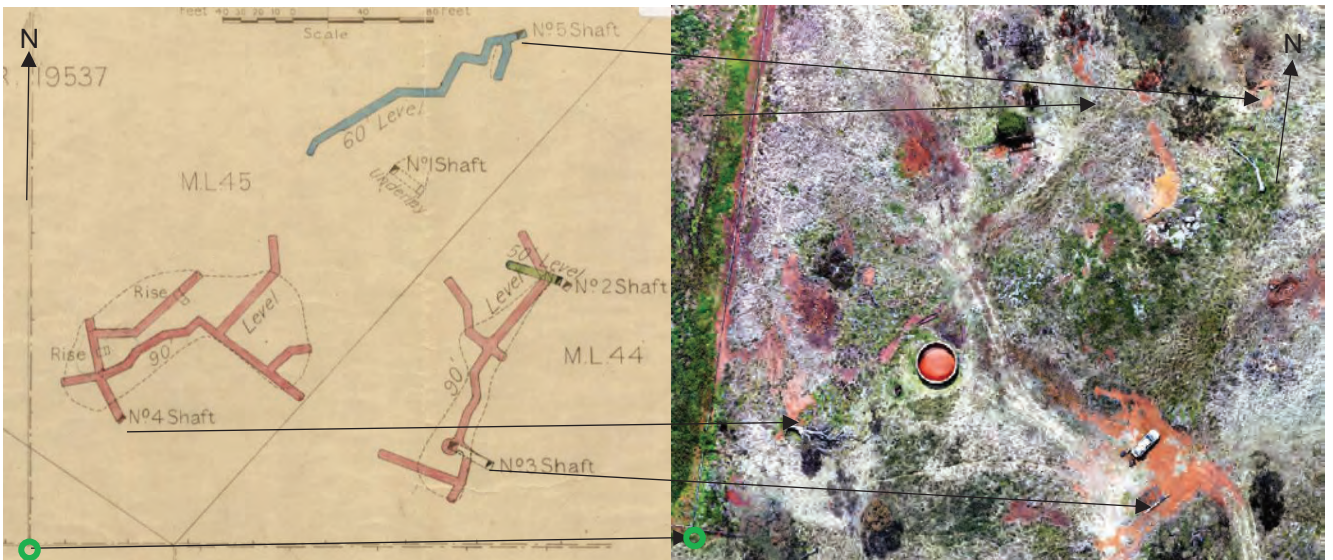
Figure 3.15 Mount Stewart Extended workings from 1922. In GS1922/016 (DIGS Ref. D003796380) and orthophoto

The above shafts are matched to visible features as shown in Figure 3.15. Mining lease and portion boundaries and fence lines were used to assist in georeferencing of mine plans, but no physical boundary markers were observed. It was assumed that the visible fences are consistent with mapped portion boundaries.

As noted in Section 3.1.1, 'levels' are nominal depths referenced from a datum. In the Grosvenor area, the datum is the No. 4 Shaft with a collar level of about 1494 feet above mean sea level (Willan, 1925). The other shafts have similar or high collar levels and to the actual depth below ground surface to the mine levels is expected to be as indicated or slightly deeper.

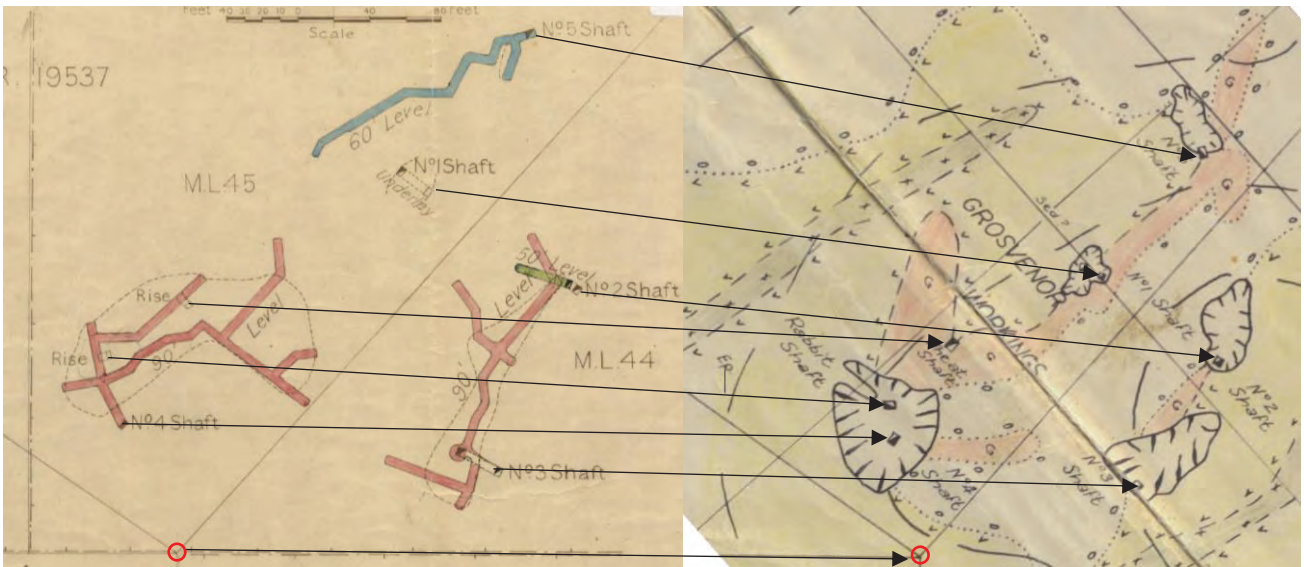
Figure 3.16 Extract of Grosvenor workings from 'Geological Map of Leadville – N.S.W' by The Zinc Corporation Ltd, 1948. In GS1948/008 (DIGS Ref. D00586920) correlation to Grosvenor plan DIGS Ref. D003796380

The 1948 geology map also shows the same shafts in this area although with slightly different names in some cases and two rises becoming the Rabbit and Wheat Shafts as shown in Figure 3.16.

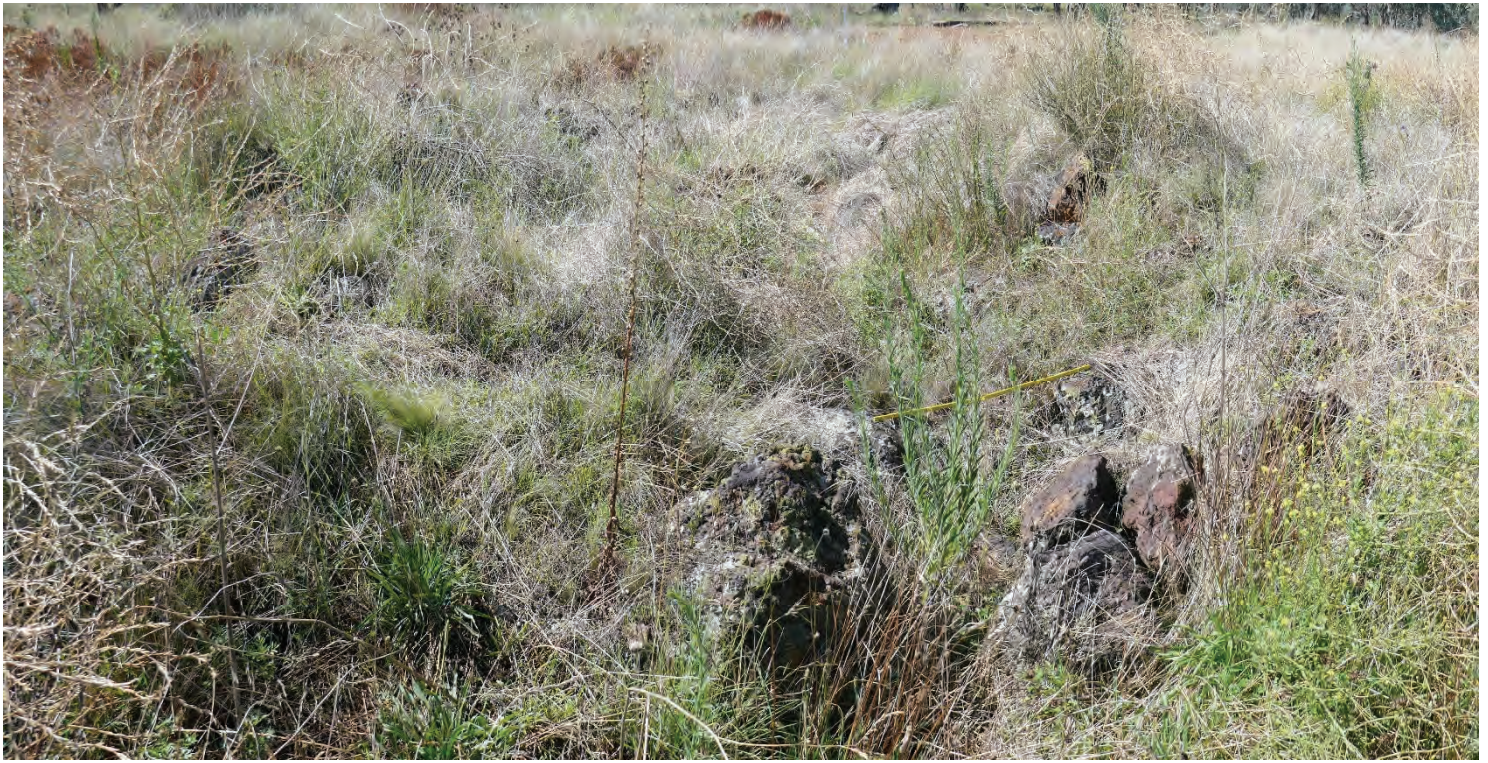
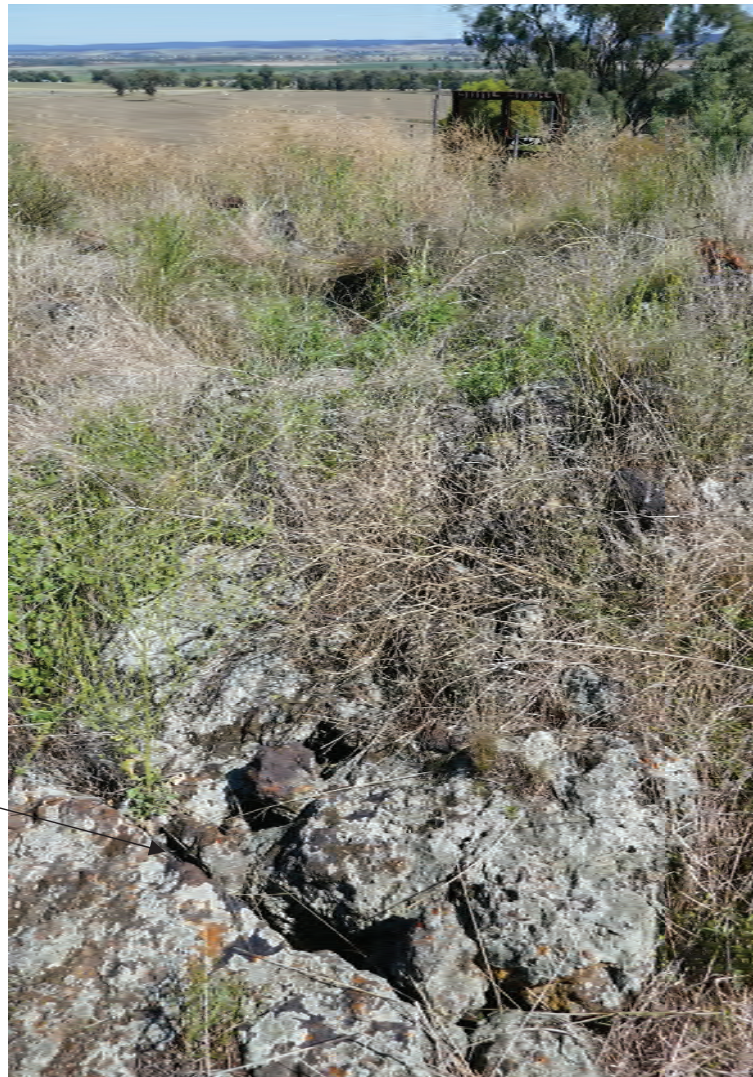
GROSVENOR WORKINGS: Possible cave-in (#103)

crack

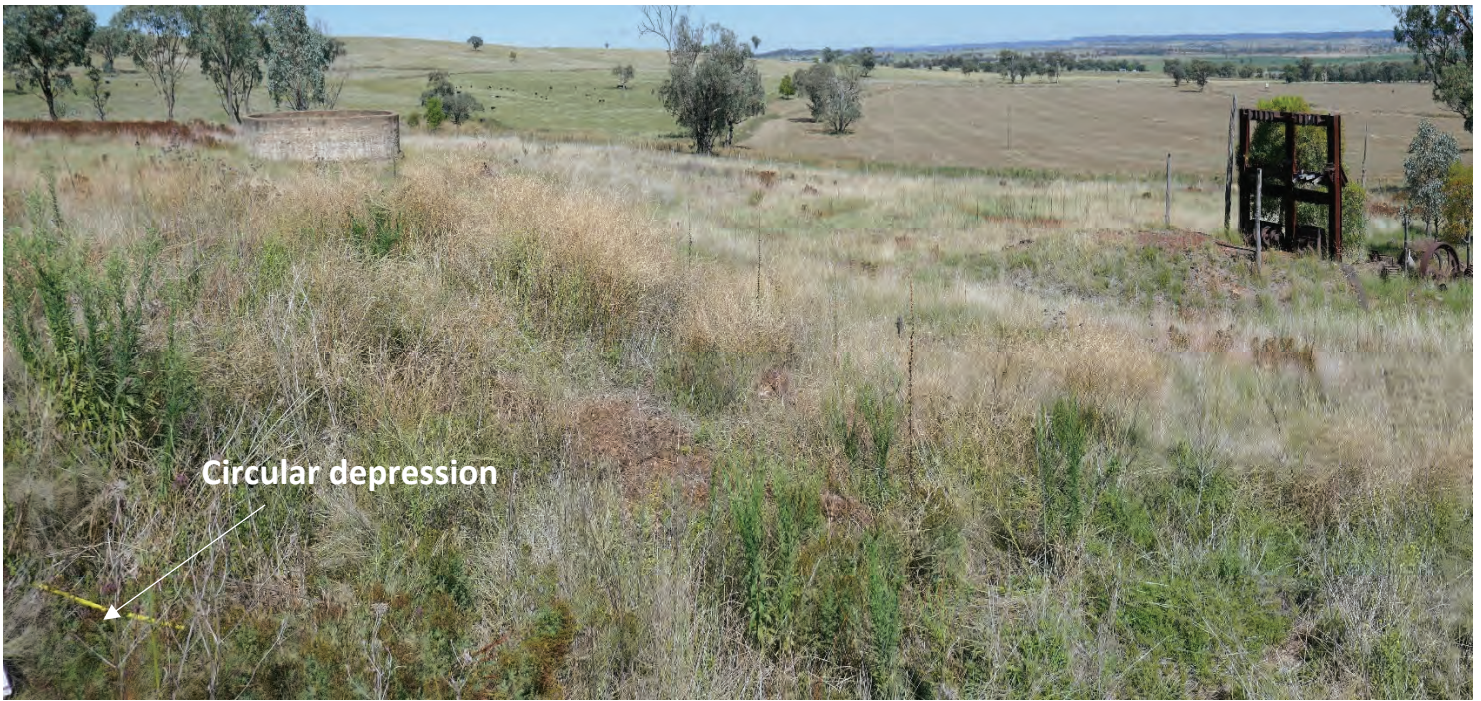
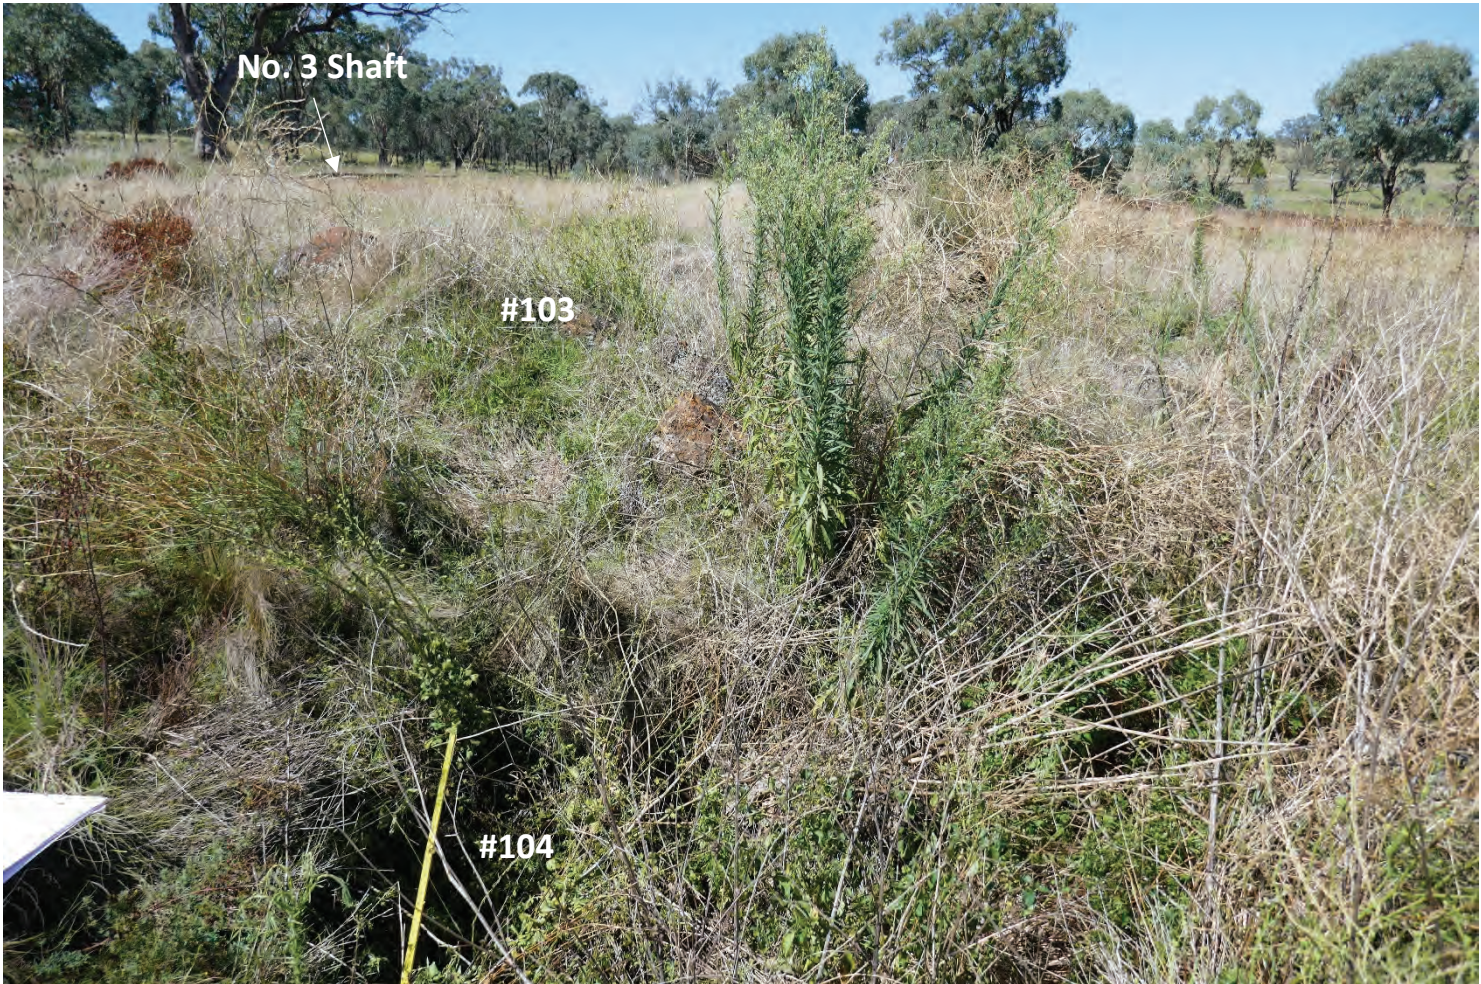
GROSVENOR WORKINGS: Circular depression (#104)

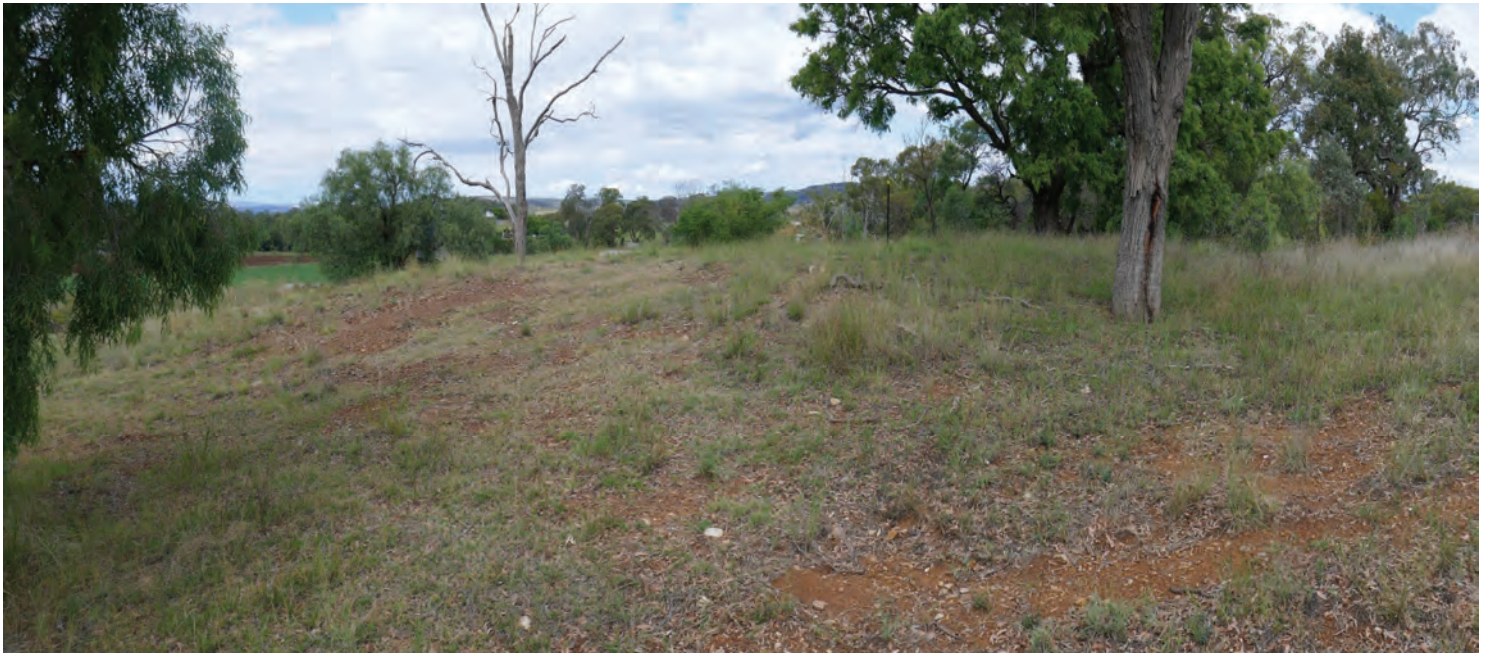
MOUNT STEWART WORKINGS: No. 3 Shaft / No. 2 Cave-in
