Investigation information release

Two workers injured at Western Riverina Quarry

Event: Two workers were injured during cone crusher maintenance work.

Location: Western Riverina Quarry, Rankins Springs

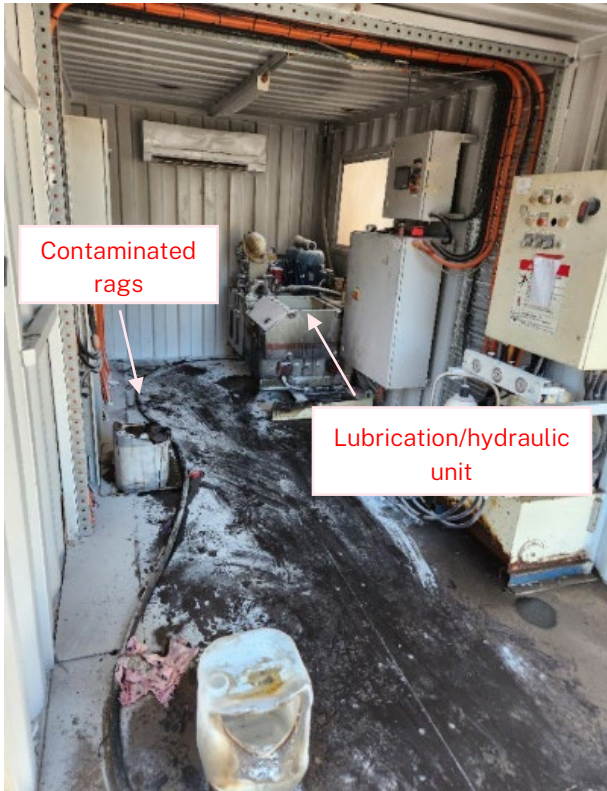
Two workers were changing the lubricating oil on a Nordberg HP300 cone crusher at approximately 11:50 am on 13 May 2024. The hydraulic/lubrication unit was located at the rear of the purpose-built shipping container, known at the site as the Crusher Lubrication Container. The container had limited ventilation.

Figure 1 Inside the Crusher Lubrication Container

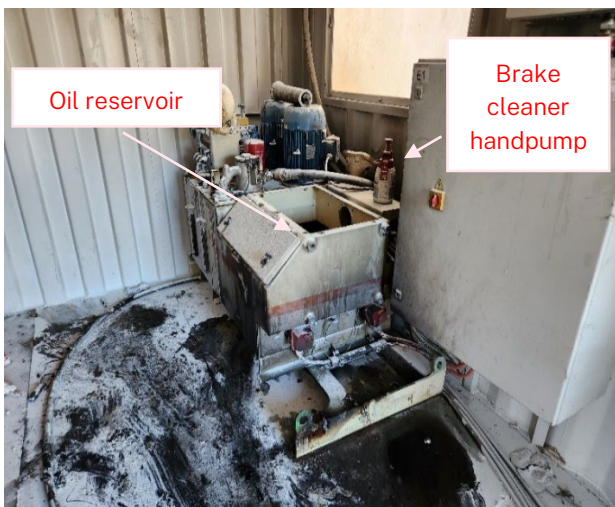
Figure 2 Oil reservoir and brake cleaner handpump

The workers were cleaning the oil reservoir with rags and brake cleaning fluid to remove sludge that had developed in the reservoir. While cleaning the oil reservoir, one worker used a Milwaukee 18-volt cordless handheld blower to clean dust and debris from the top of the hydraulic/lubrication unit. This task was stopped for a short time. Soon afterwards, the handheld blower was used for a second time and a small explosion occurred, which was followed by a fire inside the container.

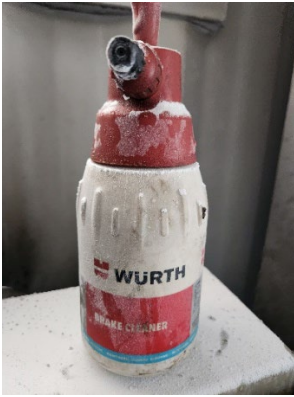
Figure 3 Brake cleaner handpump

- brake cleaning fluid is a highly flammable liquid and vapour, and should only be used in well-ventilated areas and to use non-sparking tools
- cordless battery-operated handblower uses a *brushed* motor that can create a spark (*brushless* motors are less likely to spark than *brushed* motors)
- design of the container has a requirement to separate the storage of hydrocarbons (oils) from potential ignition sources including electrical energies, hot surfaces and incendive sparking.

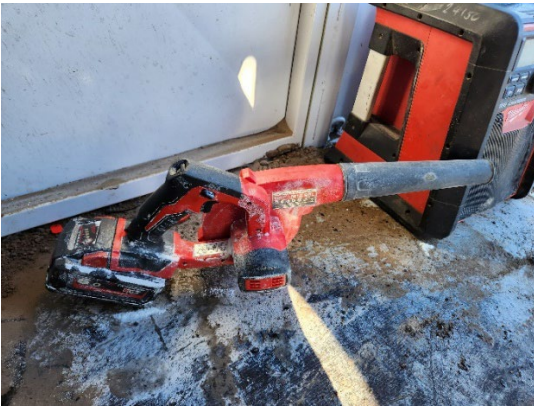
Figure 4 Milwaukee battery-operated handheld blower

- be aware of their work environment while using hazardous chemicals and electrical equipment
- refer to current Safety Data Sheets prior to handling or commencing any work involving hazardous substances
- be aware of the interaction of electrical equipment and hazardous chemicals
- ensure they comply with the mine operators' safe work procedures, hazard identification and risk management processes.
