# Weekly incident summary

## Week ending 28 June 2024

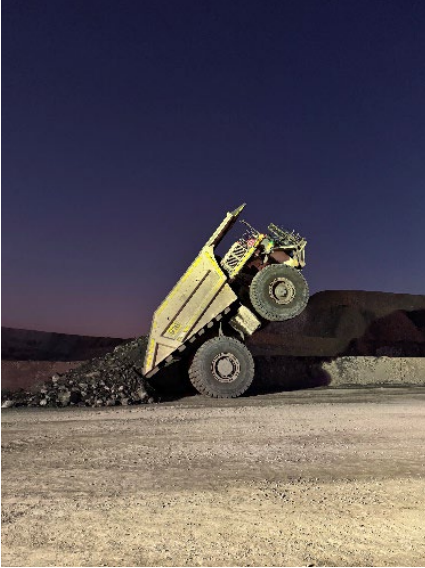
Incident type	Summary	Comments to industry
Dangerous incident IncNot0047157 Open cut coal mine	<p>A loaded dump truck was travelling up an 8% grade when it has ended up coming to rest on the rear of its tray.</p> <p>Preliminary investigation indicated the truck was placed in reverse and when it drove backward the operator braked hard, causing the truck to raise up.</p>	<p>This incident is under investigation and further information may be published later.</p>

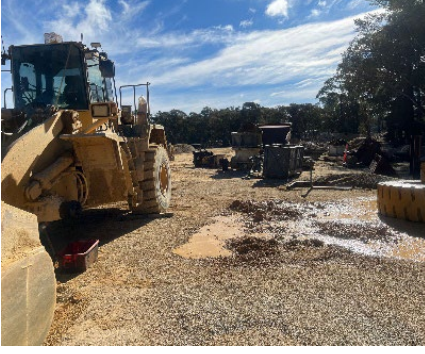
<p>Dangerous incident IncNot0047137 Construction materials</p>	<p>A front-end loader was loading a hopper bin with surge material when the front left wheel detached from the front differential. The wheel rolled about 110 metres down a roadway and came to rest adjacent to a stockpile located near the crushing plant.</p> <p>Visual inspections suggested the reconditioned differential, which had been installed about 3 months earlier had failed.</p>

<p>When changing to a different component supplier or to a different model component, a change management process must be undertaken. This must include checks to confirm compatibility with the equipment that is being fitted and for suitability for the task or duty.</p>
<p>Dangerous Incident IncNot0047139 Open cut coal mine Airborne dust and other contaminants</p>	<p>A dozer and grader operator recorded a respirable dust result of 4.9mg/m<sup>3</sup>, which exceeds the relevant shift adjusted OES of 1.37mg/m<sup>3</sup>. The worker did not specify any 'unusual' exposure conditions. The worker reported that respiratory protection was not worn during the exposure period.</p>	<p>Mine operators are reminded to ensure the highest level of controls, education and training of workers are in place to prevent exposure of workers to the hazards of respirable dust. The order in which controls are implemented must follow the hierarchy of controls. Personal protective equipment is a last line of defence against exposure</p>
