Weekly incident summary

Week ending 12 July 2024

This incident summary provides information on reportable incidents and safety advice for the NSW mining industry. To report an incident to the Resources Regulator: phone 1300 814 609 24 hours a day, 7 days a week.

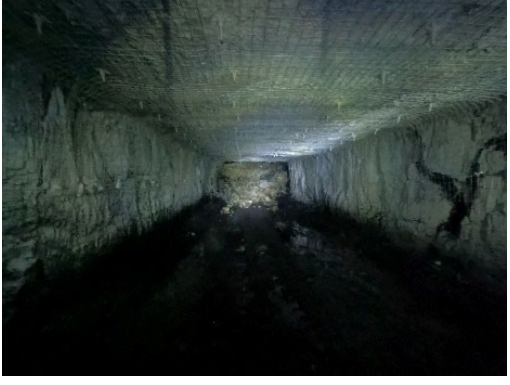
<p>A fall of ground occurred affecting an entire intersection at a heading where mining had been occurring inbye of the area during night shift. The crew had withdrawn equipment for planned maintenance on day shift before the fall occurred.</p> <p>The area design was a run out on the left-hand side of the bord and pillar panel with herringbone and floor stripping. There was an unbolted section and a bolted section through the run out. At 11am, it was observed there was a roof and skin failure in the open lift (unbolted area). At 3pm, it was reported that the fall of ground had progressed through the entire intersection (bolted and unbolted).</p>	<p>This incident is under investigation and further information may be published later.</p> <p>Mine operators are reminded of the need for workers who are required to install and maintain tell-tale strata monitoring devices to be trained on the correct installation and defect management requirements for the lifecycle of the devices.</p>

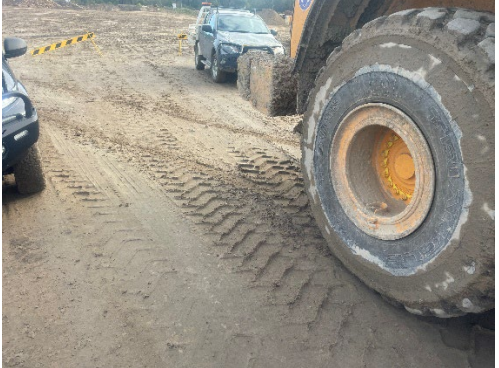
<p data-bbox="416 584 938 1128"> A loader reversed into one of 2 light vehicles that had stopped about 10 metres behind it. The first vehicle failed to make positive communications with the loader because of a flat radio battery. When the loader began to reverse, the first vehicle moved out of the way and the loader continued until it hit the second vehicle. The second vehicle operator assumed the first vehicle operator made positive communications but didn't hear anything. He had his flashing light on and sounded the horn to stop the loader. </p>

<p data-bbox="943 584 1481 707"> When stopping light vehicles, workers must not place themselves at risk of interactions with heavy vehicles. </p> <p data-bbox="943 719 1481 987"> Following a recent awareness campaign on vehicle interactions the Regulator published a video that can be used for training purposes and toolbox talks. Mine operators are encouraged to use this resource. You can watch the video on YouTube. </p> <p data-bbox="943 999 1481 1783"> To achieve positive communication, a clear direct message must be given. Additionally, the person receiving the message must actively reply with a clear understanding of the message. Supervisors should be continually monitoring positive communications compliance during every radio call on their shift. Work Health and Safety Regulation 2017 clauses 35 & 36 requires higher order risk controls be implemented and administrative controls such as positive communication, only be used when no higher order controls can be implemented. Controls such as equipment segregation and proximity awareness systems should be implemented before positive communication only systems are considered. </p>
