Investigation report

Loader fire at Cadia Mine results in serious injury to a worker

September 2024

Event: Loader fire at an underground metal mine

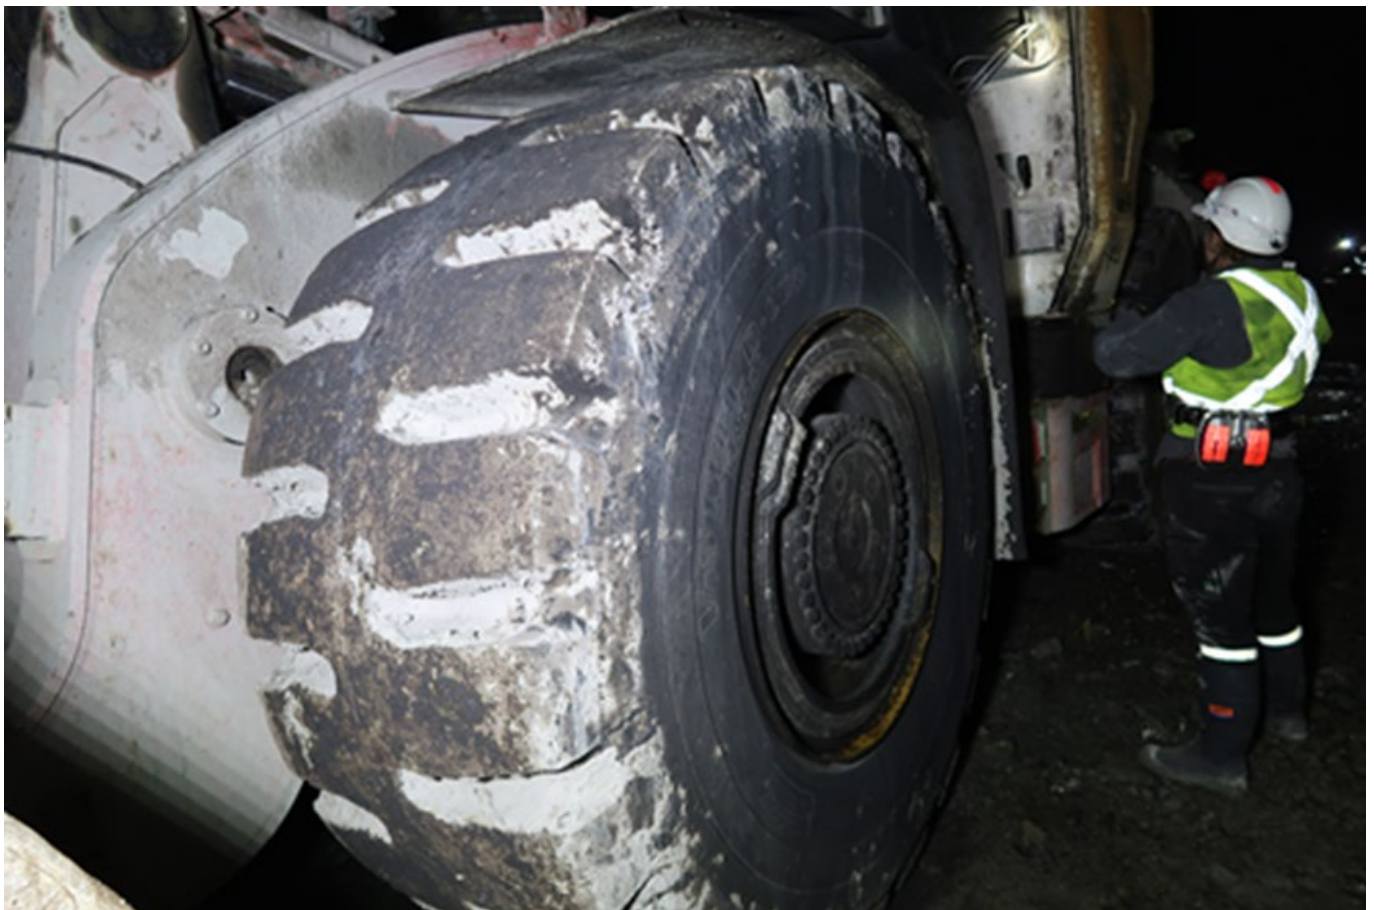
A worker was operating a LH621 Sandvik loader in the underground workings of the mine on 25 October 2021, when a fire was observed near the front left (**position one**) tyre. The worker activated the fire suppression system, exited the cabin and observed flames around the rear of the loader. The worker suffered serious burns while running past the loader's engine bay to escape the fire.

Figure 1: Fire damage to the loader's position one tyre

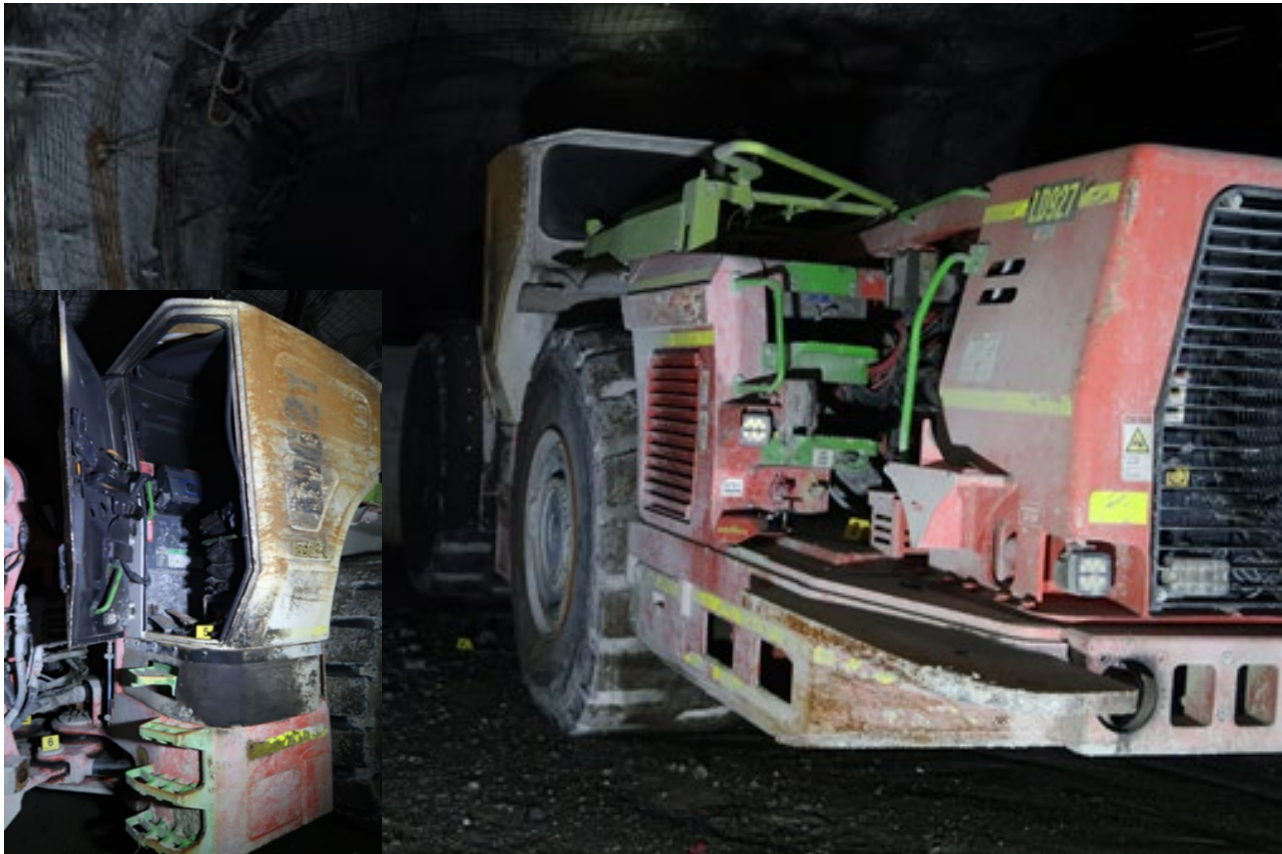
Figure 2: The rear left side of the loader and the operator's cabin with fire damage (inset)

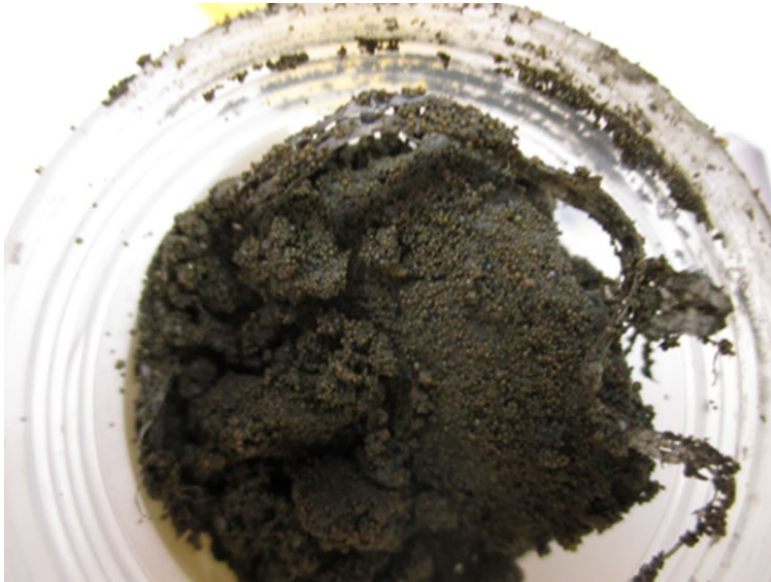
An examination of the fire scene identified, among other things, an area of scorched ground under the loader. Samples of material from the area were obtained for testing which revealed it contained 5.3% cellulose nitrate (also known as nitrocellulose) and 2% ammonium nitrate.

Figure 3: Sample of the material found at the fire scene

It was likely the material on the ground at the fire scene, either wet (paste), dry or a mixture, included traces of cellulous nitrate, which came into contact with a heat source, or friction from the loader and ignited.

Mine operators must establish and implement explosive control plans, standards, procedures, guides and training material that:

2. incorporate:
 - a. methods of disposal for explosives that are appropriate for the type and condition of the explosives – refer Explosive Regulation 2013 cl. 98 (b)

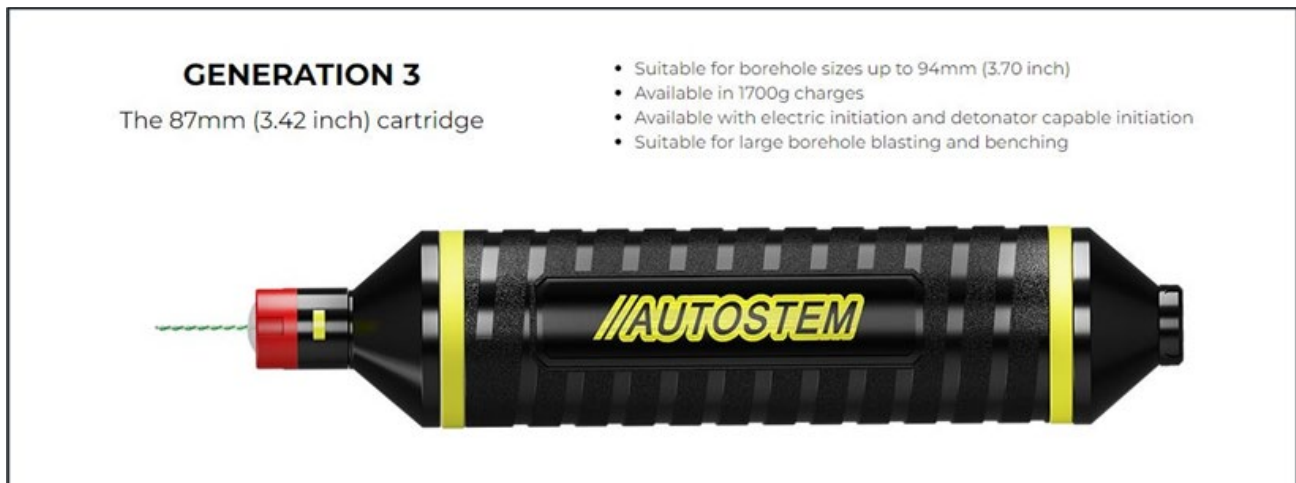
However, on 31 March 2023, the Regulator received information that led to further investigation enquiries that established that about 448 kg of an explosive mix used in an AutoStem brand product was disposed of by workers in the vicinity of the loader fire around 18 September 2021 (4 weeks before the fire). The disposal process involved cutting open the AutoStem cartridges, emptying the product onto the ground, and the product then being immersed in water on the roadway using a water cannon.

AutoStem is a class 1.4S explosive material that contains, among other things, ammonium nitrate and cellulose nitrate and can be used to break rock and concrete. It has a flash point of >180 degrees Celsius, an auto ignition temperature of >150 degree Celsius and is a flammable solid. Significantly, ammonium nitrate is soluble in water, but cellulose nitrate is not. Accordingly, exposing the explosive material from the AutoStem cartridge to water alone would not have completely dissolved it.

Figure 4: Example of an AutoStem cartridge disposed of at the fire scene

Section 11.2.2.4 of Australian Standard 2187.2-2006 Explosives-Storage, Transportation and Use provides small quantities of water soluble explosives may be disposed of using water. Noting AutoStem is only partially soluble, in that the cellulous nitrate component is not water soluble. The AutoStem safety data sheet provided it was only partially soluble and recommended cartridges be transported to a suitably qualified and equipped authority or supplier for disposal.
