Investigation information release

Worker suffers serious burns while refuelling petrol-powered water pump

Location: Divall's Quarries – Carrick Hill, near Goulburn NSW

Investigation information release IIR24-10

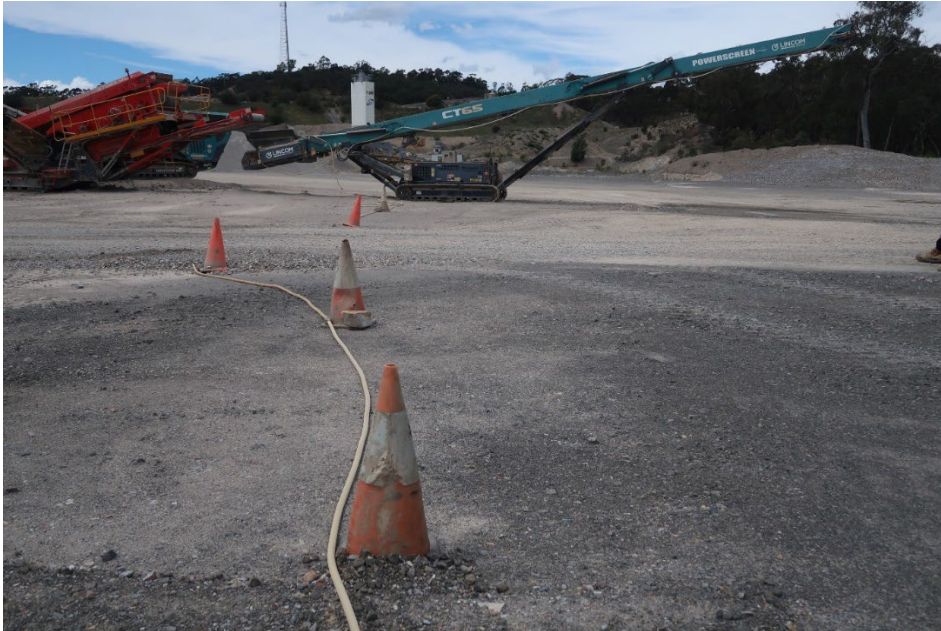
Figure 1: The mobile screener, stacker-conveyor and impact crusher plant

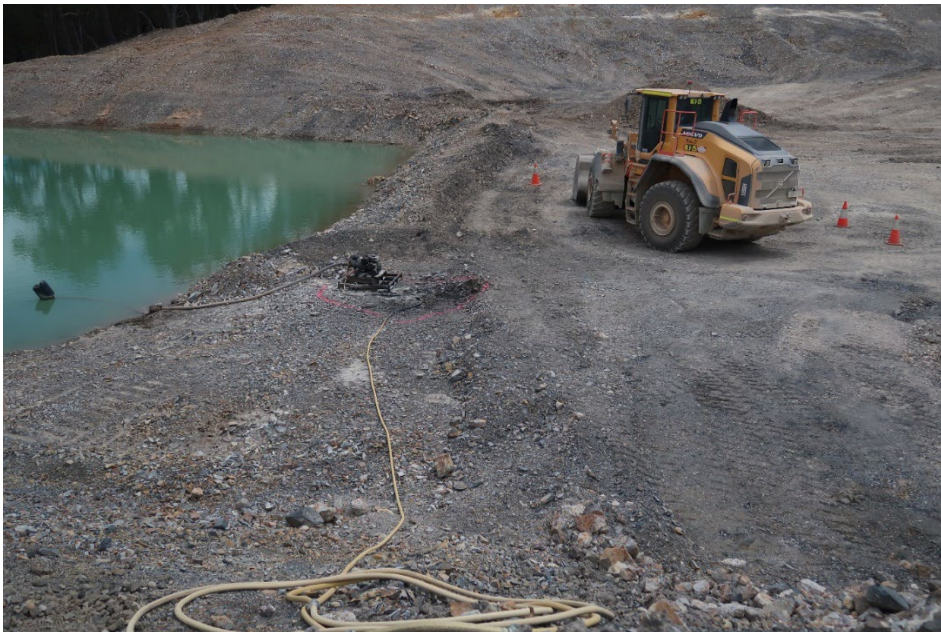
As part of the quarry's normal operations, a small petrol-powered pump was used to transfer water from a dam within the quarry via an outlet hose to mobile plant comprising a screener, stacker-conveyor and impact crusher. The water supply served the dual process of suppressing dust and conditioning the road base material.

Figure 2: The outlet hose, water pump and dam

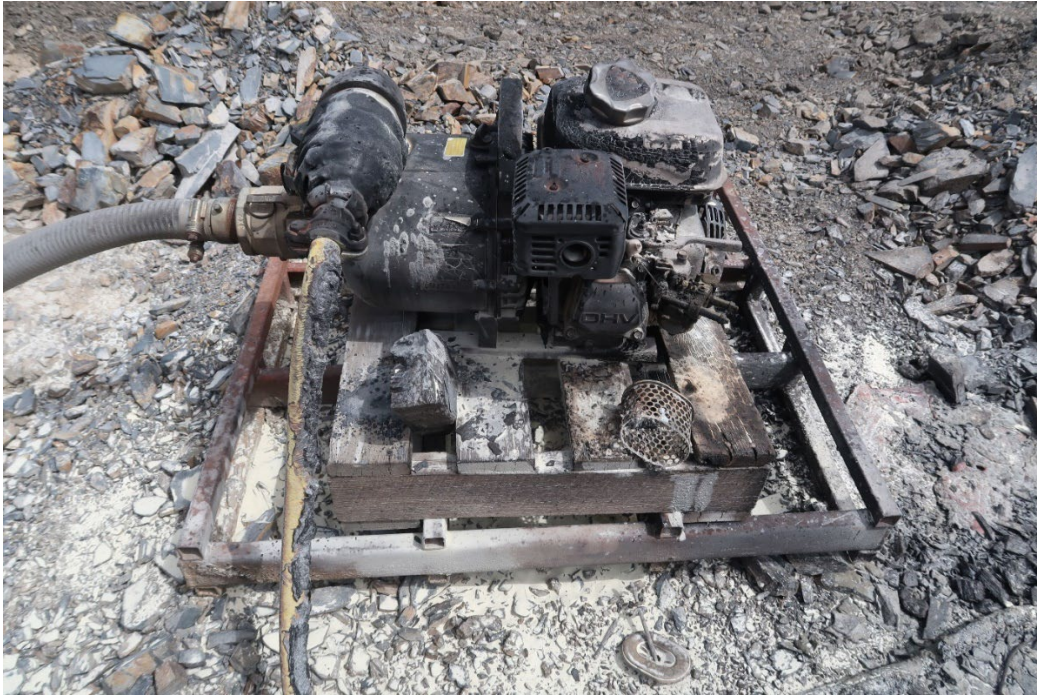
At 11.00am, the supervisor left the area in a front-end loader to load a truck that had arrived at site. Shortly after, the other worker drove to the water pump to refuel it. During the refuelling process, the pump ignited unexpectedly. The worker called the supervisor via radio and requested assistance. When the supervisor arrived at the injured worker's location, the pump was alight and the worker had suffered serious burns to his legs and hands. Preliminary inquiries indicate the

Figure 3: The fire-damaged water pump

- develop and implement safe systems of work for refuelling plant, which incorporates appropriate controls to manage the risk of ignition, including ensuring fuel cannot contact hot surfaces or exhaust gases while refuelling is taking place

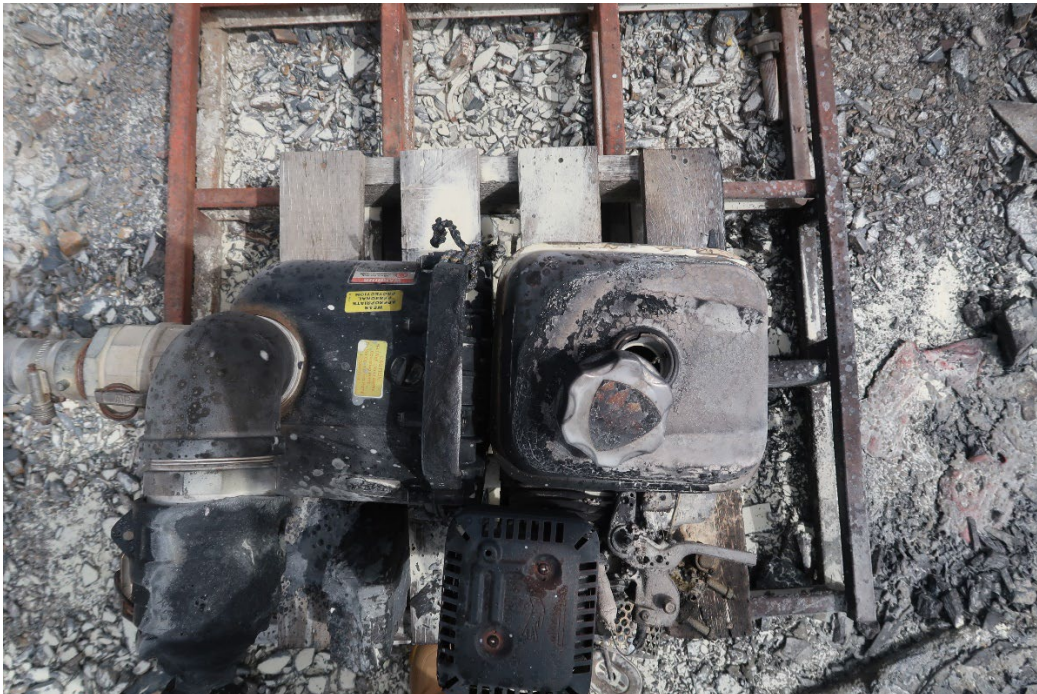
Figure 4: Top view of fire-damaged water pump
