Investigation information release

Worker suffers serious injuries while working under truck trailer

Location: Possum Brush Quarry, Possum Brush

Investigation information release IIR24-12

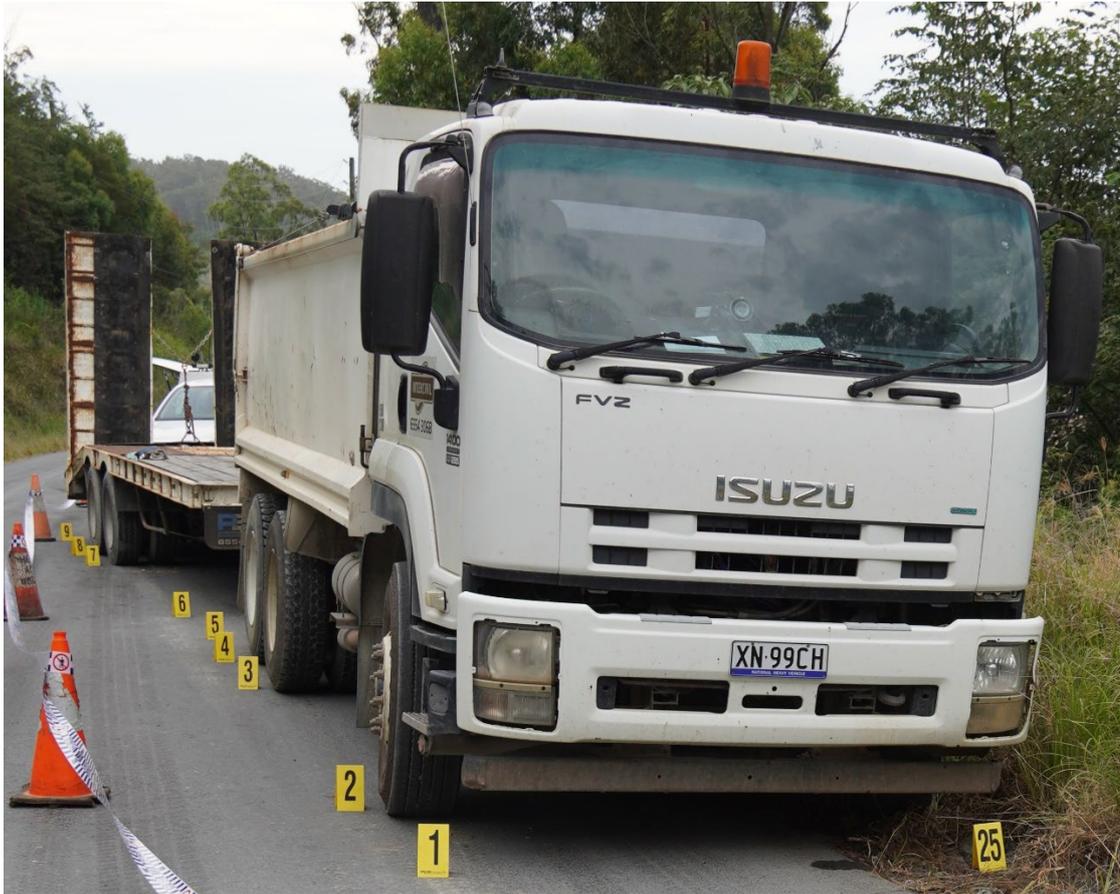
A contract worker was tasked by his supervisor to drive a road-registered truck and trailer up the inbound access road to a laydown area. The truck configuration was an Isuzu 3 axle rigid with a dual axle, double-wheeled trailer. The front nearside wheelset of the trailer was locked on and was being dragged along the bitumen road surface as the truck travelled up the inbound haul road. The worker stopped the truck on the haul road and the quarry's manager entered the cabin to try and release the locked trailer brake. The quarry manager drove the truck a short distance but was unable to release the brake. He parked the truck on the side of the roadway and asked the quarry's mechanic to attend the location to release the trailer's brakes.

Figure 1: The truck and trailer involved in the incident

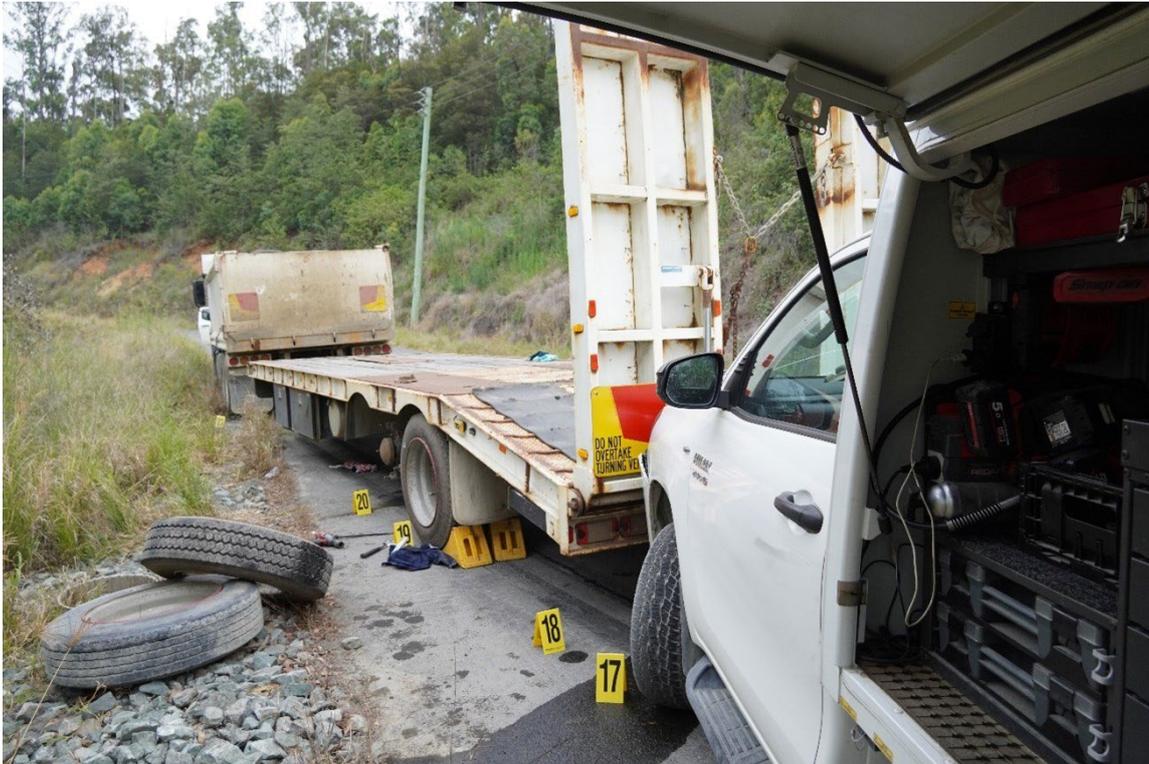
The truck and trailer rolled backwards a short distance (less than 10 metres) while the mechanic was under the trailer. The trailer collided with the utility parked behind it. The force of the impact forced the utility back several metres before the truck, trailer and the utility came to a stop.

Figure 2: The position of the vehicles following the incident

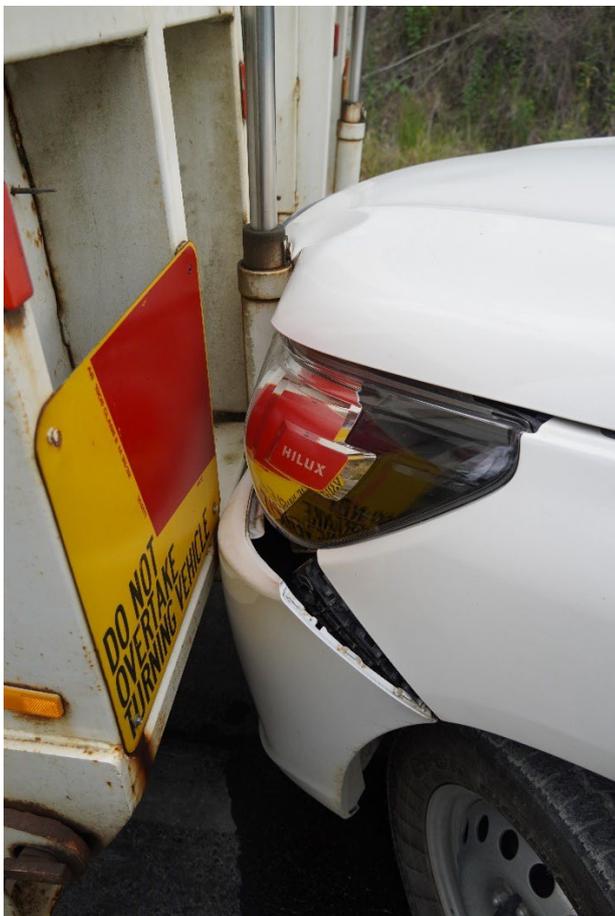
Figure 3: Collision between the trailer and the utility
