# Investigation information release

## Worker struck by conveyance in winder shaft

**Location:** Appin Mine Ventilation and Access Project, Menangle, NSW.

## Investigation information release IIR25-05

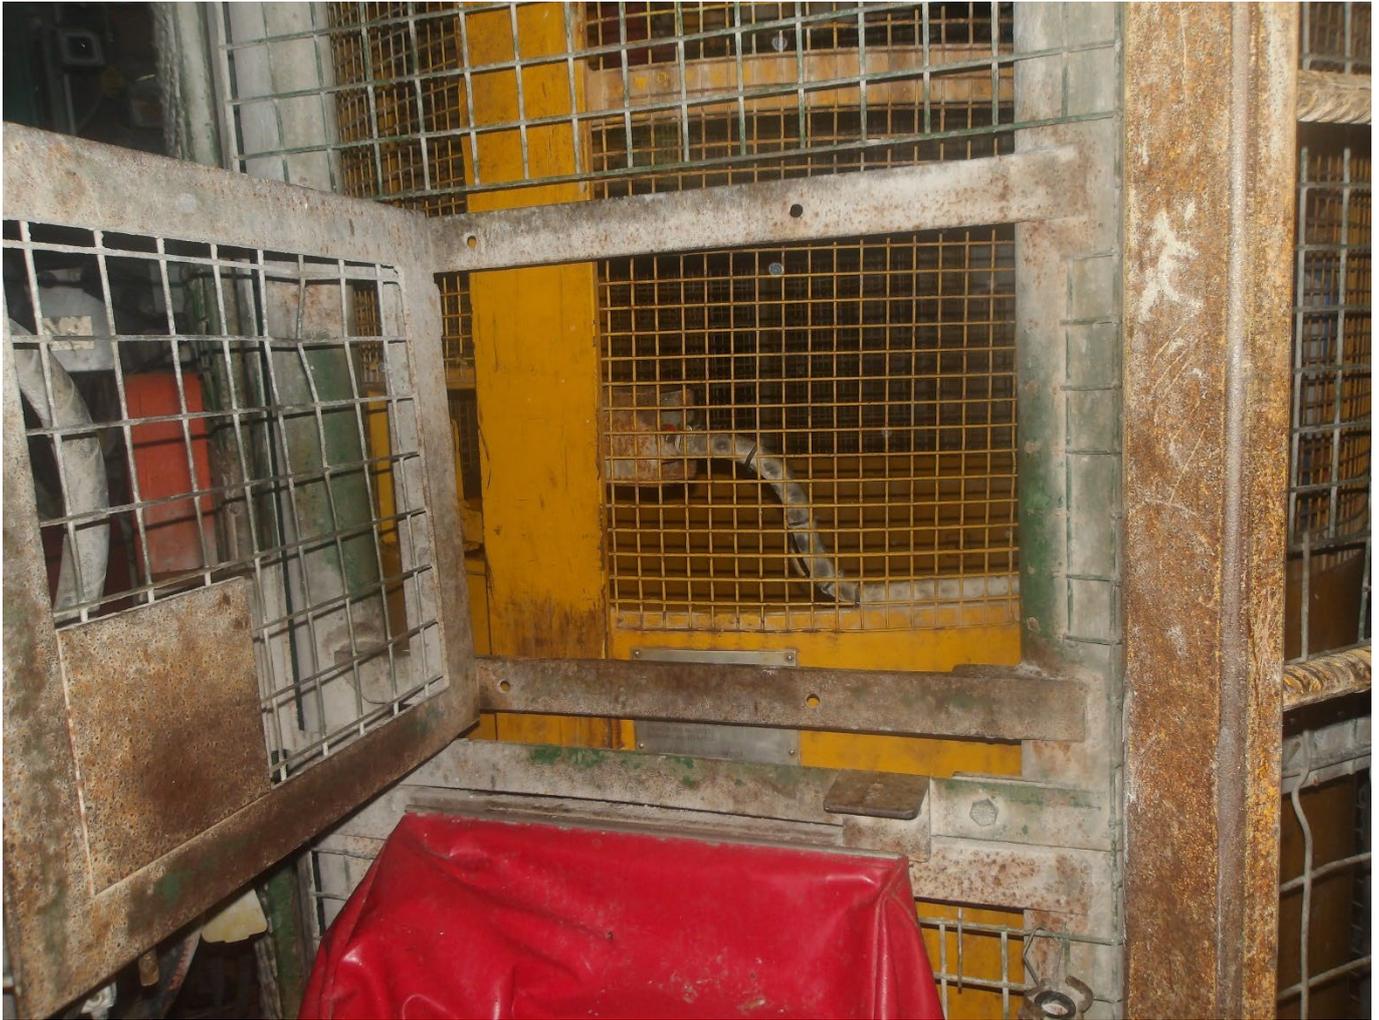
Figure 1: Personnel conveyance parked at stage level 4 adjacent to the hatch

A worker on stage level 4 of the vent shaft 8 winder was struck by a personnel conveyance travelling down the kibble well of the shaft sinking stage about 9.30 pm on 8 May 2025. At the time of the incident, the worker was attempting to provide verbal instructions to a mucker operator at a lower level. To communicate with the mucker operator, the worker extended his head and upper body through a hatch in modified guarding on the stage kibble well. The hatch was not interlocked with the winder control system. The worker suffered minor injuries to the neck and head.
