Safety Bulletin

Recent increase in heavy vehicle rollovers

This safety bulletin provides safety advice for the NSW mining industry.

Safety Bulletin SB25-03

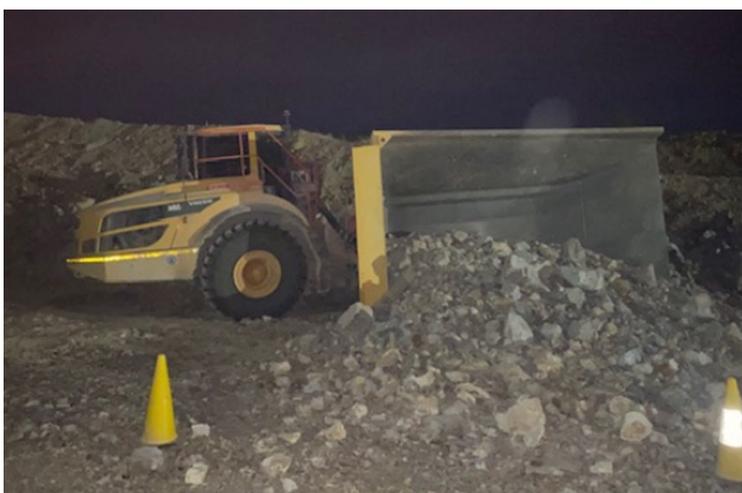
Figure 1: Reversing into windrow resulting in tub section rolling and discharging load

Mine operators should have procedures in place for tipping loads to ensure that loads are centred, and flow during tipping, and carry back is managed.

- Inspect ground conditions prior to tipping.
- Maintain situational awareness while operating mobile equipment and ensure that distractions do not interfere with safe operations.
- Report on defective equipment and not operate if the defect prohibits the safe operation of the equipment
- Drive to in a manner that allows them to retain full control of the vehicle in all instances though especially in wet weather and when recovering from wet weather events.

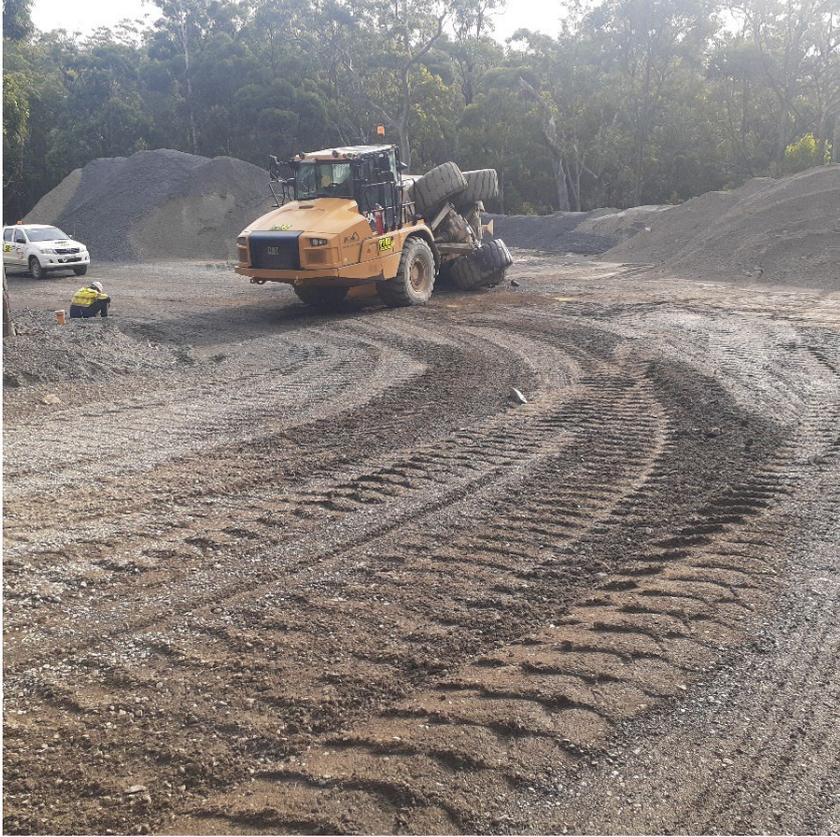
Figure 2: Loss of control on corner resulting in rear tub rolling

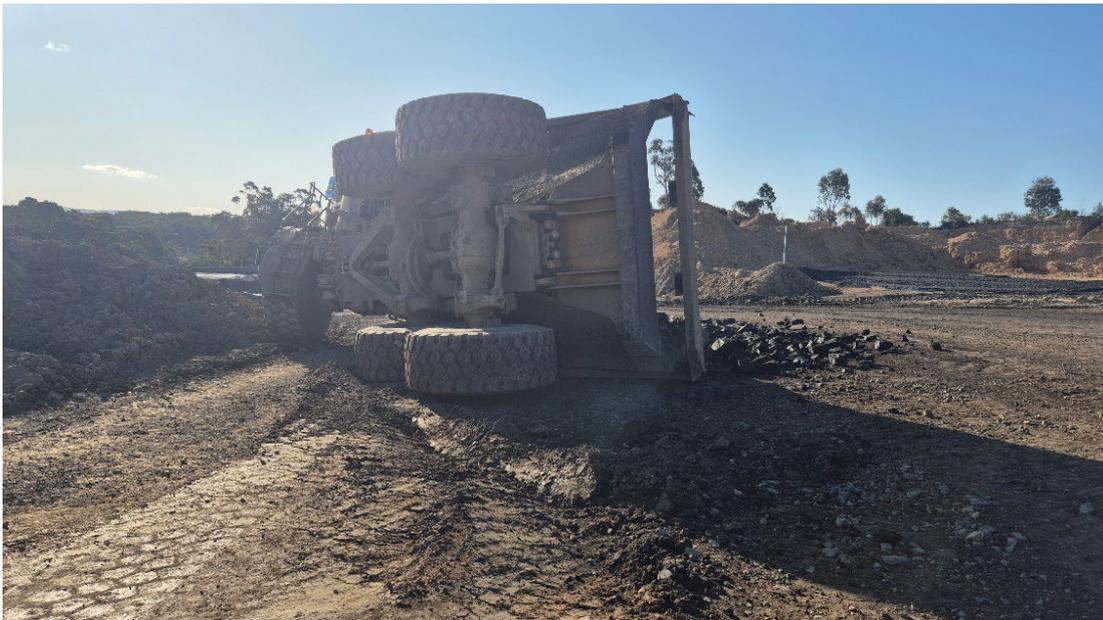
Figure 3: Road conditions contribute to rollover of rear tub

Mine operators should monitor that ground conditions are suitable for hauling, loading and tipping.

Road and dump areas must be maintained so that:

- Roadways and intersections are designed and constructed in compliance with site standards.
- Tip and dump areas are designed and constructed with suitable grades for tipping and turning.
- Tipping and dump areas have adequate bunding and windrows in place.
- Run-out tipping is avoided where possible and risk assessed when required.
