Weekly incident summary

Week ending 25 April 2025

Weekly incident summary week ending 25 April 2025

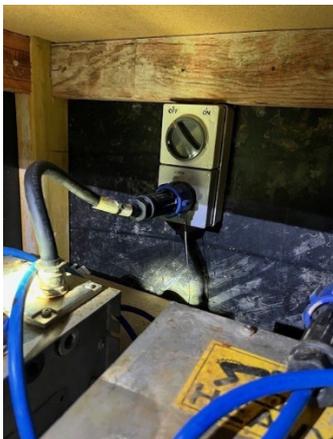
Incident type	Summary	Comments to industry
Dangerous Incident IncNot0048989 Underground coal Leave blank	<p>At the cage brace charging station for the man cage communications batteries, the shift electrician received an electrical shock and tripped the residual current device whilst replacing charged batteries.</p>

<p>Indirect contact with electricity may be caused by water or other conductive substances entering electrical equipment and providing a path across the surface of insulating materials that conducts the electricity to places and objects that are not normally energised.</p> <p>When developing control measures, mine operators should identify maintenance practices necessary to maintain the electrical equipment in the designed condition. This includes visual inspections, detailed internal inspections, and electrical circuit testing.</p>
Dangerous Incident IncNot0049001 Underground coal Fire or explosion	<p>A worker detected smoke and subsequently discovered glowing embers below a conveyor near the drive head/loop take-up area. The fire was extinguished using a fire extinguisher.</p> <p>The cause appears to be related to a conveyor tracking through the area with the belt rubbing on the fixed structure.</p>	<p>Workers conducting conveyor inspections must diligently inspect for fire risks such as accumulation of material, failing or collapsed idlers, and contact between conveyor belts and fixed structures.</p> <p>Mine operators must have systems in place to monitor, assess and prevent issues to avoid the risk of fire on conveyors, including belt wander devices in position and operating effectively to prevent contact between belt and structure. No worker should be hesitant to stop a conveyor if it poses a fire risk.</p> <p>Refer to Code of practice Mechanical engineering control plan for further information.</p>
