Weekly incident summary

Week ending 9 May 2025

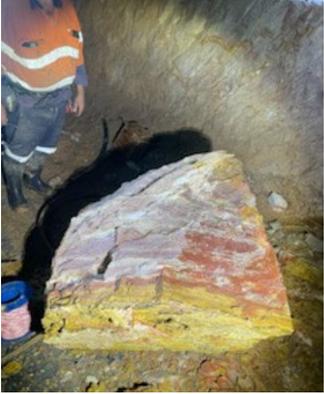
Incident type	Summary	Comm to industry
Dangerous Incident IncNot0049042 Underground metals mine Ground or strata failure	Two workers were charging a face when a large rock around 2 to 3 tonnes dislodged from a height of about 2.5 metres, grazing one workers' head, and striking him on the shoulder. The face was scaled earlier prior to work commencing.	Mine operators must assess the risk associated with ground and strata to identify all foreseeable hazards. Identified hazards must be managed in accordance with the hierarchy of controls. Face inspections should identify intersections of geological structures at risk of forming wedge failures and appropriate controls should be implemented to minimise the risk to workers.

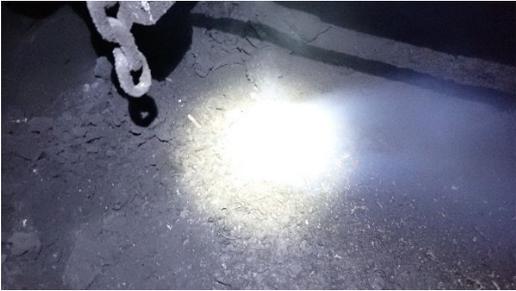
<p>Dangerous Incident IncNot0049044 Underground coal mine Fire or explosion</p>	<p>While undertaking a conveyor and thermography inspection, a deputy noticed haze and smoke coming from the ground.</p> <p>There was a glow from the ground and the thermography camera measured 264 degrees at that point.</p> <p>It was discovered that the return conveyor belting was rubbing on the return structure frame.</p> <p>The conveyor was shut down and the area was doused with water.</p>

<p>This incident illustrates the importance of conveyor inspections following work where changes have been made to the conveyor. Mine operators must plan to monitor and inspect conveyors after events such as bulk roller change out or conveyor belt replacement.</p> <p>Further information: Code of practice Mechanical engineering control plan</p>
<p>Severe Incident IncNot0049070 Underground coal mine Mine shafts and winding systems</p>	<p>A worker was struck on the head by a man cage as it travelled through the work stage in the shaft.</p> <p>The worker placed his head and shoulders through a hatch into the kibble well to communicate with the mucker operator below him.</p> <p>The worker was struck when the man cage was being lowered through the stage, with the chamfered edge of its base colliding with the worker's hard hat. The worker rapidly pulled his</p>	<p>This incident is currently under investigation.</p>

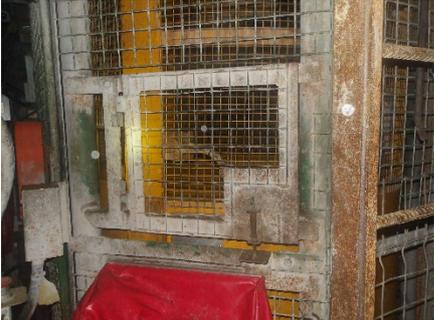
Incident type	Summary	Comm to industry
	<p>head back scraping his neck on the hatch sill causing a small abrasion, and neck soreness.</p>
