# Central West participatory ergonomics

Ergonomic initiatives

Published by NSW Department of Trade and Investment, Regional Infrastructure and Services  
Central West Participatory Ergonomics- Ergonomic Initiatives

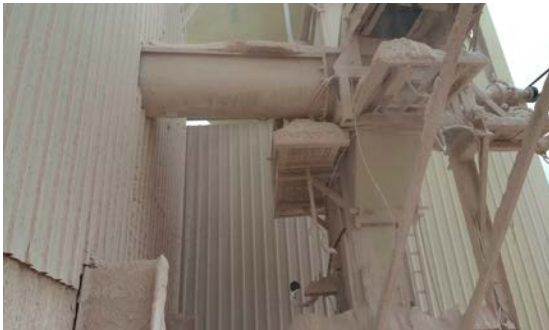
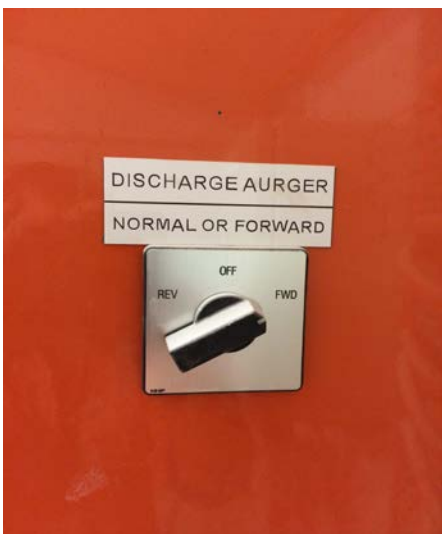
The augur became blocked or chocked from small mill balls of lime or increased moisture within the product.

Unblocking involved working at heights with an elevated work platform. In addition the operator would be required to use a heavy hose to unblock the augur or if this was unsuccessful use a needle gun that would require exposure to vibration for long periods of time.

Install a reverse switch on the augur control board. When a blockage occurs switch the augur in reverse for approximately five seconds, then change switch and 90% of the time the blockage is clear. If the augur remains blocked, open the air activated door on the bottom of the augur and run in reverse until emptied, then change direction back, shut door and operate. This will clear the blockage.

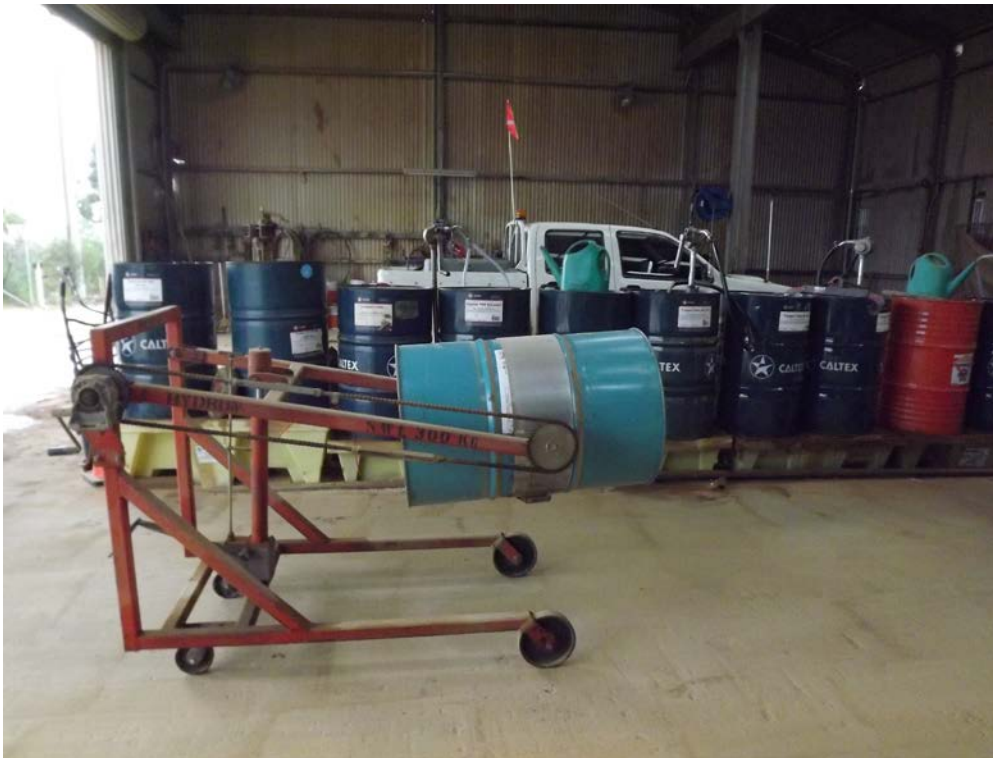
Dust suppression concentrate is supplied in 200Lt drums. These drums are stored in an area of the workshop not accessible with an overhead crane. The drums need to be manhandled to dispense the concentrate.

The implementation of a 200Lt drum lifter and mover to handle the concentrate. The lifting device has a winch system that can hold the drum in any position and a foot pump to help lift the drum in the air.

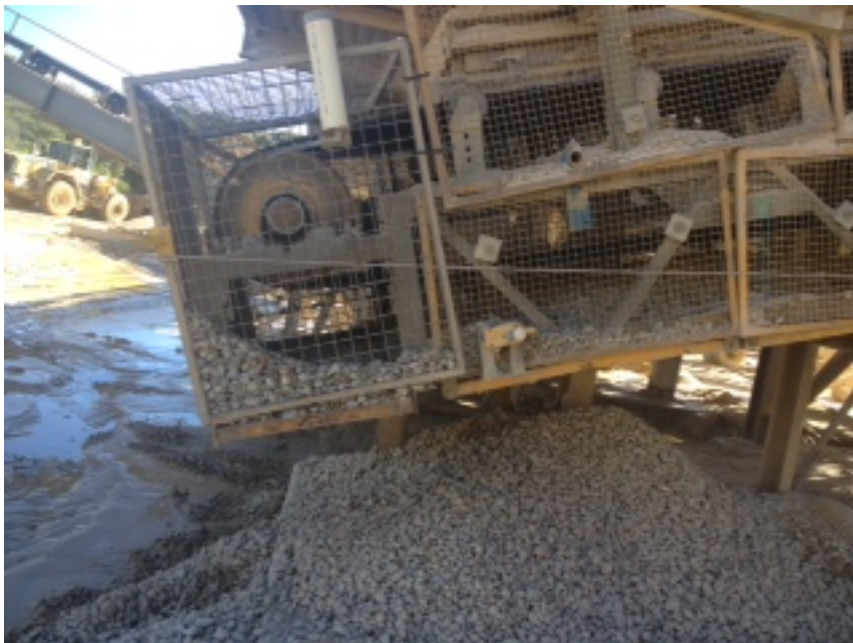
The build of material in the guard of the C9 trail drum roller, there are number of risk factors within job these include:

- Posture:
  - leaning over to undo the bolts
  - twisting when shovelling out materials
  - bending to scrape materials from the spillage area
  - crouching to reinstall tail drum guard
- Exertion:
  - High exertion to take the weight of the guard when full of material so the guard bolts can be removed
  - High effort in shovelling the material out of the tail drum area
- Repetition
  - This task can occur many times per week due to wet weather factors
- Vibration
  - Transferred vibration is experienced when shovelling material
- Duration
  - This task usually takes between 30 minutes to 1 hour to complete.

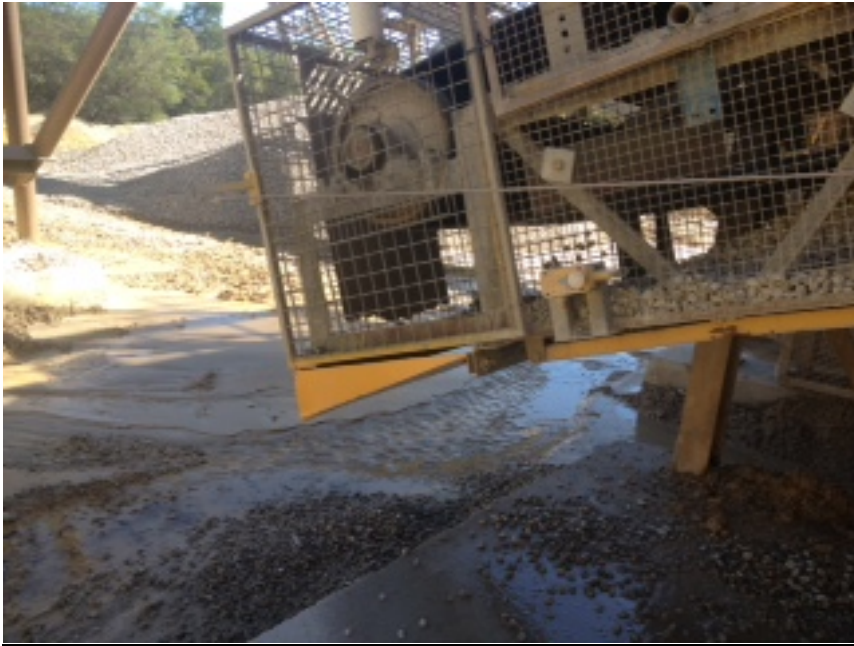
- Redesign tail drum roller guard so material can be cleared without removal of the guard
- Construct and install guard

The guard installation has now eliminated the hazardous manual task. Prior to the guard being created there was an 80% exposure rate to the hazardous manual task, with the installation of the newly designed guard the exposure risk for this task has been eliminated.

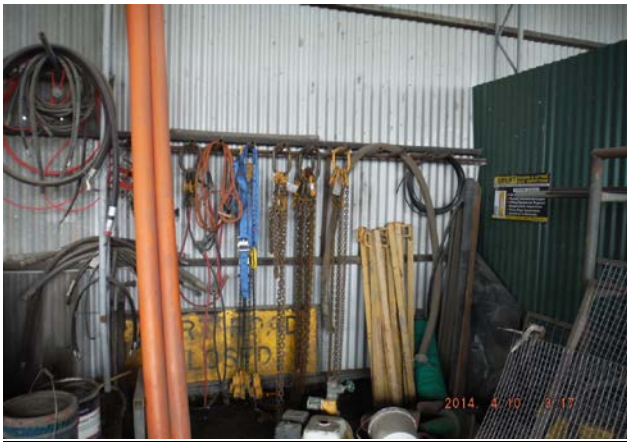
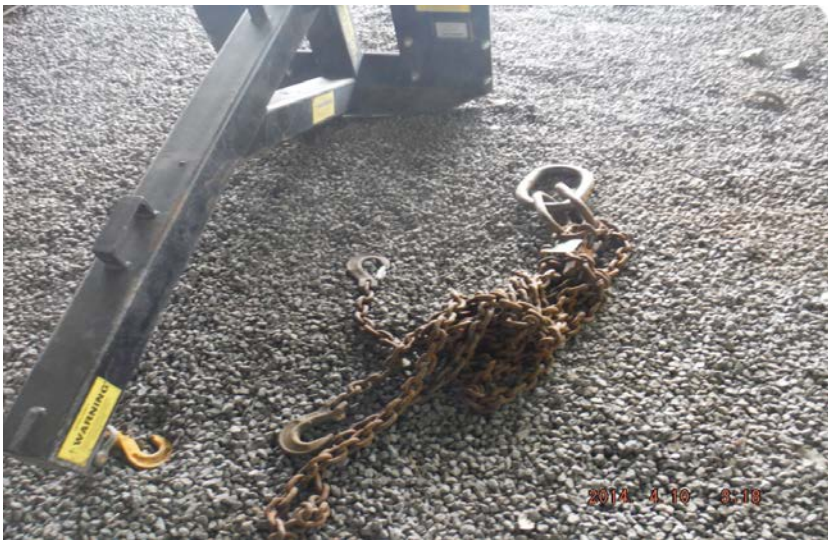
Lifting of chains at Molong was identified as a hazardous manual task. The issues identified by the work team include:

- Heavy lifting – some of the chains weigh approximately 40kg.
- The chains were being stored on the chain rack which required the workers to lift the chain above shoulder height to attach to the hooks.
- Due to the mass of the chains, people were not putting them away on the chain rack, and as such people were leaving them on the floor making them a trip hazard.
- Housekeeping was poor and objects were being placed in front of the chain hooks.

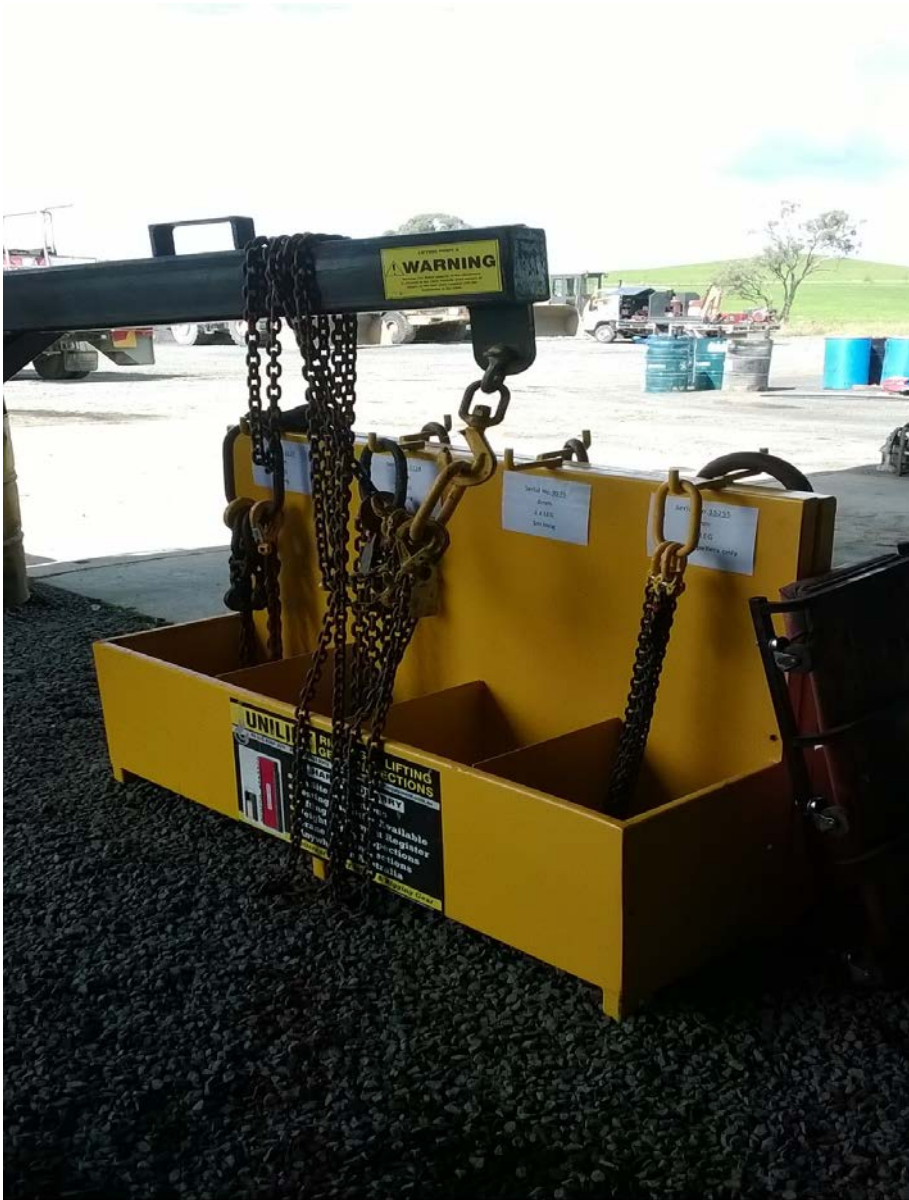
Developed with supplier a chain box, so the chains would be easy to put away, there is no awkward lifting and no trip hazards. Had seen something similar on site visit to Westtrac but the quarry decided to extend the chain box to include signs, and dates the chains need to be tested and tagged. Since implementing the solution it has reduced the hazardous manual component of lifting the chains has saved time and the staff know exactly where each chain should go.

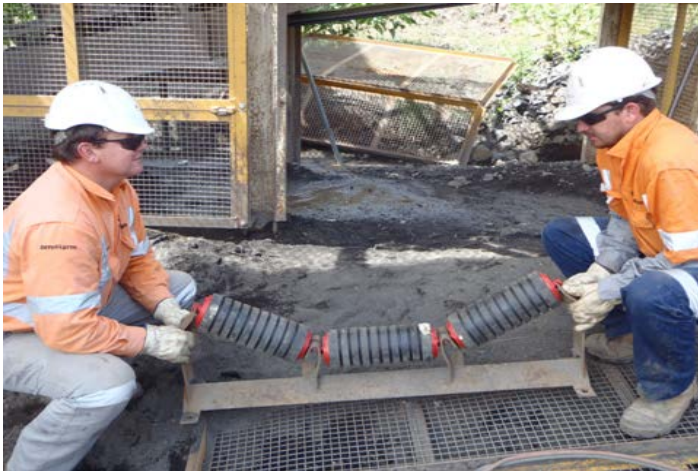
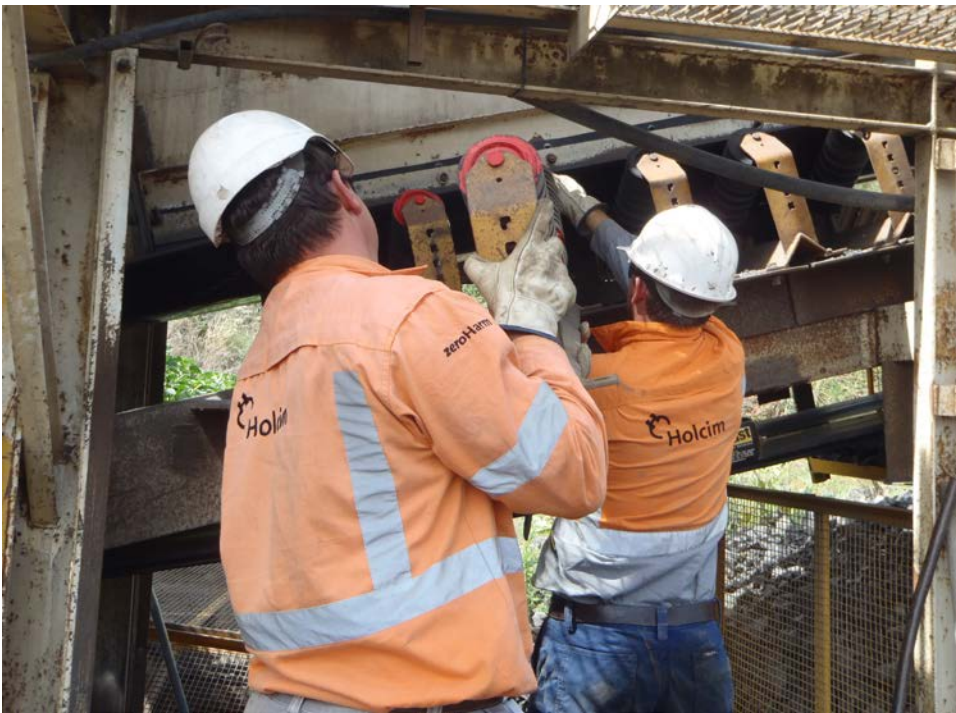
Finding a way to eliminate spillage and reducing the risk of injury when changing the impact rollers. To change the impact rollers required awkward posture, twisting of the back and heavy lifting with each of the impact rollers and frames weighing more than 40kg. In addition there is increased risk of exertion with the use of a crow bar and there was also the issue of increased risk of pinch points of the hand when undertaking the task.

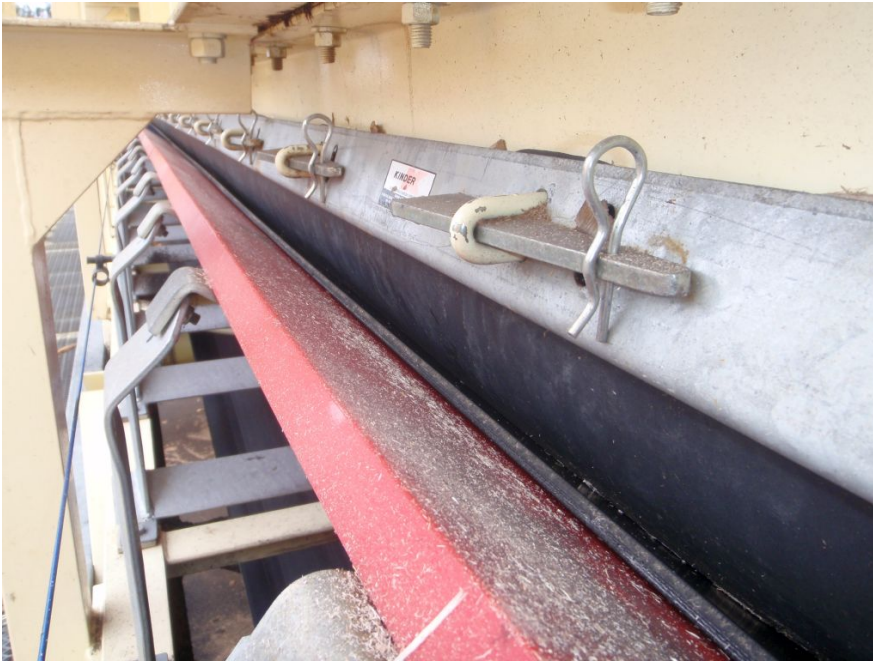
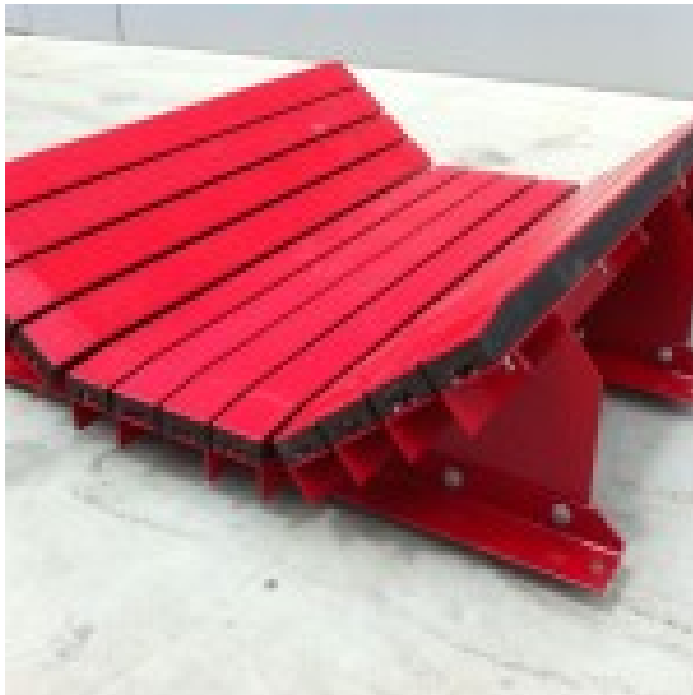
To remove the use of impact rollers and change to an impact bed, this would enable conveyor area to be at one level to improve the skirting rubber adjustment and minimise the deterioration of the skirts. In summary positive outcome as a result of the changes include:

- Less spillage due to support under impact zone
- Less rollers to maintain

- Less hand movement from using the spanner and less vibration from using a rattle gun when adjusting skirting rubber
- Less time spent adjusting the skirting rubber due to support of the impact zone
- Less manual handling issues

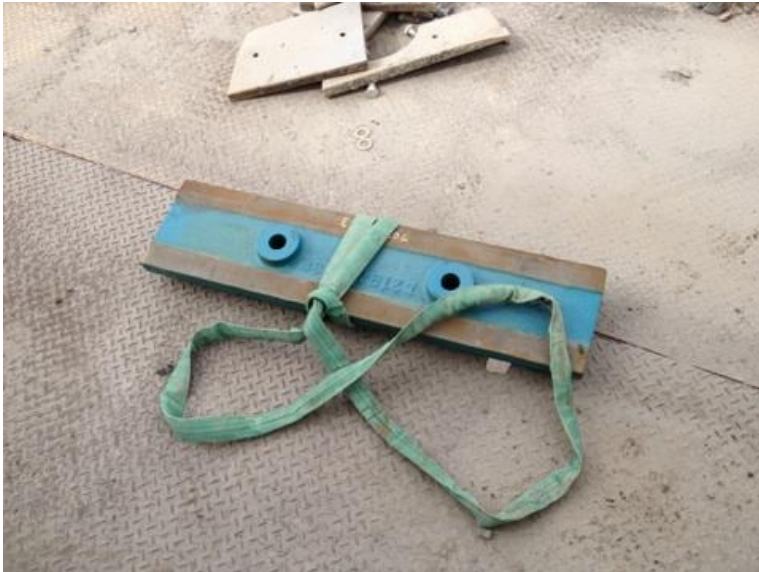
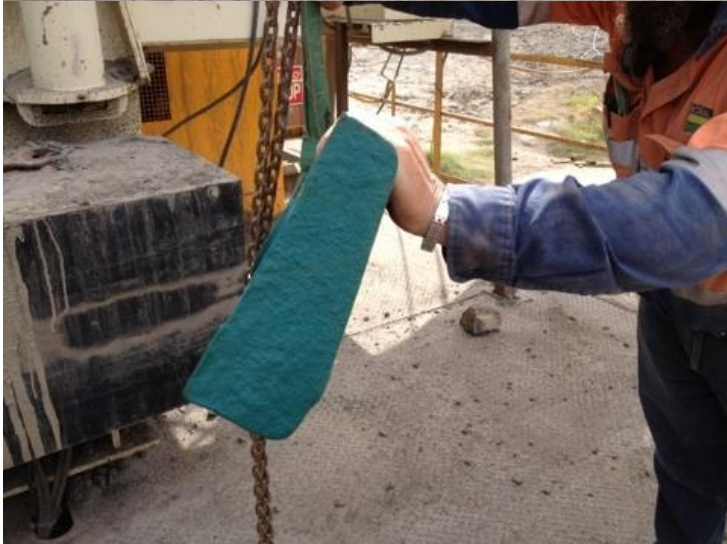
Previous way to install the plate was with a sling, you manually had to push the plate into position which increased the risk of pinch points with the hands. The team was also required to locate the holes for the bolts with the sling holding the plate out of position. The plate weighs 200kg.

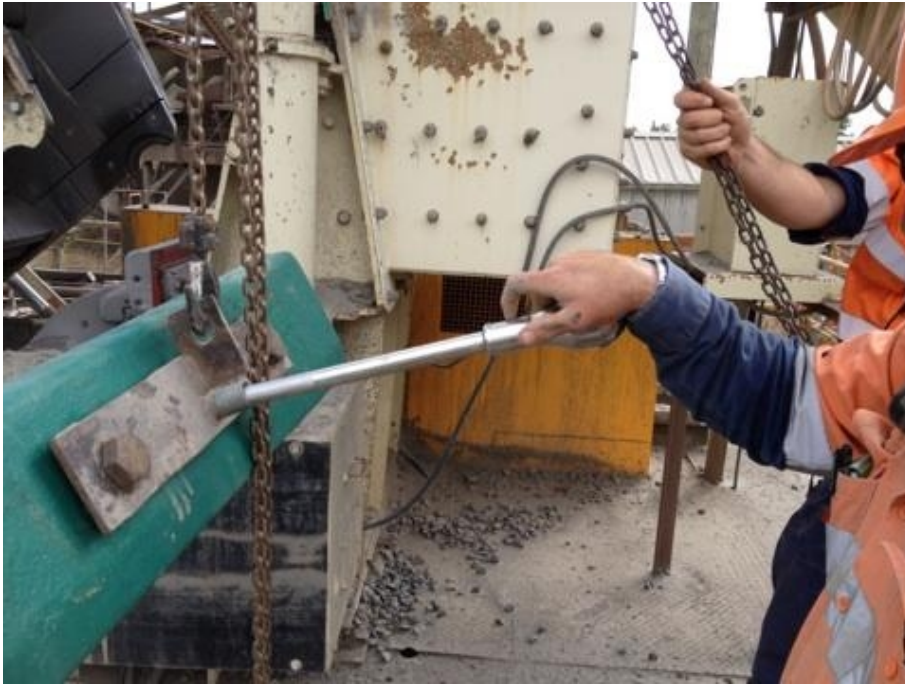
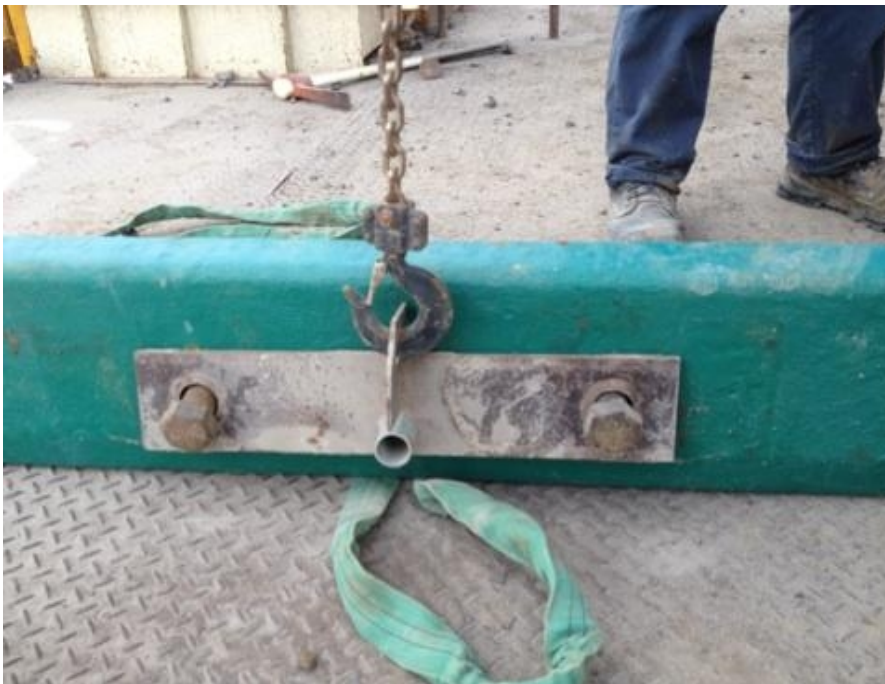
Design a tool to minimise the manual handling required when installing breaker plates. The design of the tool allows for the correct location of breaker plate mounting points which reduces the exposure of hands to the plate minimising risk of pinch points. It has also minimised manual handling required by exertion and awkward position.

It has made the job safer as it has reduced the exposure to pinch points, the exertion required to move and hold the plates and the posture required to get inside the crusher to manouver the plate.

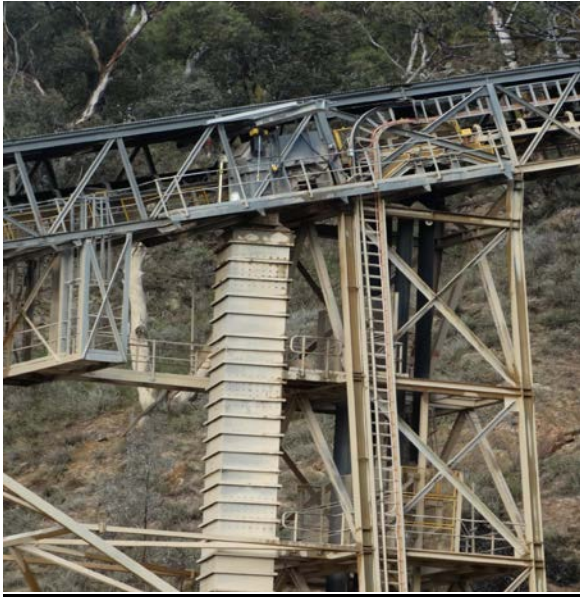
Install a new mono rail beam with electric hoist, to raise tools and part to each level of the scalps chute.

It reduces the need to carry all material up several flights of stairs. It has also reduced the time to repair the scalps chute, by approximately five hours.
