MINE SAFETY INVESTIGATION UNIT

INFORMATION RELEASE

Fatality

Incident date	9 September 2014
Event	Track mounted excavator tip over
Location	Karuah Quarry, Karuah NSW

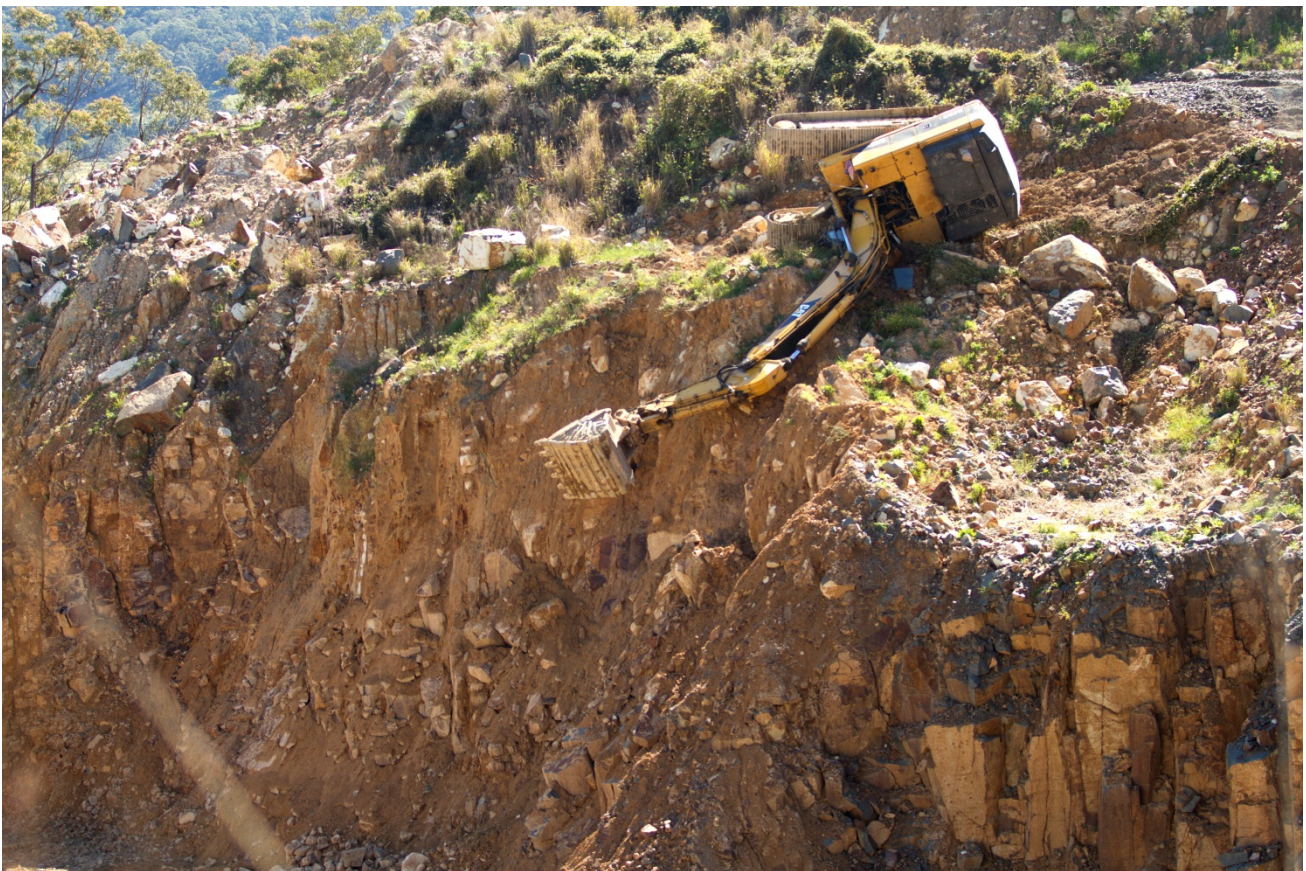
Image 1: Resting position of excavator at top of quarry face - Photograph by Investigation Unit

The excavator rolled onto its left-hand side, down slope, resulting in fatal injuries to the operator.

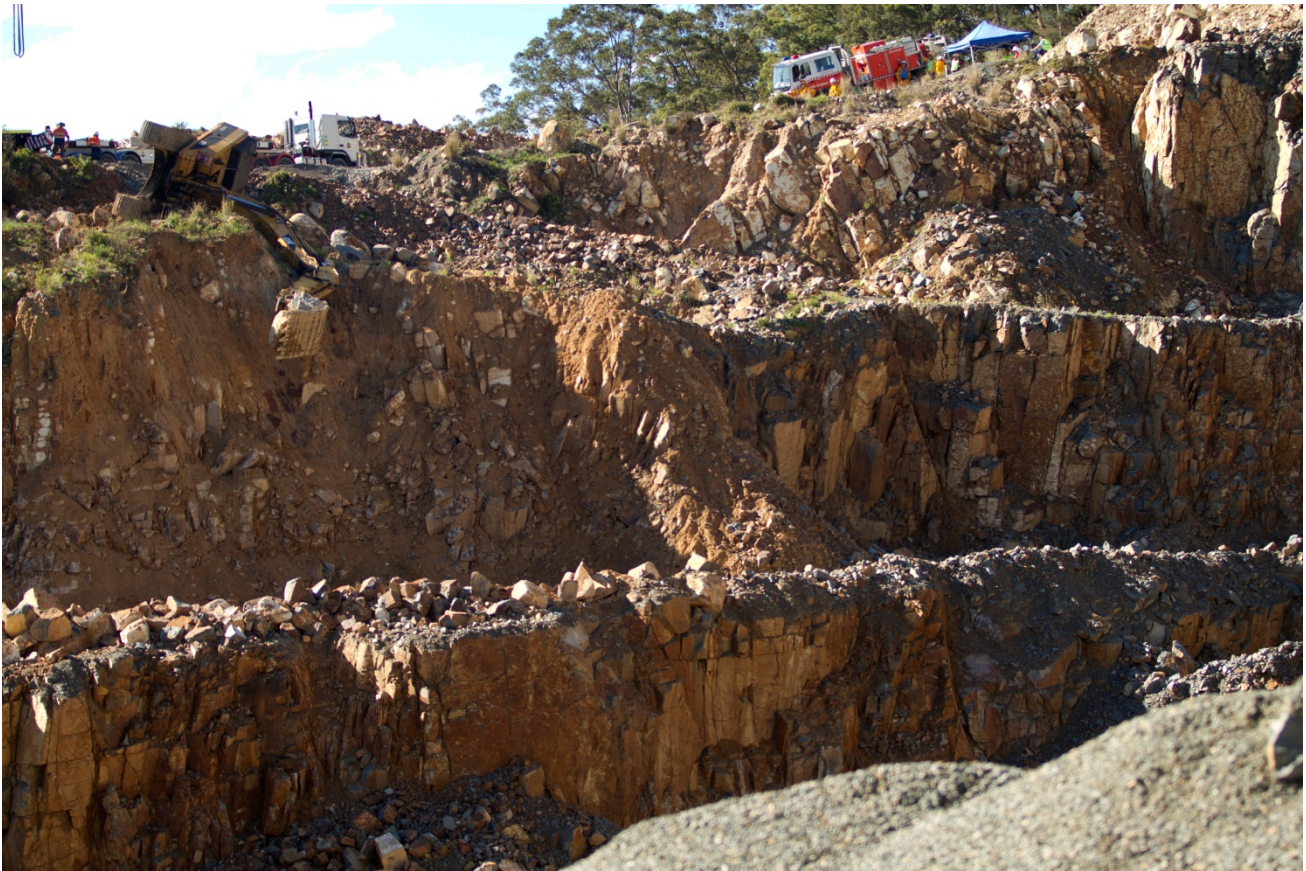
There was a vertical drop from the top of the face to the bench below of about 12 metres.

A number of large rocks and boulders were sitting on the sloping ground above the quarry face and the bench below.

Image 2: Bench and quarry face –showing rock in excavator bucket - Photograph by Investigation Unit

The excavator bucket was found to be holding a large rock weighing about 3 tonnes.

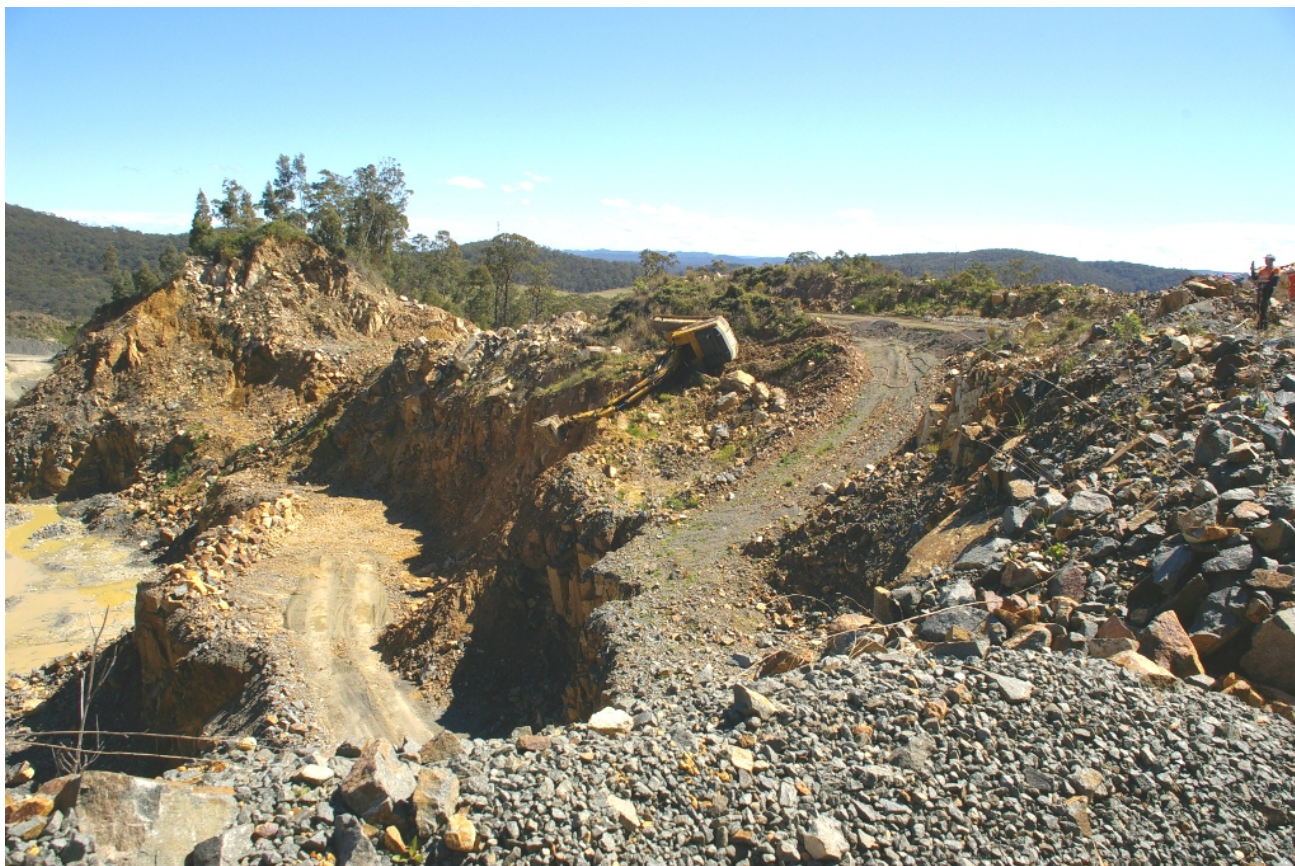
The face is about 20 metres to the east of the road and pad area, with the intervening space comprised of sloping unimproved ground. The gradient of this slope will be determined as part of the ongoing investigation.

Image 3: Position of excavator between road and face - Photograph by Investigation Unit

A large rock was positioned between the excavator's track marks.

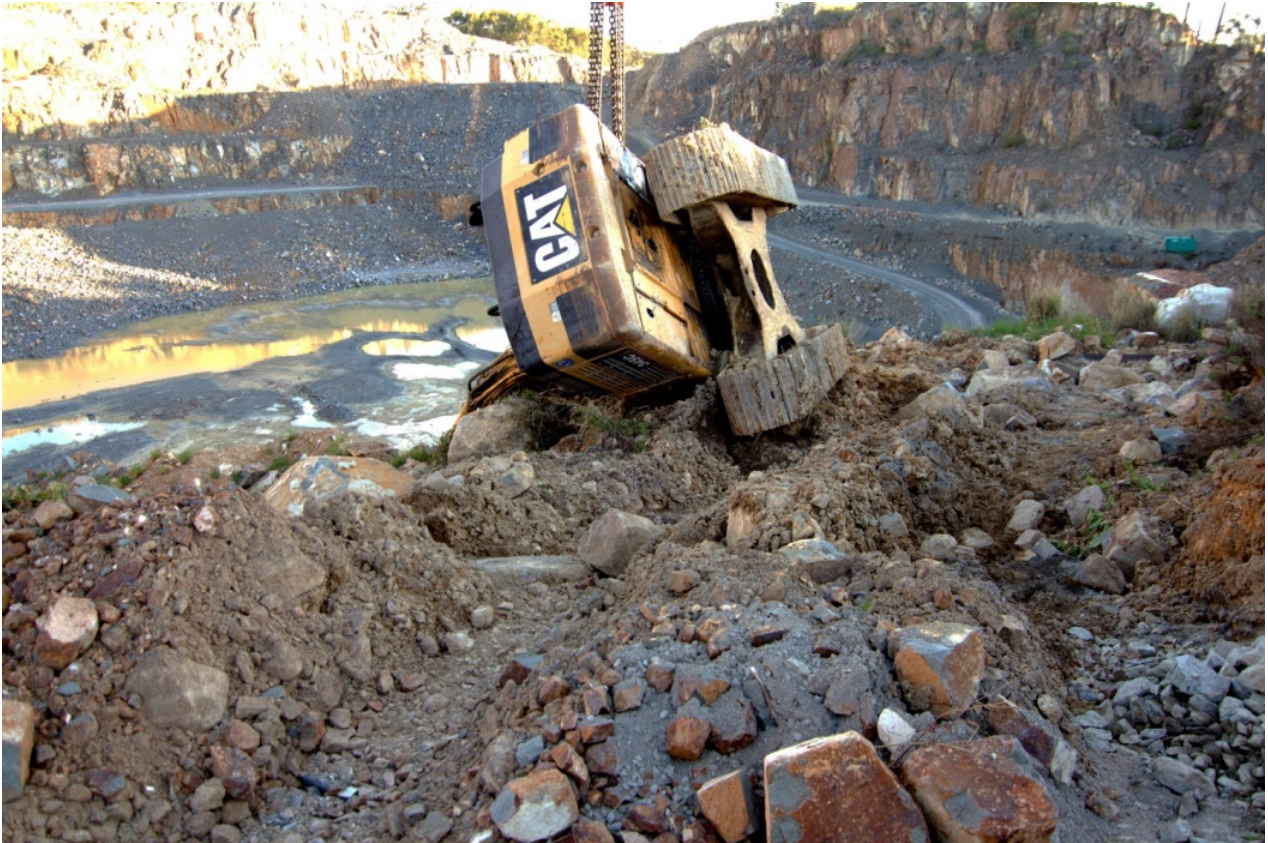
Investigators are examining what factors caused the machine to exceed its tipping point.

Image 4: Orientation of superstructure to the track frame on excavator - Photograph by Investigation Unit
