# SAFETY ALERT

## Draw bar failure on dog trailer

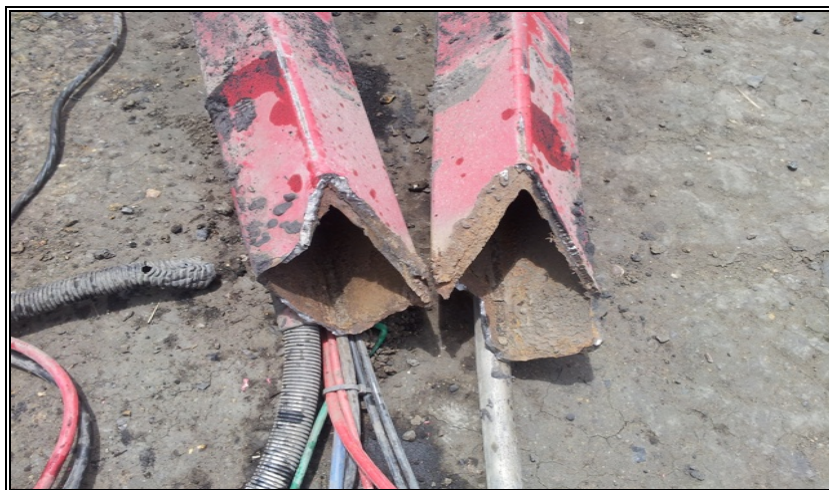
As the loaded vehicle drove away, the drawbar on the dog trailer catastrophically failed at the welded area adjacent to the ring hitch, see figure one. The truck and trailer was transporting coal on private and public roads.

*Figure One – Failed drawbar on dog trailer*

1. When material was tipped out of the truck body the dog trailer was turned to the side and the draw bar would have contact with the tyres or the truck structure. This caused side loading on the drawbar. This was standard procedure.
2. There was no evidence of any inspection on the dog trailer drawbar area to pick up any damage or defects.

Mines should have a system to ensure all road registered trucks operating on the site are periodically checked for structural integrity. This system should be part of the mine's mechanical engineering management plant and should include –

1. Inspection of all drawbars, couplings, pins and other structural components.
2. Visual inspection by a competent person of the drawbar connection.
3. An independent Non-Destructive Testing inspection of the drawbar connection and an inspection report, at periodic intervals depending on the duty cycle.
4. A review of the mine's tipping rules for truck and dog trailer combinations to prevent side loading on the drawbar and coupling. Task-based observations should be completed on a routine basis.
5. Carrying out periodic audits on the equipment and system to measure the effectiveness of the inspections.
