# SAFETY ALERT

## Failure of explosion protected diesel engine system

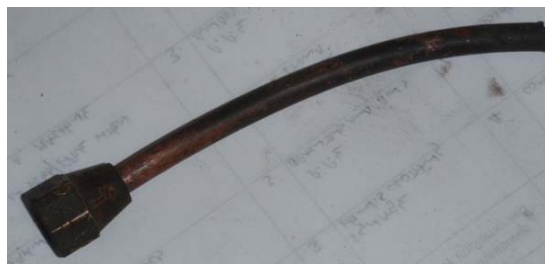
The vehicle was being driven along a main underground transport road when the operator witnessed sparks coming from under the dash. A copper pipe used to gather raw gas samples from the exhaust manifold test point had catastrophically failed.

Cu pipe fatigue crack.

Raw exhaust & sparks coming out of here

*Aftermarket 1/4" Cu pipe extension tube*

The copper pipe extension was installed to assist in routine raw exhaust gas sampling. While it is uncertain, the sparks were most likely from hot carbon particles in the raw exhaust of the diesel engine system, glowing as they become oxygenated in the atmosphere.

Any extension to the gas test point connection at the exhaust manifold is subject to significant vibration, potential inadvertent damage, fatigue and/or heat affected failure. Copper pipe may become brittle and be subject to fatigue cracking in situations of frequent vibration and/or excessive heat.

1. Diesel engine systems should not be altered unless the alteration is design registered.
2. All mines and owners of diesel engine systems should check their diesel engine raw exhaust gas points for unauthorised alteration, such as copper pipe extensions, wrong fittings and exhaust flametraps in lieu of caps.
3. If found, immediately remove all extension pipes to the gas sample point and plug the test point with an appropriate fitting, where this has not been accessed as part of the design registration for the diesel engine system.
4. If remote sample points are required for raw gas testing, then use an appropriately purpose built sample line and immediately after testing is complete, remove the sample line and block off the sample point back at the exhaust manifold with the appropriate fitting
