# SAFETY ALERT

## Deputy crushed by load haul dump machine attachment

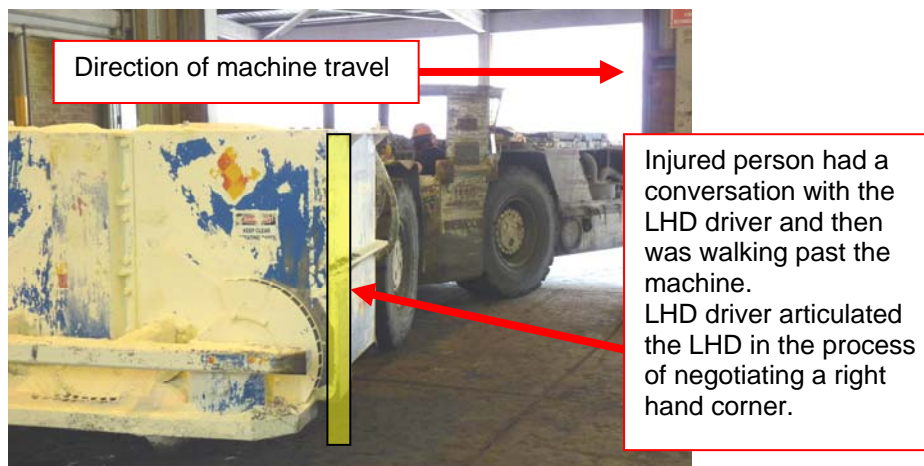
The shuttle car cleared the travel route and the LHD operator commenced to turn right to clear the roadway. The LHD operator was facing in the direction of machine travel and was not aware that the deputy had not cleared the No Standing Zone of the machine.

The deputy was still in proximity to the moving machine in a position of danger. The deputy was struck by the bumper bar of the stone dust pod as the LHD articulated to negotiate the right hand corner.

- Audit and review the compliance with No Standing Zones around mobile machinery.
- Ensure Transport Management Plans and mine rules are implemented.
- Ensure mine rules and schemes related to No Standing Zones are positively enforced.

- Ensure, in particular, that machine operators and supervisors enforce compliance with No Standing Zones around mobile equipment.
- Ensure a system of positive communication between machine operators and pedestrians is in place to ensure people are not located in No Standing Zones before mobile machinery moves.

- Review and identify the application of proximity detection devices to minimise the risk to the lowest level reasonably practicable with reference to *Occupational Health and Safety Regulation 2001*, clause 5 Hierarchy of Control – engineering controls.
