DATE: DECEMBER 2018

Walkway collapse puts workers at risk

This safety alert provides safety advice for the NSW mining industry.

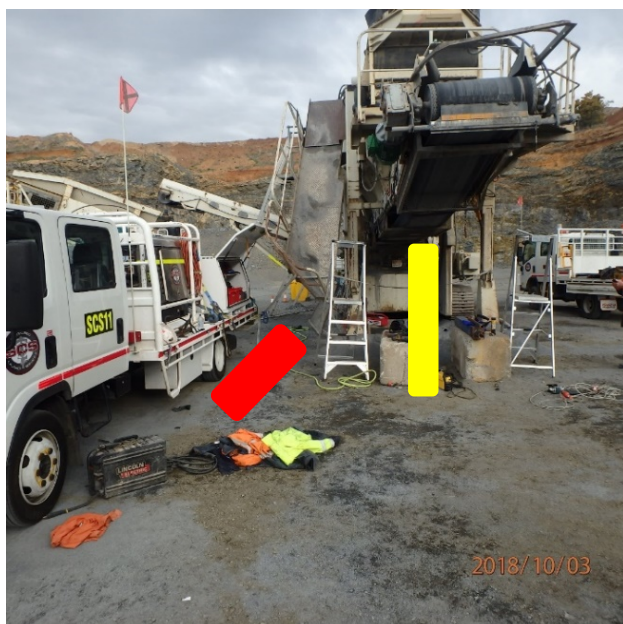
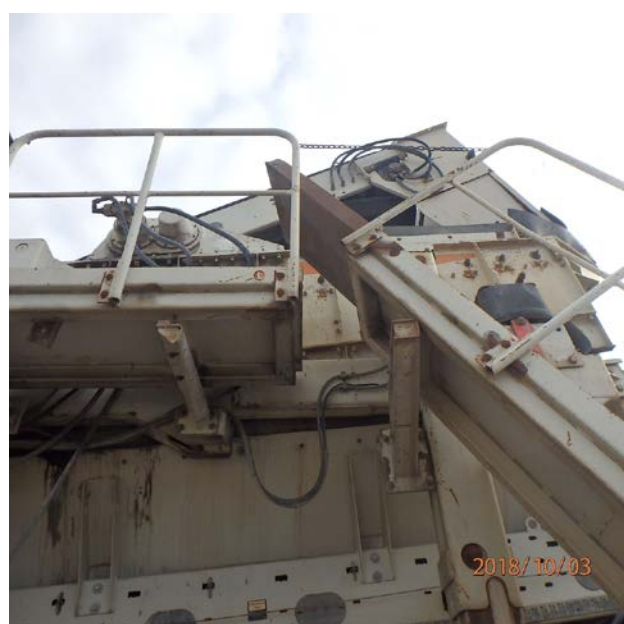
A contract leading hand supervisor (heavy plant fitter) fell about four metres to the ground when a platform walkway pivoted at a junction after supporting bolts were undone during maintenance at a quarry. There was an alteration to the maintenance task from the originally planned task.

The worker was on the end of the walkway and was ejected from the walkway when it collapsed. The worker suffered a dislocated right shoulder and fractures to his right shoulder. After hospitalisation, he had a brace fitted to his shoulder. Another worker at ground level was at high risk of injury from the collapsing walkway.

Photographs 1 and 2: (Left to right) View of the collapsed walkway adjacent to the service truck. The injured worker (depicted in red) and the worker adjacent to walkway (depicted in yellow). (Right) View of the pivoted walkway. (Photographs by the Resources Regulator)

1. Contractor management systems to ensure adequate monitoring and evaluation of compliance for tasks undertaken by contractors.
2. The competency requirements of supervisors to ensure effective risk management of maintenance tasks and contractors undertaking the tasks.
3. Risk management processes to ensure effective identification of hazards and implementation of appropriate controls during change management for planned task assessments. Ensure that appropriate information is provided to contractors undertaking maintenance tasks on equipment.
