SAFETY ALERT

BYPASS OF ANTI CLIMB BARRIER TO OVERHEAD POWER LINE

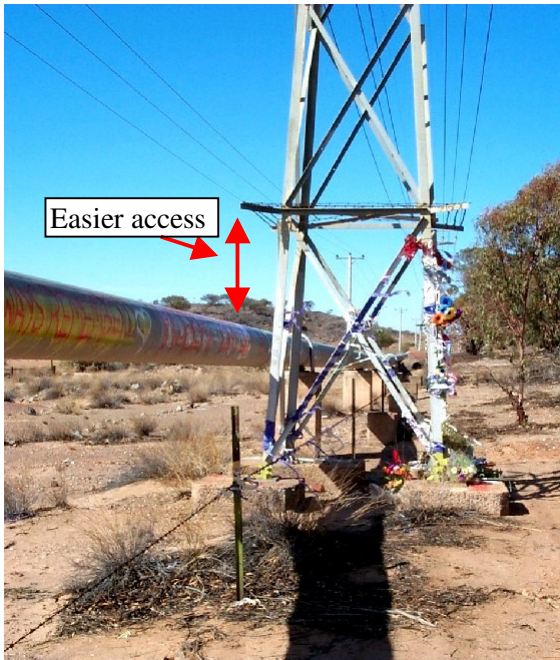
Photo 1

An elevated pipeline which was installed near the towers may have provided a pathway to bypass the *anti climb* barriers.

At the time of the incident:

- pipeline may have provided an easier path to bypass the anti climb barrier
- anti climb barriers have minimal external extension
- anti climb barriers have no prevention of internal access.
