SAFETY ALERT

HAUL TRUCK TIPS ON TO BACK WHILE DUMPING AT STOCKPILE

Report No: SA 04 -24
Comet ID: 317516030001
Date: 08/10/2004
Prepared by: Mat Barnes
Phone: (02) 4942 2300

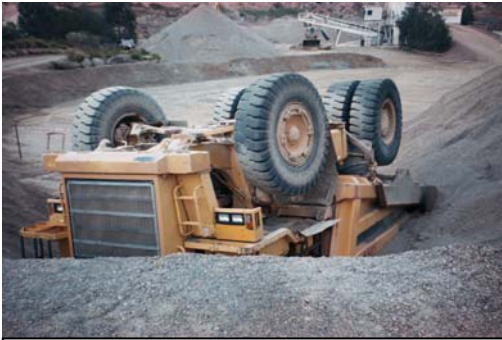
Truck on back where front-end loader had been removing material

This incident may have been far more serious as a short time before the incident a front-end loader was at the base of the stockpile removing material. The rear dump truck may have come into contact with the loader. The operator risked serious injury when jumping from the dump truck.

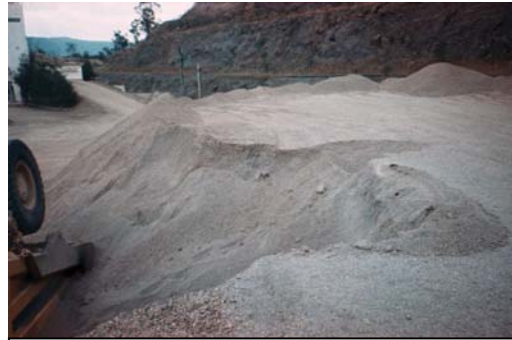
Top of stockpile – Note: bunding not sufficient to stop truck rolling

- Procedures were in place requiring a protective earth bund to be maintained along the edge at the top of the stockpile but they were not followed.
- The dump truck operator was reversing near the blind side of the stockpile.
- The weather conditions and visibility were good at the time of the accident.
- The dump truck operator was competent.
- The dump truck was in good mechanical condition.

- Review risk assessments, standards and safe work procedures for tipping on and management of stockpiles.
- Ensure adequate training, inspection, maintenance and supervision for compliance with stockpile standards.
- Ensure that operators of heavy vehicles fitted with a ROPS understand the need to wear seatbelts.
- Cabins of all vehicles should be cleaned and free of unsecured objects that may injure a person during an accident.

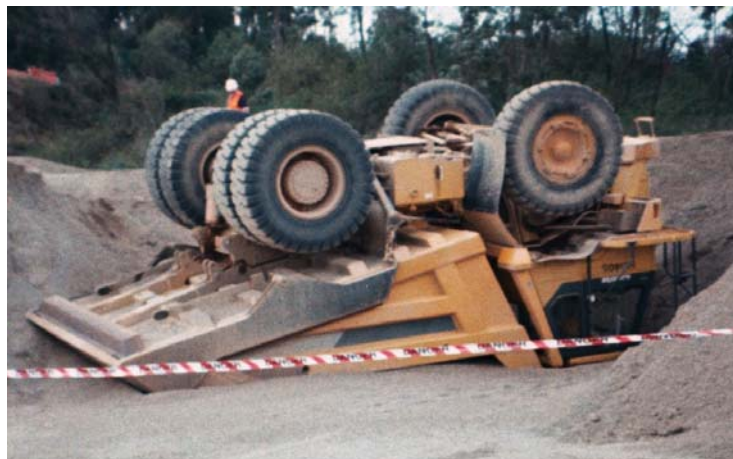
Truck on back - Note: ROPS kept cabin intact
