# SAFETY ALERT

## INJURY TO EXCAVATOR OPERATOR

Report No: SA05-04  
File No: 05/1521  
Comet ID: 317519933001  
Prepared by: Angus Mc Douall  
Date Created: 05 April 2005

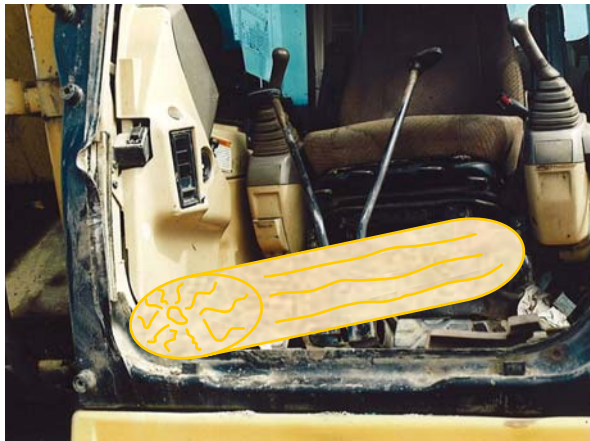
As the excavator slewed towards the truck, both poles dislodged. One pole fell to the ground, while the other speared into the operator's cabin.

**Direction of the pole**

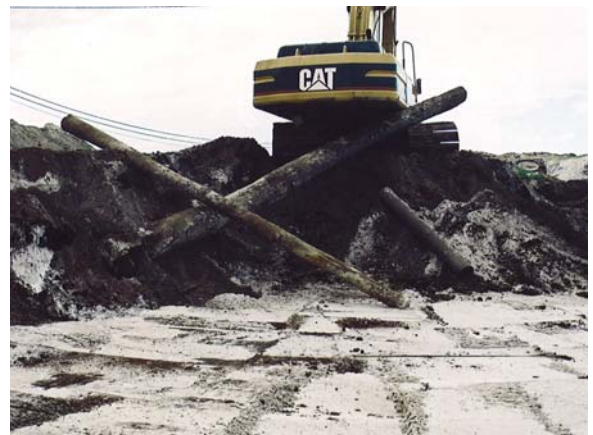
**Poles final resting place**

The pole lodged against the track controls, driving the machine forward. This resulted in the pole jamming across the operator's leg and into the access door. It was not able to be determined whether evasive action by the operator knocked the slew control or whether the end of the pole came into contact with the lever. Fortunately the cabin rotated to the left and the pole was released.

- The operating conditions, weather and visibility were not considered to have contributed to the incident.
- The excavator was well maintained and performed its functions as per design, however the absence of a log grab contributed to the incident.
- A log grab for the excavator was owned by the company, but was not available on site.
- Documented work procedures were in place for general earthmoving activities.
- Accepted work practices had been established for the removal of nuisance timber in the overburden.
- The event consisted of a change from normal work practises.

Review risk assessments and safe work procedures to ensure that all-potential hazards associated with earthmoving have been identified and controlled.

Ensure that fit for purpose equipment is available on site and is used when activities differ from core earthmoving work.

Review the adequacy of windscreen protective devices where materials are handled that have the potential to be propelled towards the cabin.
