DATE: APRIL 2018

## Increase in shattered windscreens on mobile plant

This safety bulletin provides safety advice for the NSW mining industry.

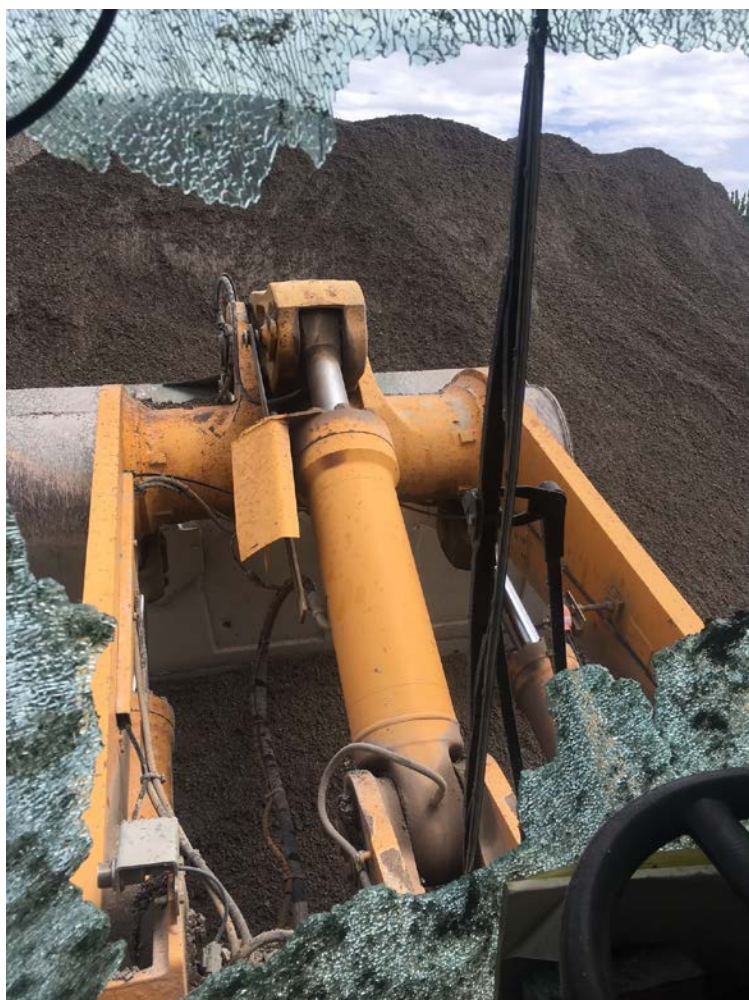
**Figure 1: Rock in the loader bucket fell backwards rolling off the tilt cylinder into the cabin. (SinNot-2017/00529)**

**Incident 1:** A front end loader was on the final product road base stockpile. The loader operator crowded the bucket forward to tip material out and then crowded back. When crowding back, a 20 mm rock struck the windscreen causing it to shatter. In this case the operator was not injured.

[MDG15 Guideline for mobile and transportable plant for use at mines \(other than underground mines\)](#) offers guidance in relation to an operator's cabin and protection. In relation to windscreens, a risk assessment should be conducted to determine the required glass specification for protection from impact and pressure, and as a minimum, recommends windows should only use laminated glass.

- install laminated glass as a minimum standard
- provide sufficient technical information of the glass (including various options) offered in the mobile plant for end users to consider as part of their risk assessment activities.

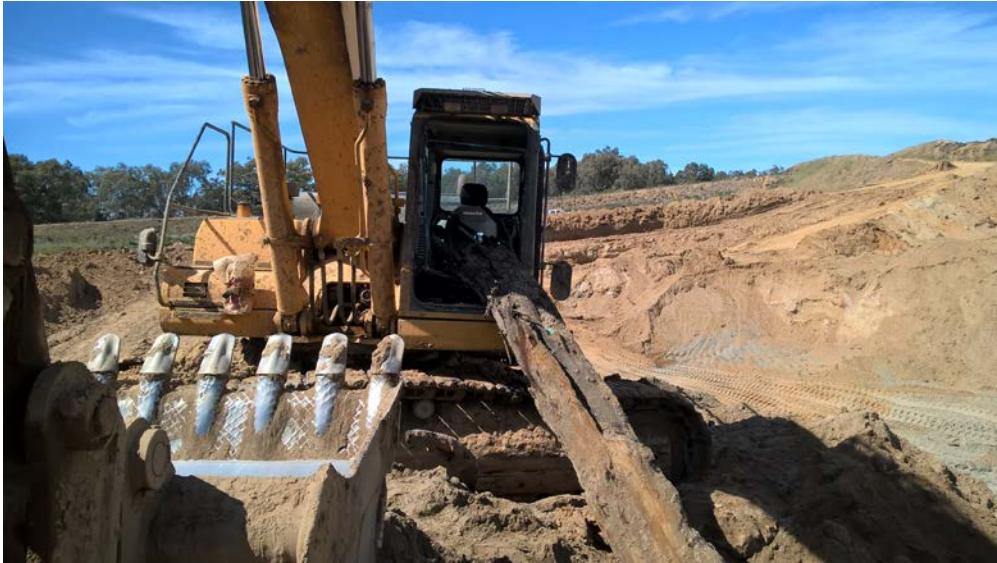
Figure 2: While lifting a log with an excavator, the log slipped and entered the cabin front window. (SinNot-2017/01622)

**Incident 3:** An excavator was in the process of removing a log about 3 m long from where it was buried in sand when the log slipped and went through the windscreen. It landed on the cabin 'travel controls'. The operator suffered minor finger lacerations.

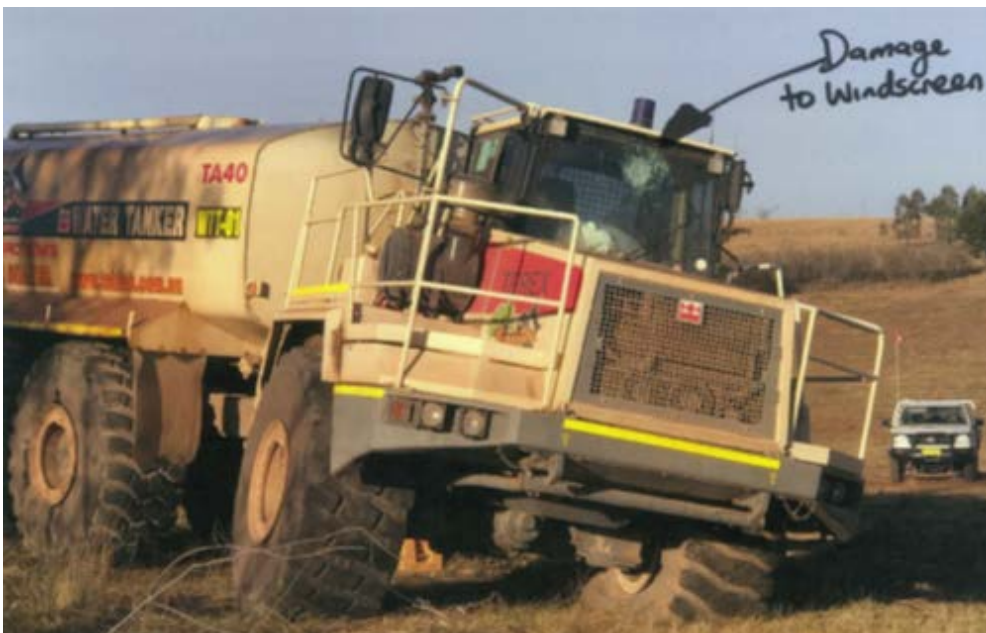
Figure 3: A piece of wood ejected from a mulching machine struck the windscreen of a water cart. (SinNot-2017/01683)

**Incident 4:** A mulching machine and water cart were clearing scrub and timber. As the water cart re-entered the work area, a piece of wood about the size of a soft ball spat out of the mulcher and travelled about 30 m before hitting the water cart's windscreen at the operator's head height. The result was a smashed windscreen, but no glass entered the cabin. The driver suffered no injuries.
