WEEKLY INCIDENT SUMMARY

Week ending Friday 21 August 2020

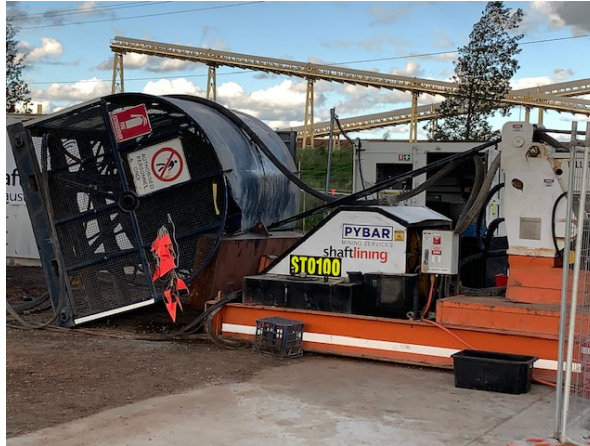
INCIDENT TYPE	SUMMARY	COMMENTS TO INDUSTRY
Dangerous incident IncNot0038029 Underground metals mine	<p>During shaft-lining operations, a winch cable snapped, resulting in a shotcrete hose-reeler moving about two metres and hitting the back of the shaft-lining rig.</p> <p>Up to 700 kilograms was suspended from the shaft-lining rig at the time. The lining rig weighed about 12 tonnes and was on the ground near the shaft opening. The cable reeler weighed about two tonnes and was behind the lining rig.</p>	<p>Winch ropes should be regularly inspected during all tasks. Triggers for rope replacement should be determined according to the task, the rating of the ropes and the risk associated with rope failure.</p> <p>Mines must identify all risks associated with rope failure and implement controls to protect workers in the event of a failure, such as safe standing zones and remote operation.</p>

Plant that has the potential to move under strain should be secured in position where possible.
