WEEKLY INCIDENT SUMMARY

Week ending 5 April 2019

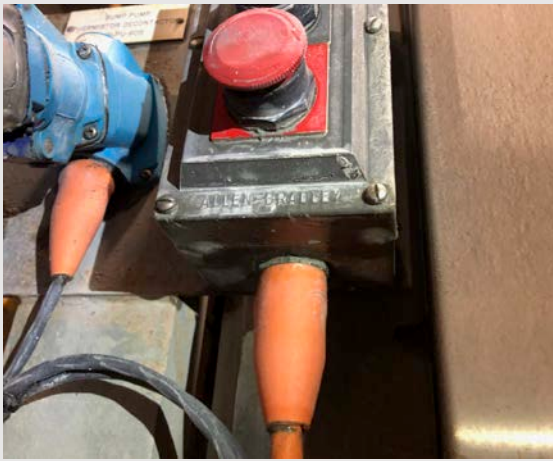
<p>Dangerous incident IncNot0034292</p>	<p>A worker suffered an electric shock in a metalliferous processing plant. A water leak was spraying over the pump control station. The worker activated an emergency stop and suffered an electric shock. The worker was cleared of injury. An investigation identified water ingress into the switch which had made contact with the 110-volt supply. As there was no earth connection within the switch, it remained live.</p>

<p>In areas prone to water spray, electrical equipment should have a suitable IP rating. Where 110-volt control systems are installed, earthing arrangements should be confirmed and the use of extra low voltage control systems should be assessed.</p>
