Weekly incident summary

Week ending 3 February 2023

Document control	
CM9 reference	DOC23/24824
Mine safety reference	ISR23-04
Date published	10 February 2023
Authorised by	Deputy Chief Inspector Office of the Chief Inspector

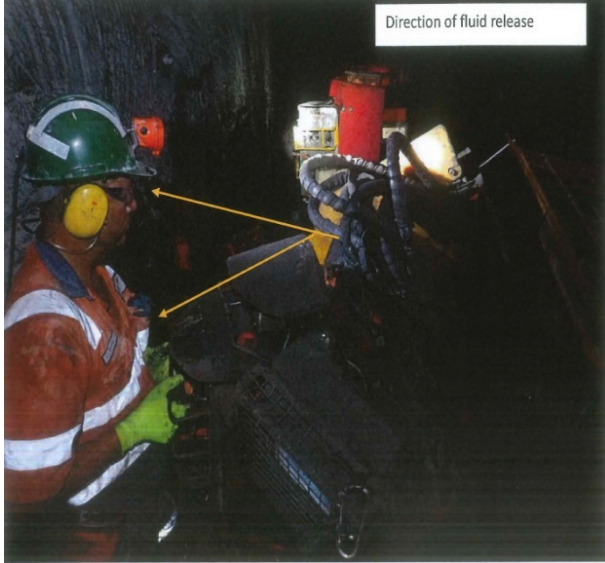
<p>Inexperienced operators must have appropriate training and supervision.</p> <p>Systems of work should be clear and unambiguous with regards to discharging stored energy before work is undertaken.</p>
<p>Dangerous incident IncNot0043982 Underground coal mine</p>	<p>A worker was operating a rib bolter on a continuous miner when a hose failed. The worker was hit on the forehead and arm with hydraulic oil. The worker was assessed at hospital and cleared of injury.</p>	<p>Mine operators must ensure that hydraulic systems are maintained appropriately to prevent loss of hydraulic fluid under pressure.</p> <p>Controls such as shielding must be considered to protect workers from the risk of fluid release near a workstation or area where workers are likely to be.</p>
