**HUNTER VALLEY  
OPERATIONS**

**HVO WEST PIT  
WS 117 DUMP FAILURE**

**GREG MCCORMACK**  
MANAGER OF MINING ENGINEERING

**KUDRET TUTUK**  
SENIOR GEOTECHNICAL ENGINEER

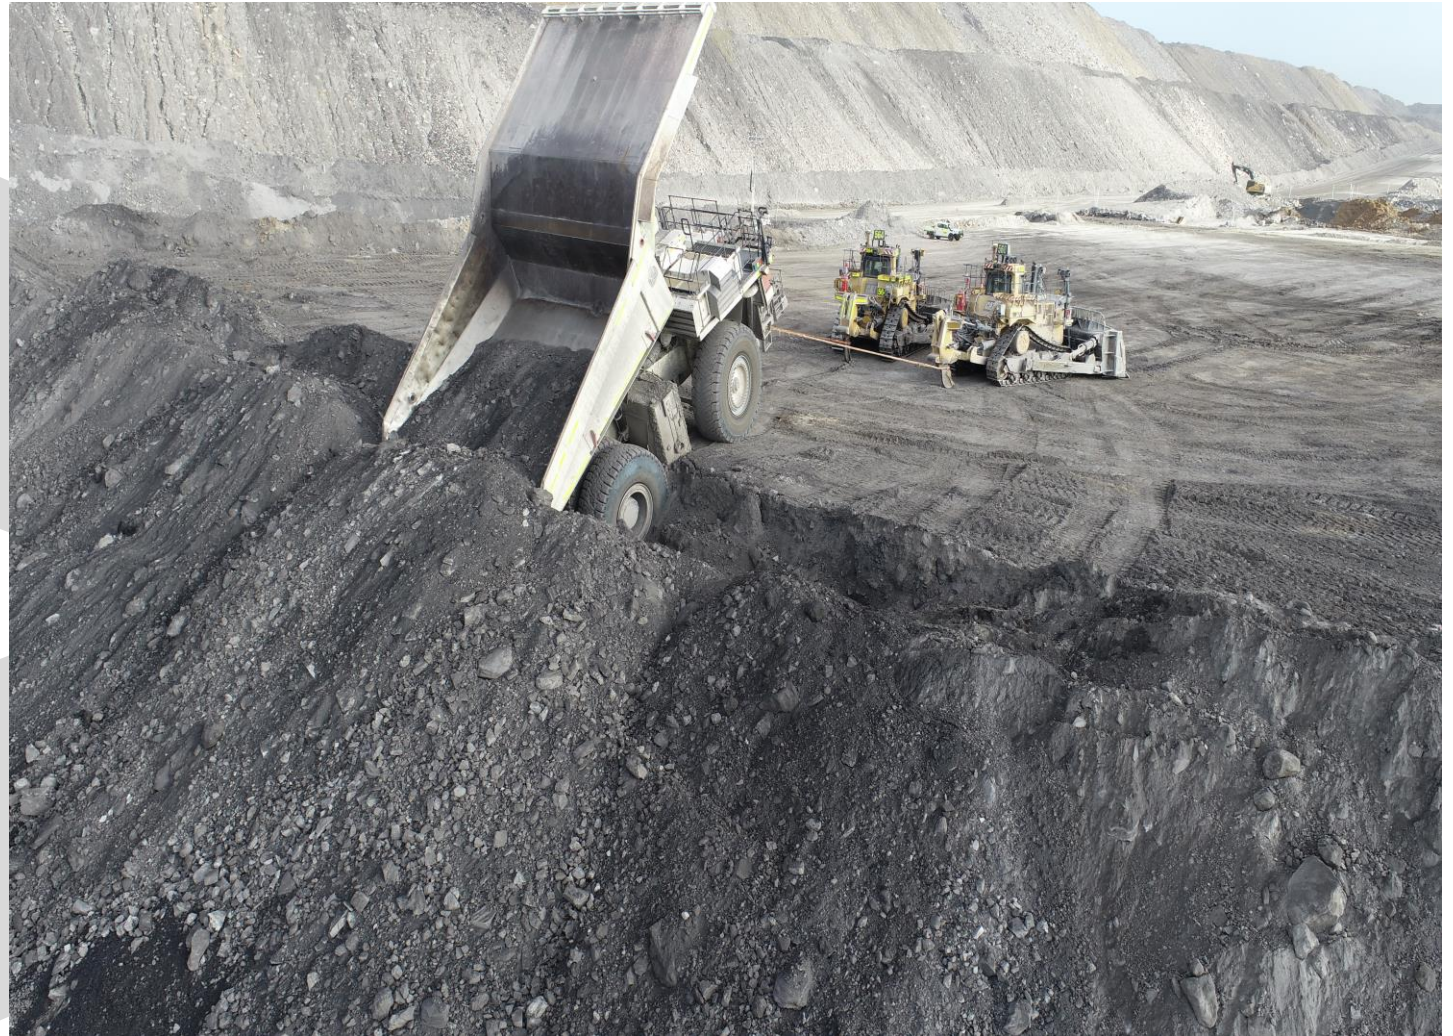
- Resource Regulator attended site next morning to inspect the incident scene and gather relevant information.
- After the scene was cleared a risk assessment was undertaken for recovery of the truck inclusive of other operational and functional testing before being returned to the fleet.
- HCOM developed to communicate Incident details across site and group.
- WS 117 area secured to preserve scene to facilitate investigation.
- **Following the incident, The site Geotechnical Engineer and DAS Mining's Geotechnical Engineer were engaged to conduct a review of the WS117 Dump including material characterization to assist with the investigation .**
