Weekly incident summary

Week ending 4 August 2024

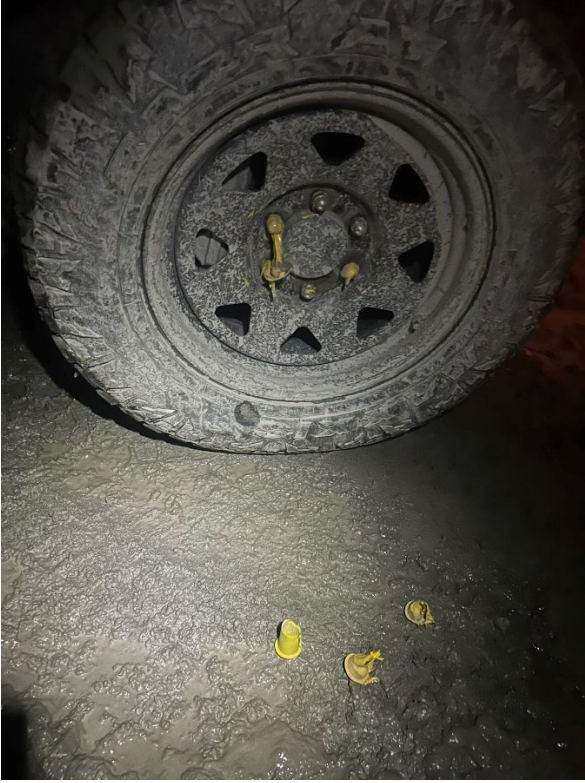
Incident type	Summary	Comments to industry
Dangerous incident IncNot0047366 Underground metalliferous mine	<p>A mine worker was driving a light vehicle with 3 other occupants down a decline when the service brake became unresponsive. The driver shifted to first gear and applied the park brake and stopped the vehicle. It took 118 metres to bring the vehicle under control and stop.</p> <p>The wheel nut indicators appear to have melted off due to high heat from the brakes. Low range was not engaged.</p>

<p>Brake fade (or vehicle braking system fade) is the reduction in stopping power that can occur after repeated or sustained application of the brakes of a vehicle, especially in high load or high-speed conditions. Brake fade is caused by a build-up of heat in the braking surfaces and the changes and reactions in the brake system can be experienced with both drum brakes and disc brakes.</p> <p>Mine workers are reminded that before commencing a decent they should choose an appropriate gear with the appropriate speed range to allow the engine braking to maintain speed.</p> <p>Mine operators must ensure that their workforce is trained and</p>

<p>competent to operate vehicles in underground conditions.</p>
<p>Dangerous incident IncNot 0047351 Underground coal mine Roads or other vehicle operating areas</p>	<p>A mine was undertaking work on its main travel roads as part of recommencing mining operations. The mine was scheduled to transport some heavy mining equipment underground. Due to wet conditions, the mine operator decided to do a trial run with the mine dozer and attachments on wet concrete on a 1 in 5 drift. During the trial the dozer lost traction and the jib attachment hit a disused 8 inch poly pipe on the right-hand rib line, damaging the pipe. Before the incident, it was ensured no personnel or vehicles were in the drift except for the dozer and operator.</p>
