Investigation report

Investigation into a serious drill rig incident at Ashton Coal Mine on 12 August 2012

Report prepared by the NSW Mine Safety Investigation Unit

July 2014

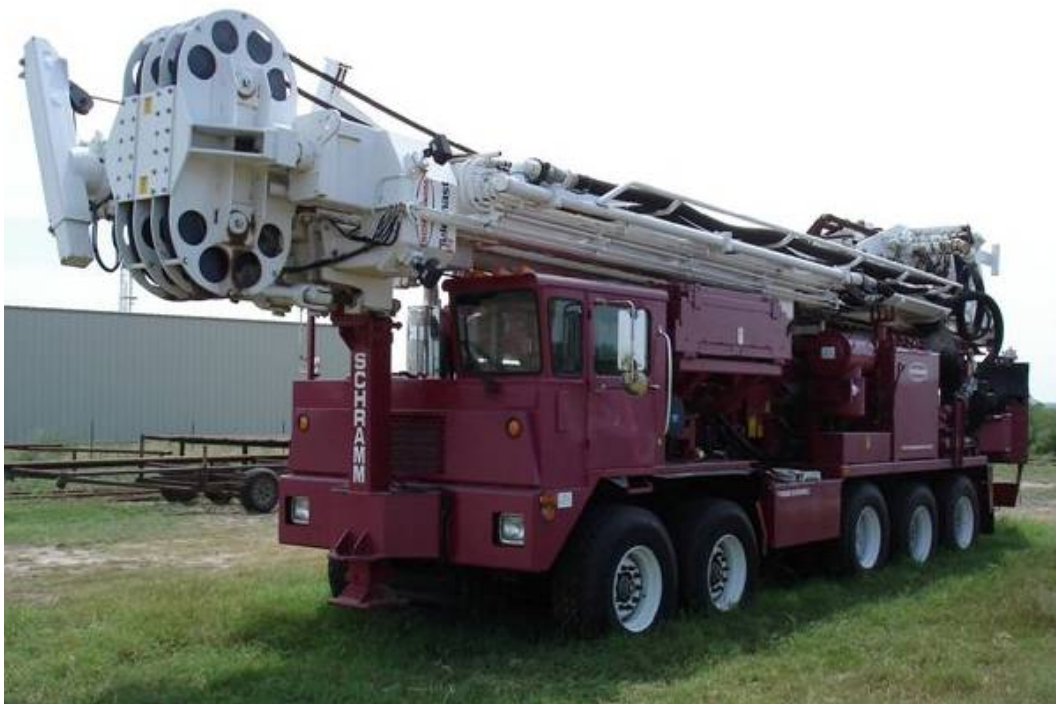
Figure 3. The Schramm T130XD drill rig²

An assessment and functional test was carried out on the rig post incident. There were no adverse findings related to the function of the rig.

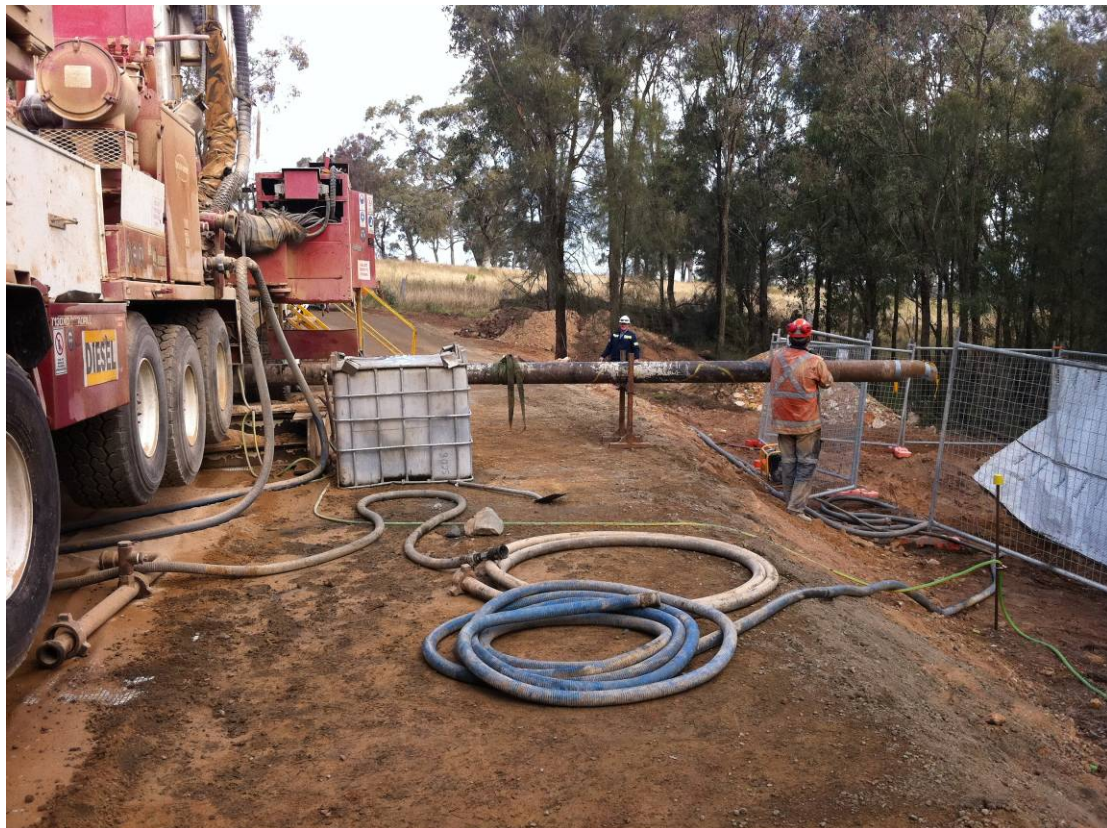
Figure 5. Borehole 3 operations, showing terraced drill pad design.

Due to the voluntary conservation constraints placed on the operation, the drill pad design was critical. Silver City Drilling specified the drill pad requirements to the contract holder. The drill pad was a terraced design, whereby the drill rig sat on an upper level of the terrace, and the sump sat on a lower terrace approximately two metres below. A photo of the drill is provided in Figure 5.

Drilling at Borehole 3 required the installation of conductor casing into bedrock. This is standard procedure for this type of drilling.

Drilling began on 27 June 2012, about 4.30pm. The conductor casing was set to a depth of five metres as this was as far as the drill rig could penetrate with the large diameter spade bit required for opening the hole to the required diameter. A bore log of a borehole near to Borehole 3 suggests that bedrock (consolidated ground) started at a depth greater than 7.5 m.

The lack of capability of the spade bit to penetrate to a greater depth appears to have been associated with the condition of the spade bit. It was reported that the spade bit was well worn with many of the tungsten carbide cutting edges worn out.
