Published Investigation Report

Serious inrush incident at the Cadia East
Mine on 21 February 2010

Mine Safety Investigation Unit

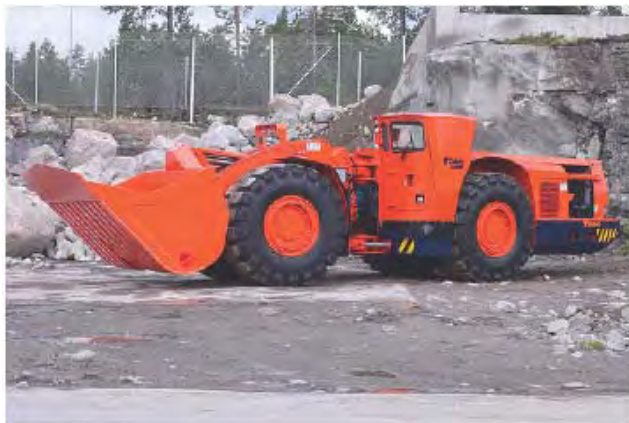
Photograph of a bogger

TORO 0011 LHD.⁷

The same model as the bogger that was used to bog out beneath the raise bore hole and was pushed back 30 to 40 metres by the inrush.

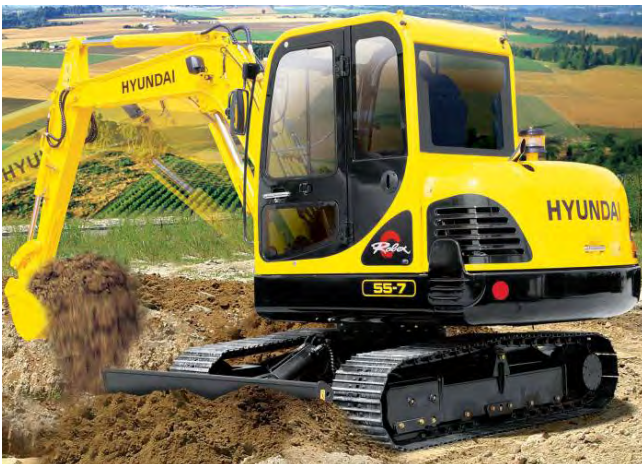
Photograph of a Hyundai Model 55-7 Mini Excavator.⁸

The same model as the excavator that was washed approximately 300 metres along the drive.

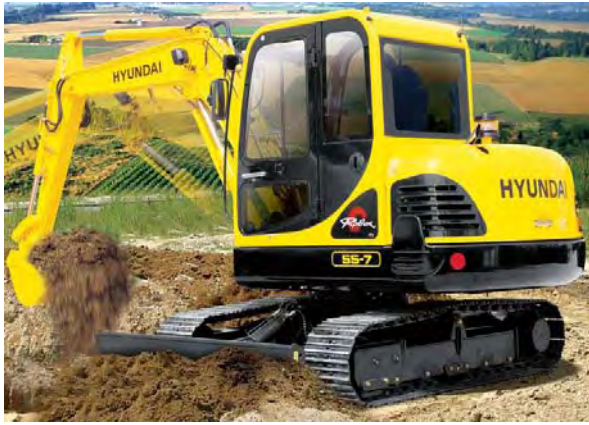
Photograph of a Hyundai Model 55-7 Mini Excavator.

The previous photograph is of the excavator over on its side covered with the inrush material. The following photograph of the same model excavator gives a perspective of the height of the material covering the excavator.

The same model as the excavator that was washed approximately 300 metres along the drive.

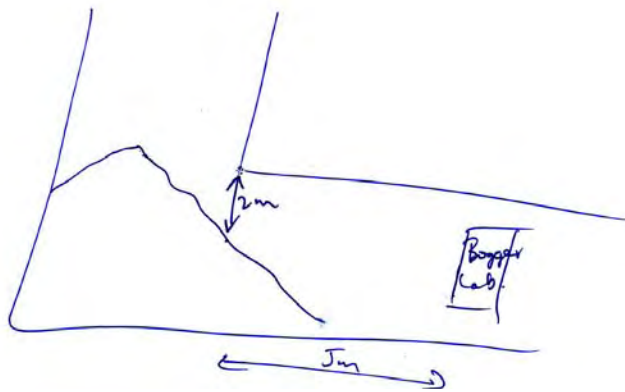
Extract from a diagram that was drawn by Chaim Sproles during an interview.

Chaim Sproles also depicted a 5m approach limit placed on the Bogger when removing the reamed cuttings. The 5m limit reduces the potential of the Bogger entering beneath the shaft and being struck by any object falling down the shaft.

The reamer cuttings are at the bottom of the shaft.

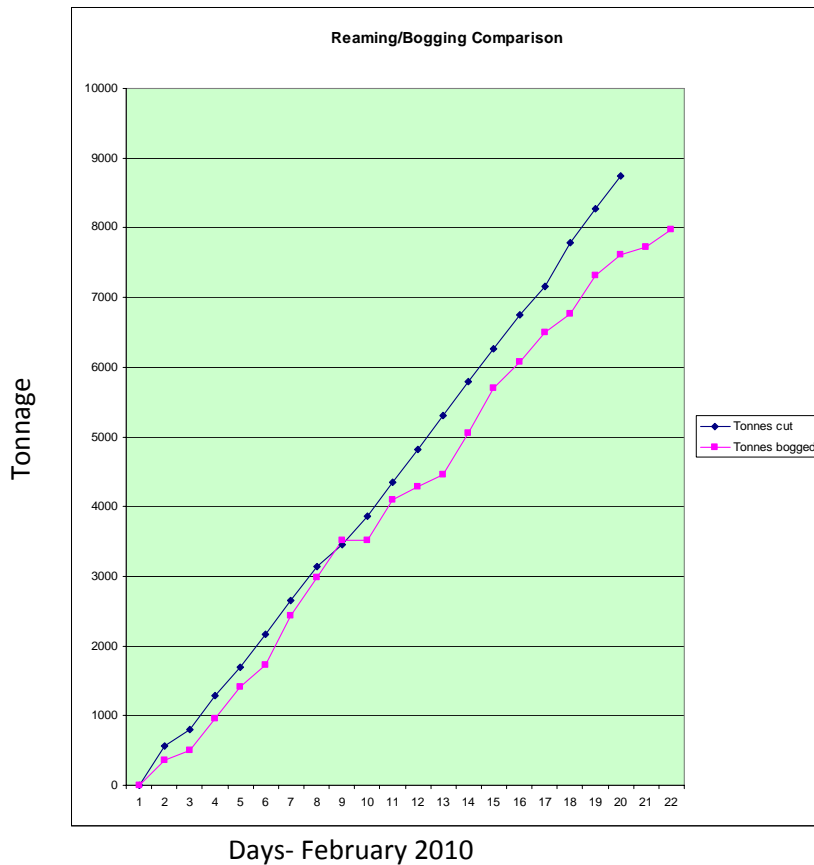
Graph1.

The graphs are not promoted as an accurate assessment of tonnes reamed versus tonnes bogged but merely to show there was a significant variation.

This graph was drafted using a bogger bucket criteria of 20 tonne for each bucket bogged.

The mine reconciliation document identified every bucket load to be 20 tonne.

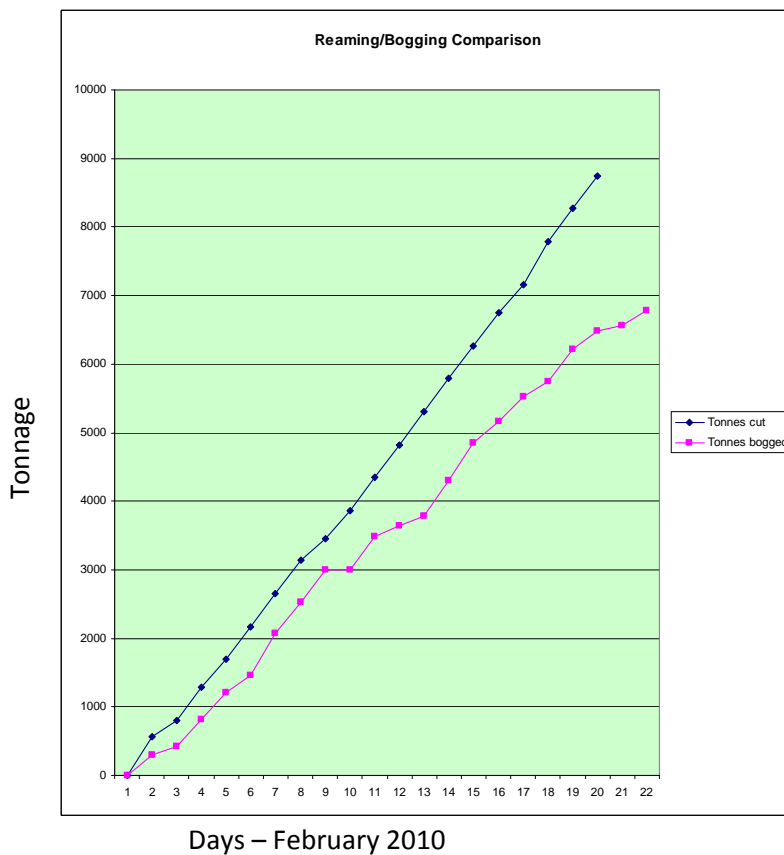
Graph 2.

This graph was drafted using bucket criteria of 17 tonne for each bucket bogged as indicated by a crew supervisor during an interview.

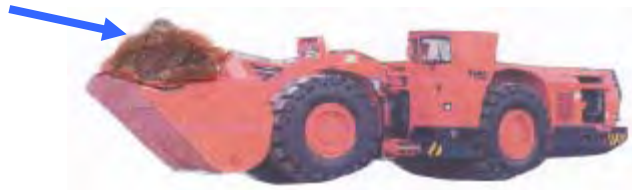
Picture modified by A Piggott

In the absence of water a bogger is able to scoop up a considerable amount of “dry” reamed cuttings from beneath a shaft, to the extent they may pile up above the bucket lip as indicated by the blue arrow in the picture below.²⁸

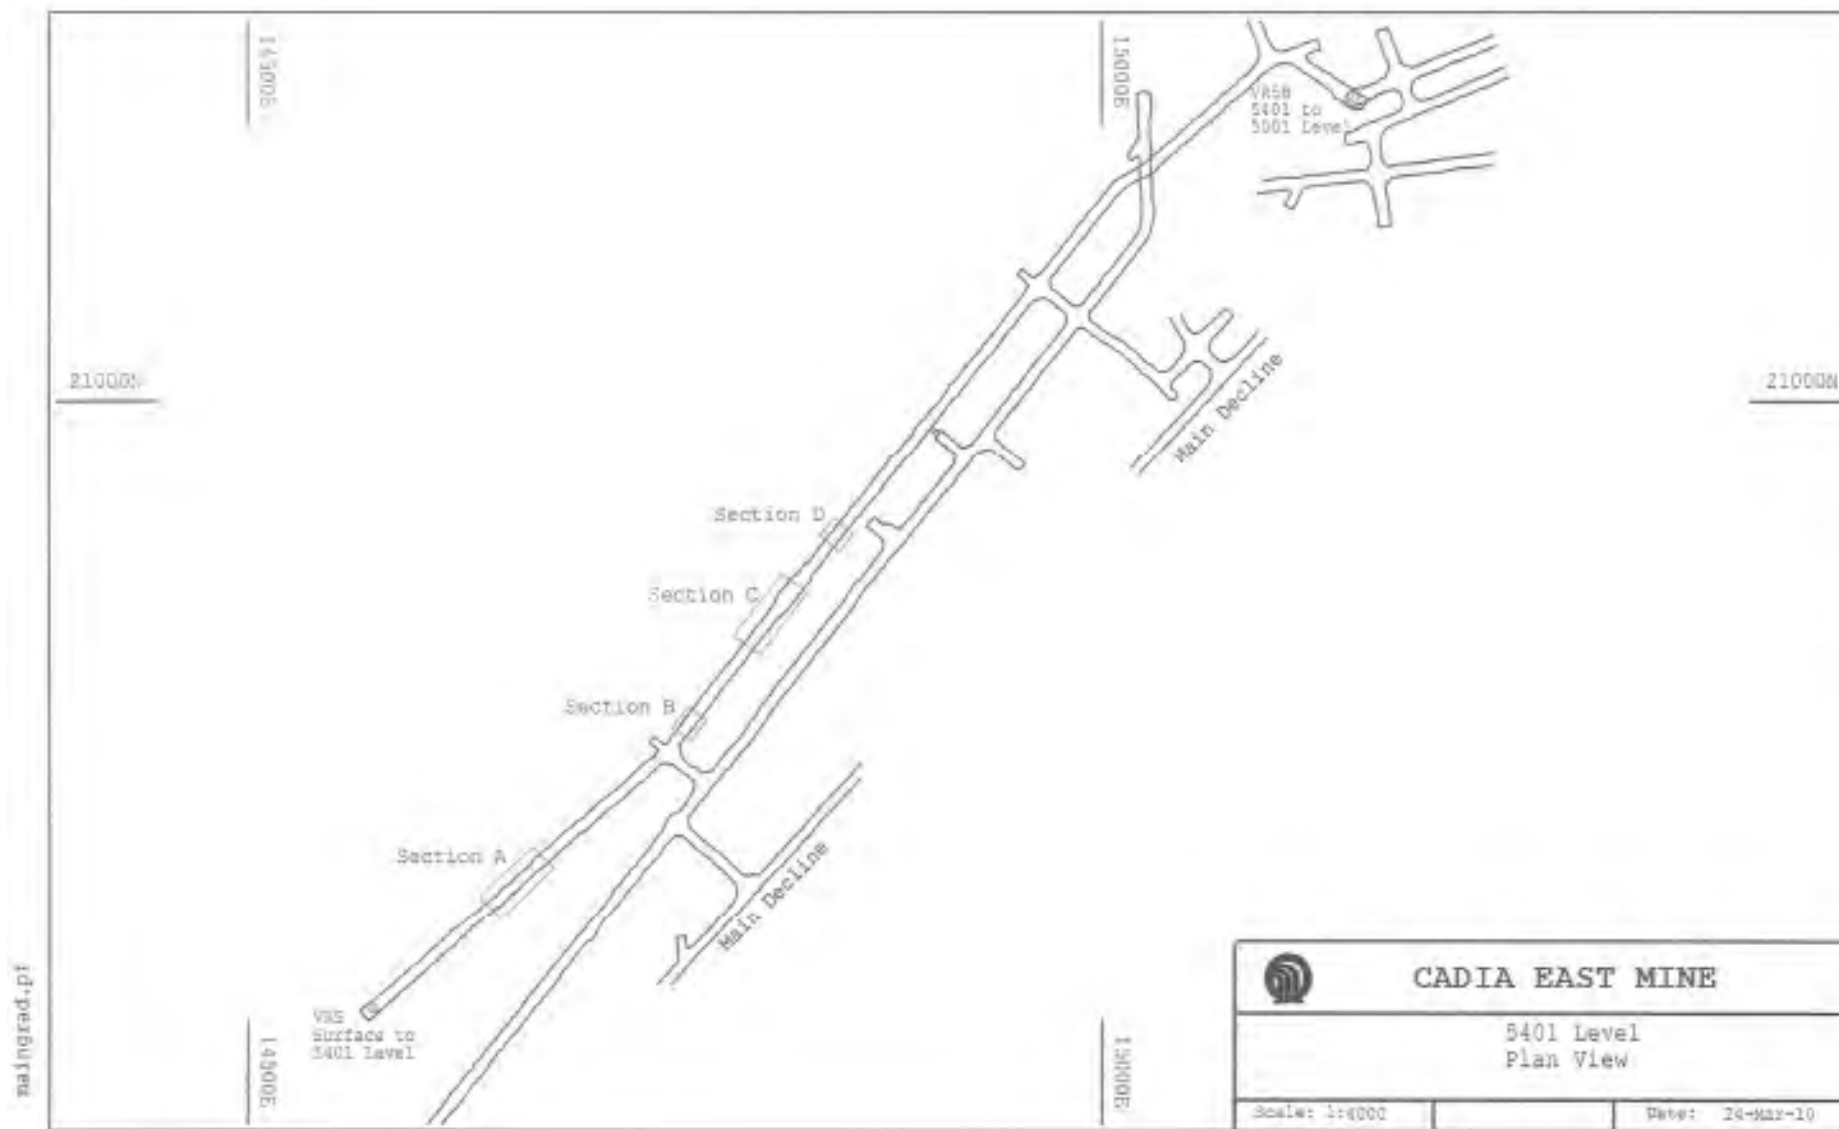
Plan view of 5401 level identifying areas where inrush heights were surveyed

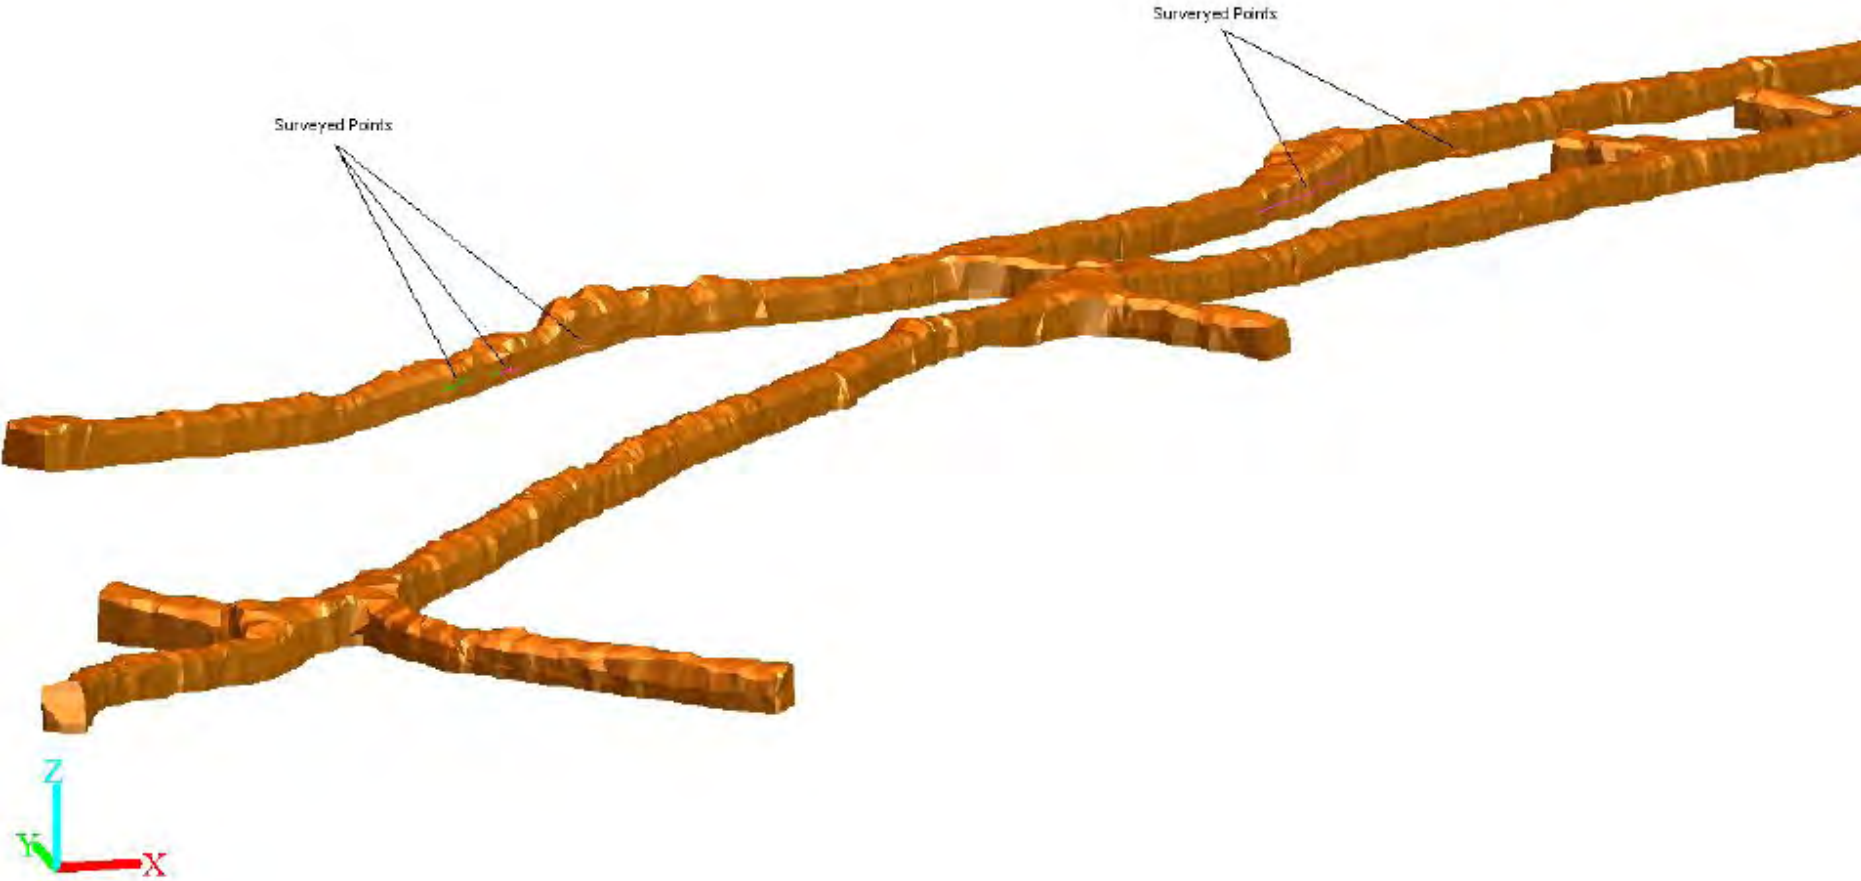
Computer generated view of 5401 level identifying areas where inrush heights were surveyed of the height of the inrush.

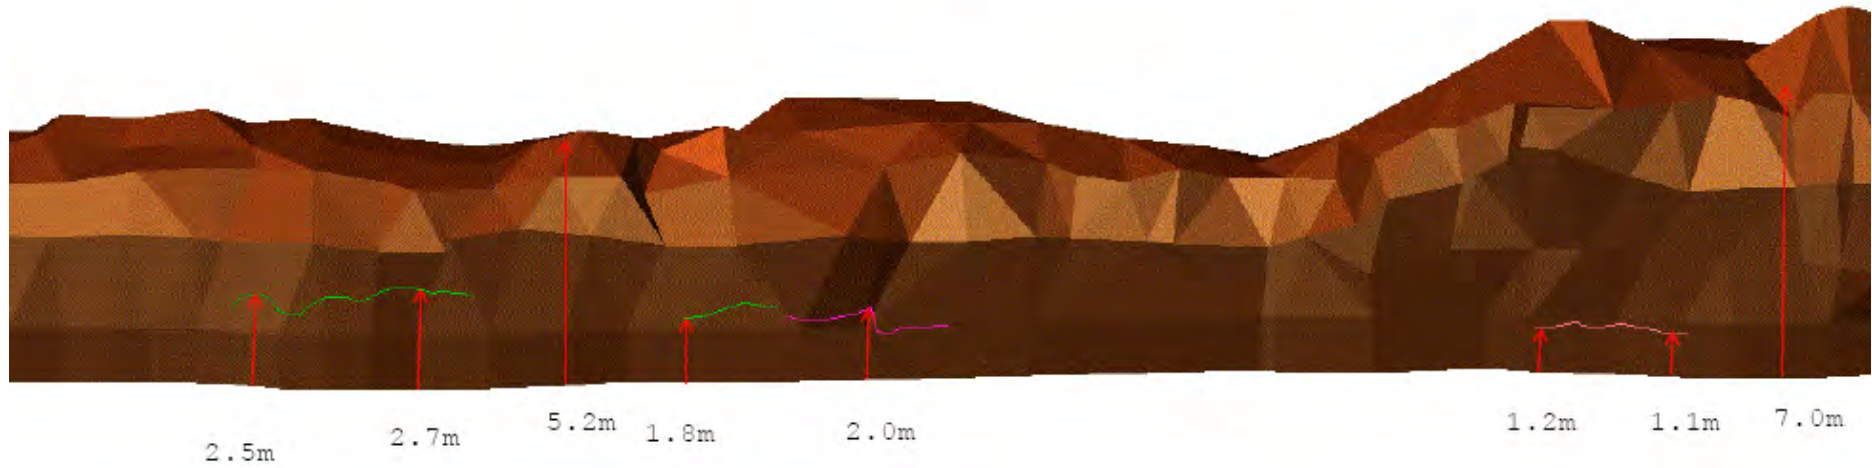
Computer generated views of the height of the inrush - Section A

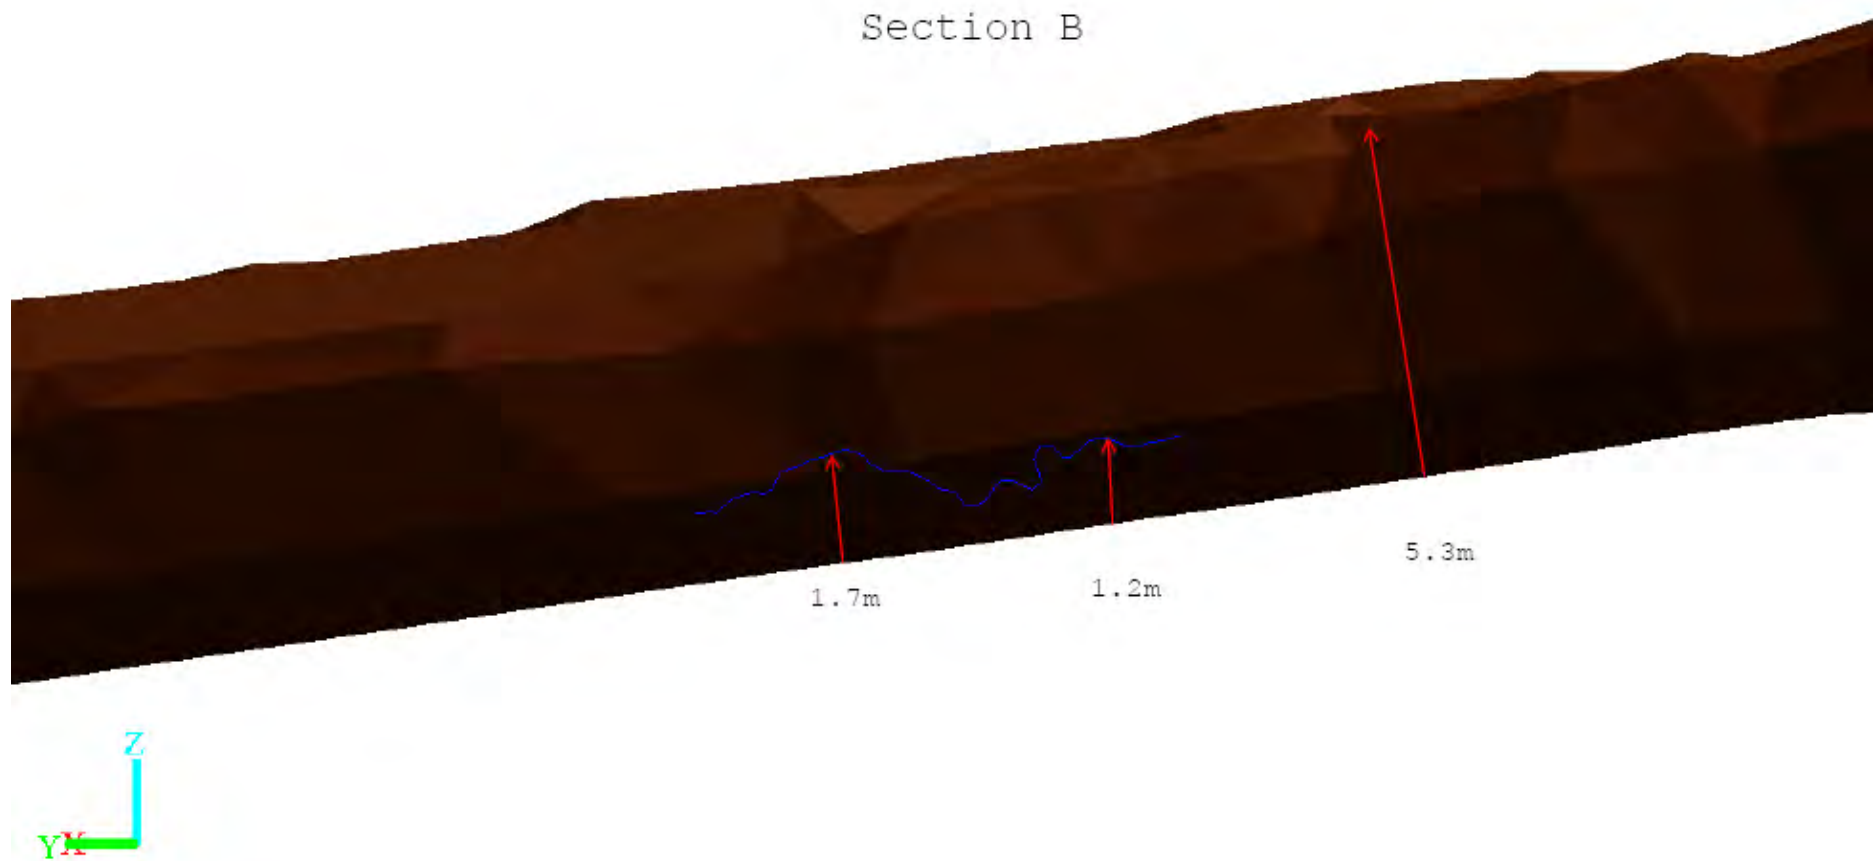
Computer generated views of the height of the inrush - Section B

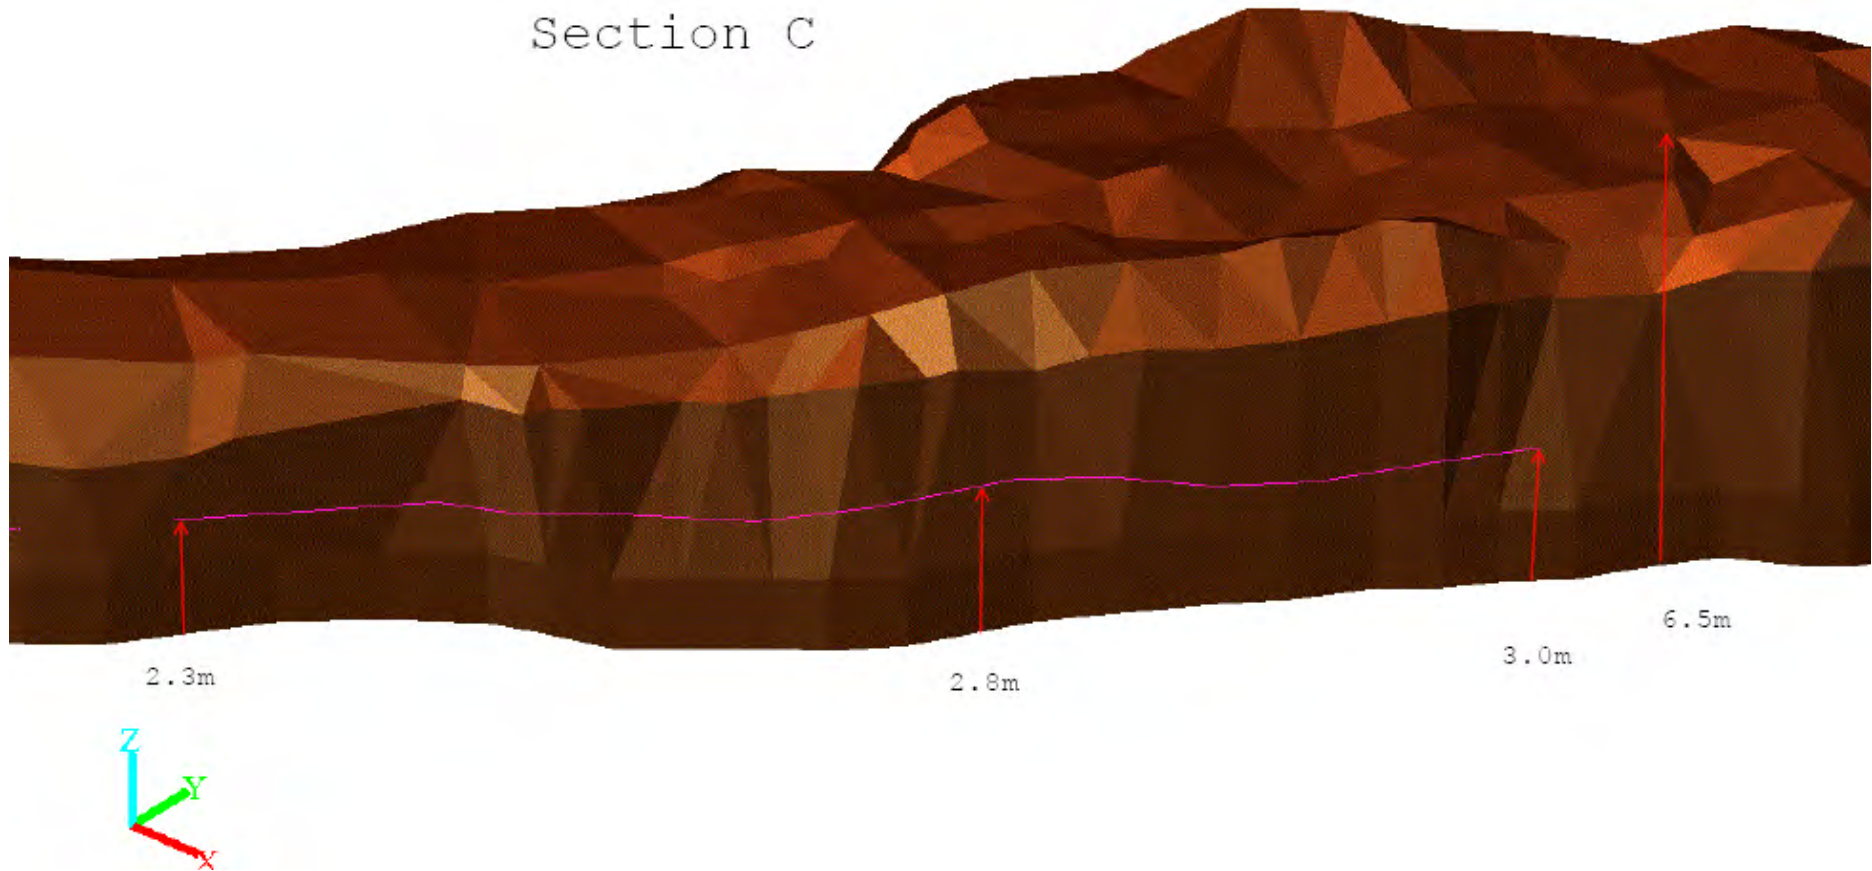
Computer generated views of the height of the inrush - Section C

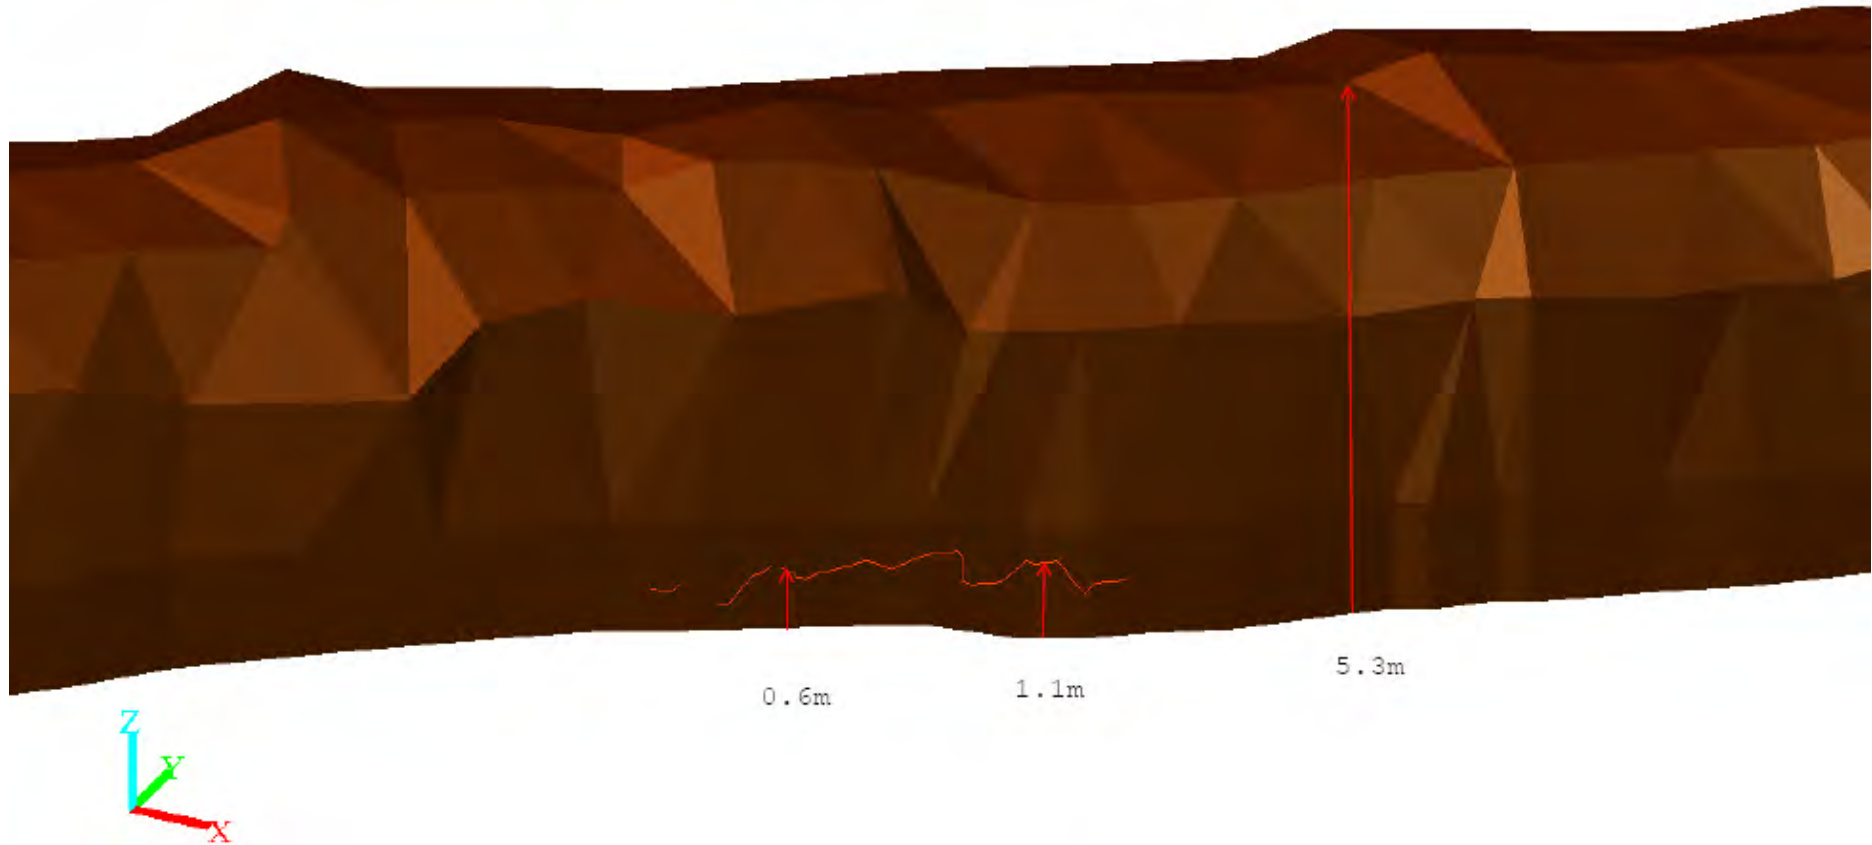
Computer generated views of the height of the inrush - Section D

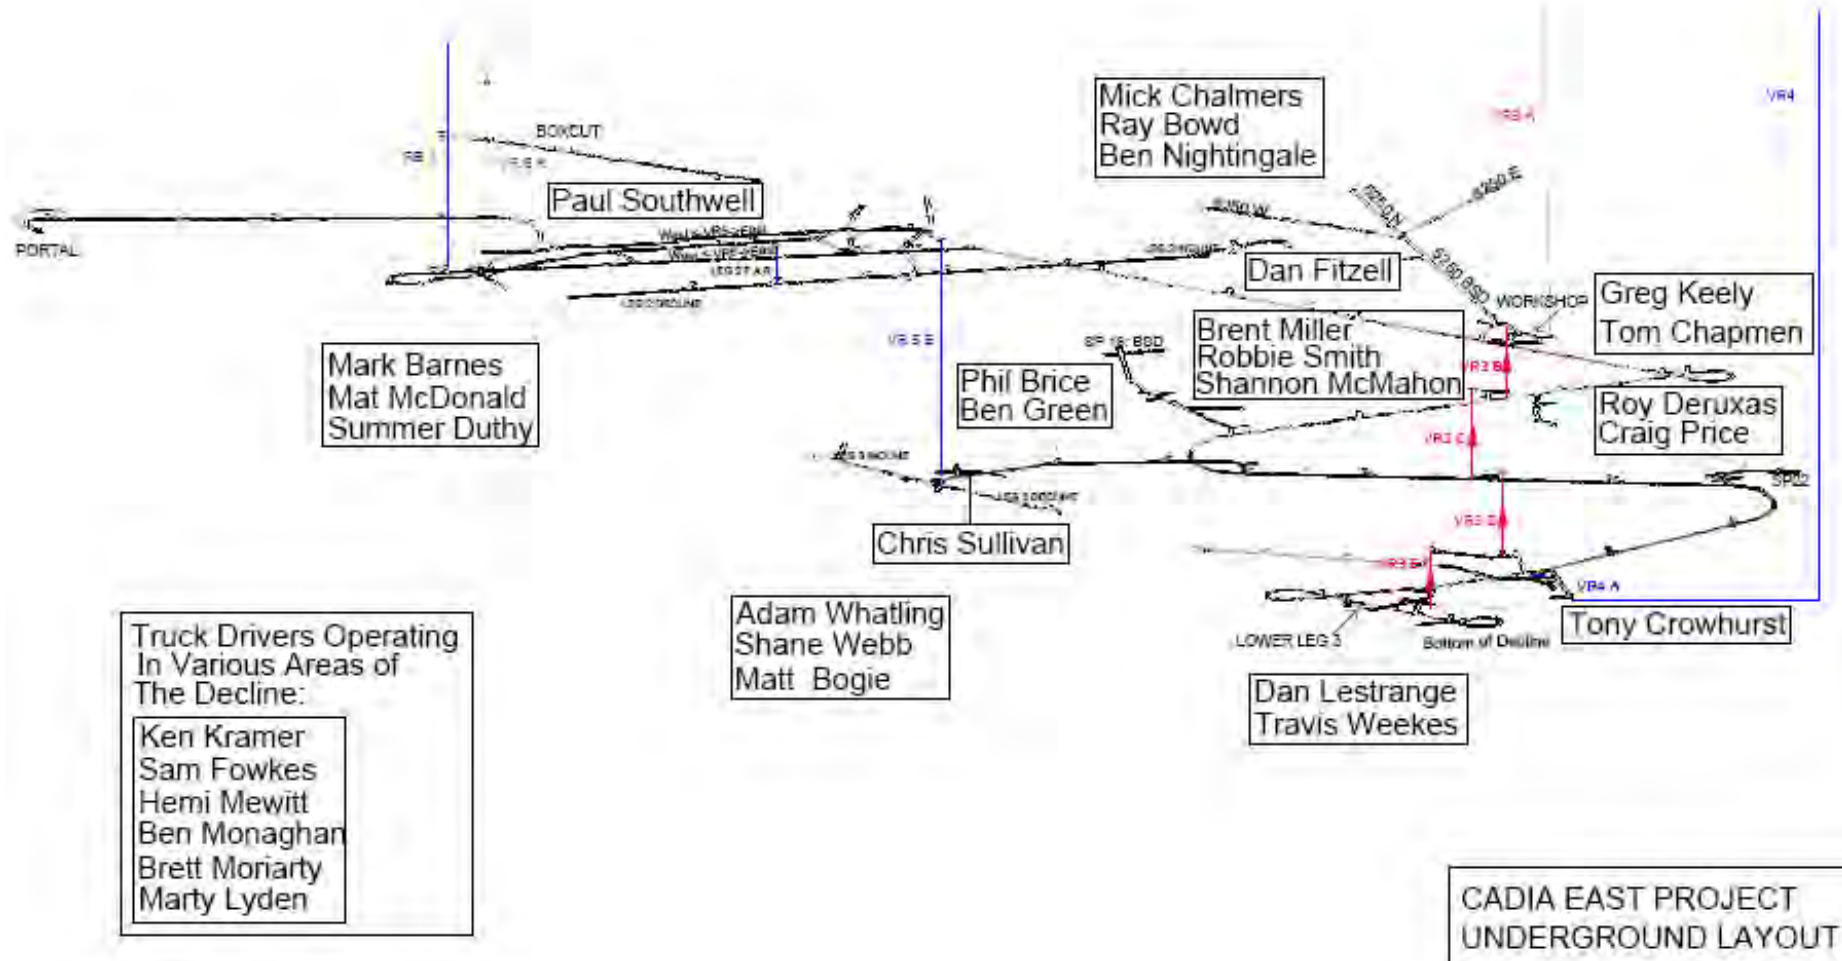
Plan 7. Cadia East Emergency and Fire-plans Primary Ventilation Survey extract - lists where persons were in the mine at the time of the inrush
