COMPLIANCE AUDIT PROGRAM

# Compliance Audit Program 2016 Report

June 2017

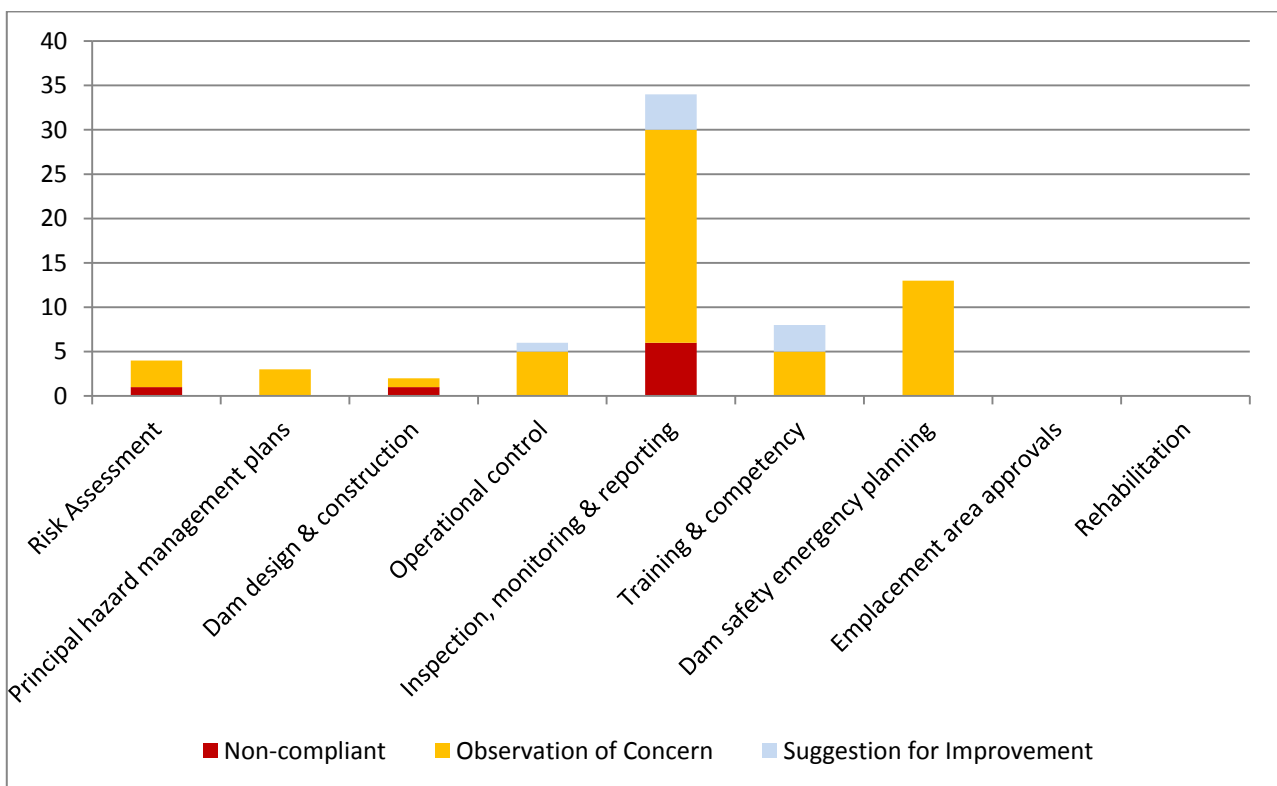
Figure 3:1 Non-compliances, observations of concern and suggestions for improvement

As part of the program, the regulator identified a total of eight non-compliances and 54 observations of concern. A further eight suggestions for improvement were also noted. What these non-compliances, observations of concern and suggestions for improvement were issued for is summarised in Figure 3:1.
