Investigation Report

Incident resulting in fatal injuries to a
subcontractor on Eastern Star Gas
Petroleum Assessment Lease 2 on
1 August 2009

Report prepared for the Director-General of the
Department of Industry and Investment by the
Investigation Unit, Thornton

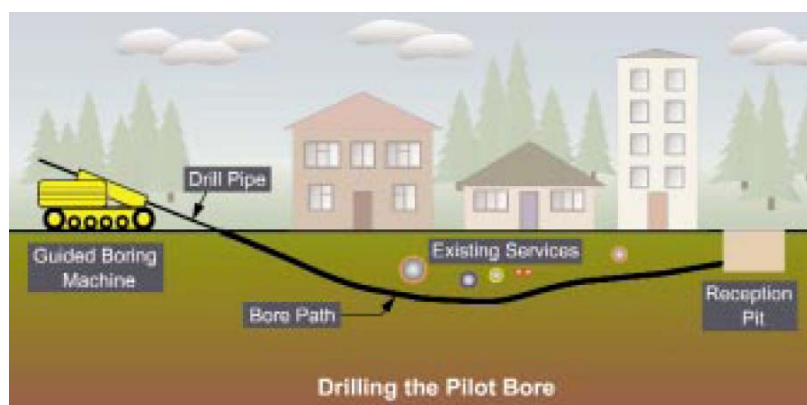
In the HDD method a pilot hole is drilled using the directional drilling technique that allows control of line and depth. Once the drill string arrives at the reception pit a reaming device is attached and the pilot hole is enlarged as the reaming bit is returned along the path of the pilot hole. The formed hole is lubricated, sealed and its profile maintained using a drilling mud. See diagram below.
