**NSW
Resources
Regulator**

Investigation report

The death of Mark Siegel at mineral claim 44507 near
Lightning Ridge on 4 November 2016

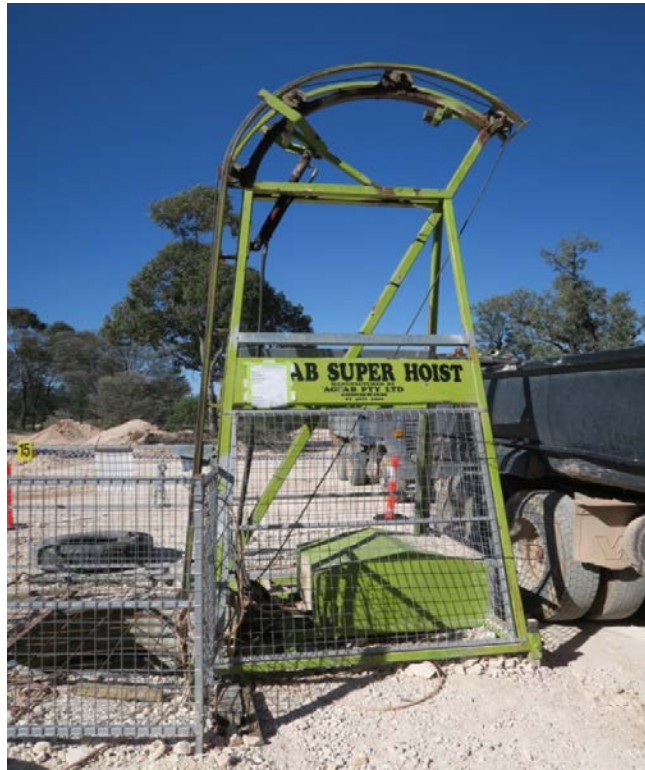
Figure 3: The Ag-Fab hoist on claim 44507.

The super hoist was bought second hand several years before the incident.

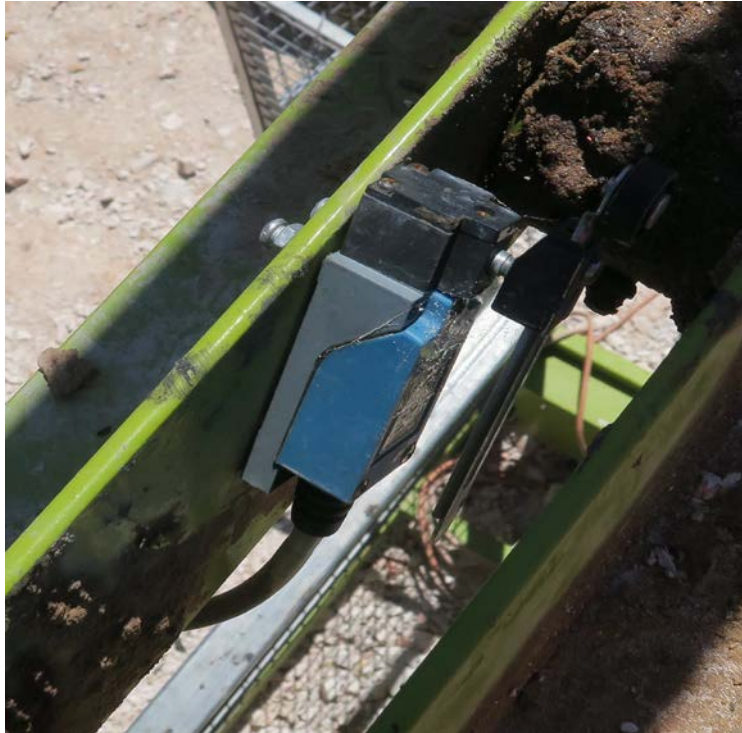
Figure 10: The limit switch at the top of the hoist.

The Ag-Fab hoist has two limit switches. A limit switch is an electromechanical device that consists of an actuator mechanically linked to a set of contacts. When an object interacts with the actuator the device operates the contacts to make or break an electrical connection. The hoists limit switches are designed to send an electrical signal to the control box, which activates pre-programmed settings to raise and or lower the bucket. The first limit switch (figure 10) is at the top of the hoist and the second limit switch (figure 11) is inside the sump.

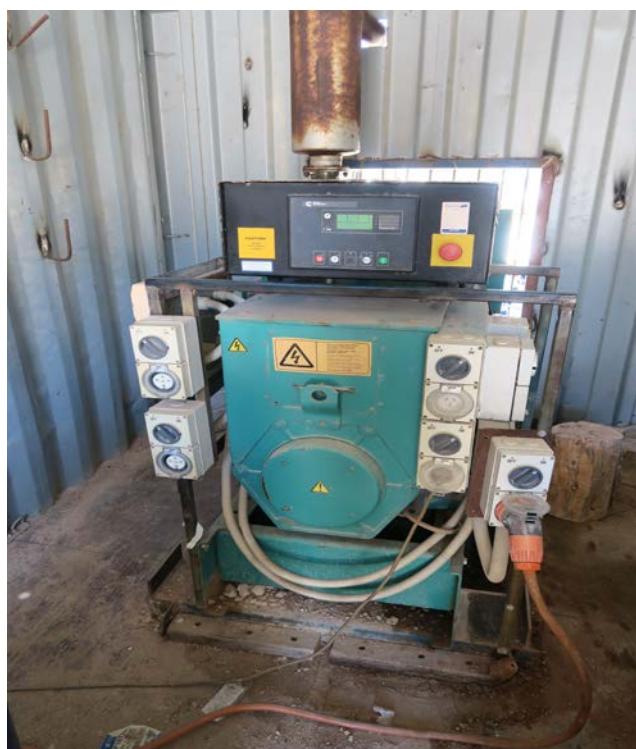
Figure 12: The generator that powers the electric motor to the hydraulic system and underground lights.

The hoist was powered by a 240/415 volt Cummins Power Generator model ES62.5 (S/N 301141) in a shipping container near the super hoist (figure 12). The generator uses diesel fuel. The generator was made in Singapore with a manufacture date of 2003.

An examination of the hoist's hydraulic and electrical system was completed by investigators and mine safety engineers. While some unrelated electrical issues were observed (see section 8), there was no evidence to support a finding that there were any electrical or hydraulic (hose) malfunctions, which contributed to the incident. Worker 2 provided evidence that showed the generator had sufficient fuel

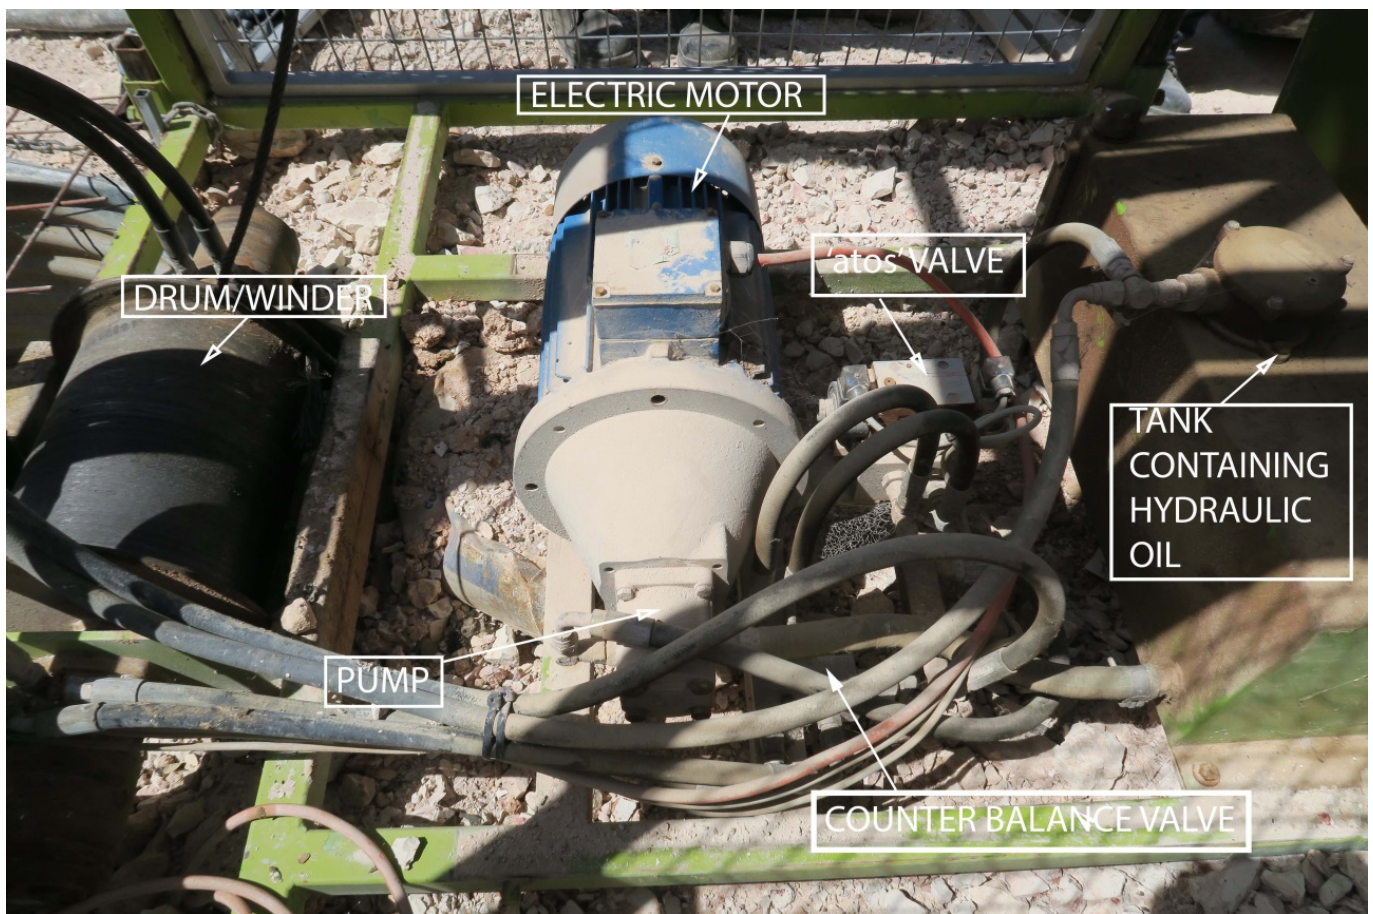
Figure 13: The hoist hydraulic electrical/mechanical system at MC 44507.

Oil (hydraulic fluid) housed in the hydraulic tank is circulated through hoses by a Casappa pump powered by a western electric, 5.5 KW 415-volt induction motor. The oil circulates, under pressure, through the hoses and passes through a solenoid and counter balance valve, both of which direct the flow of oil. The oil moves through the system via the pump, which generates enough pressure to turn the hoists drum, winding the cable on and off.

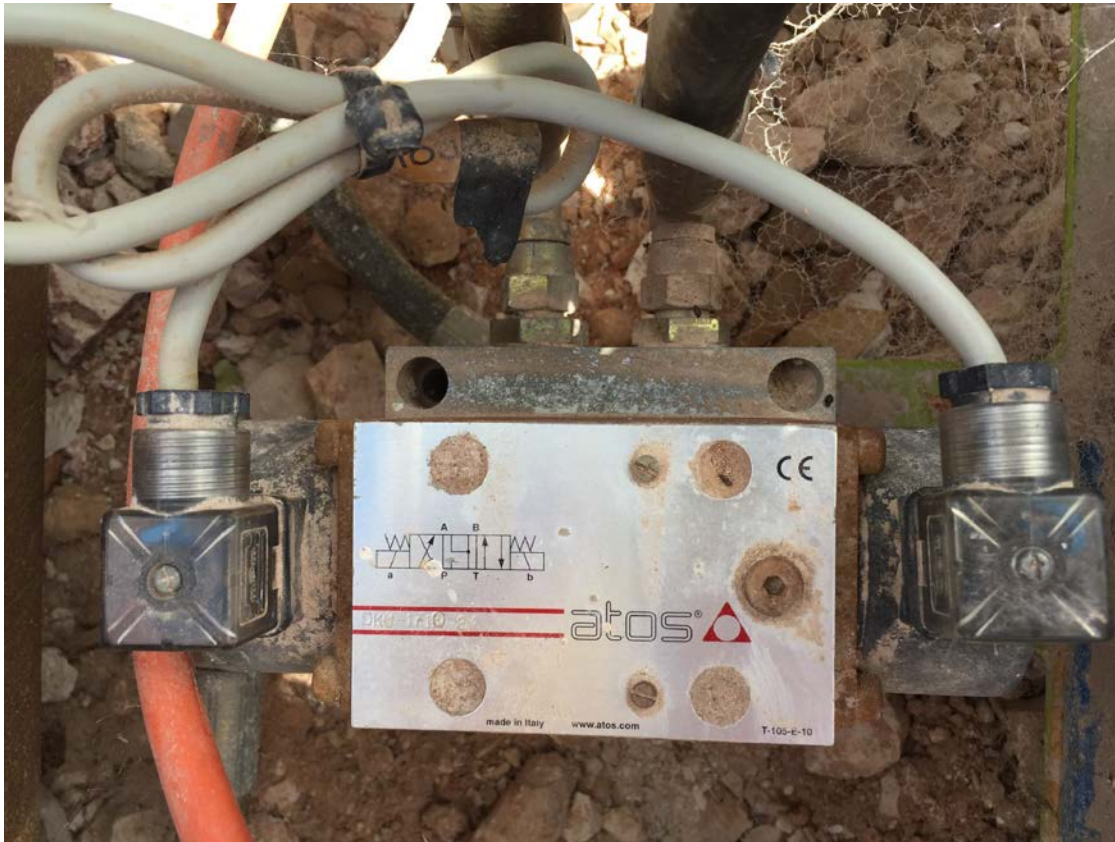
Figure 14: The Atos solenoid valve.

The solenoid valve was manufactured by Atos (Italy) and imported and distributed in Australia by Southcott Pty Ltd (figure 14). The original valve model was number DKU-1713-X-00 (figure 15), however at some point it was converted by person(s) unknown to model DKU-1710-X-00 (figure 16). Examination of the valve revealed a new model number was stamped over the original number. The manufacturer of the hoist, Ag-Fab Pty Ltd, bought a large number of items, including solenoid valves, hoses and other equipment from Southcott Pty Ltd over several years.

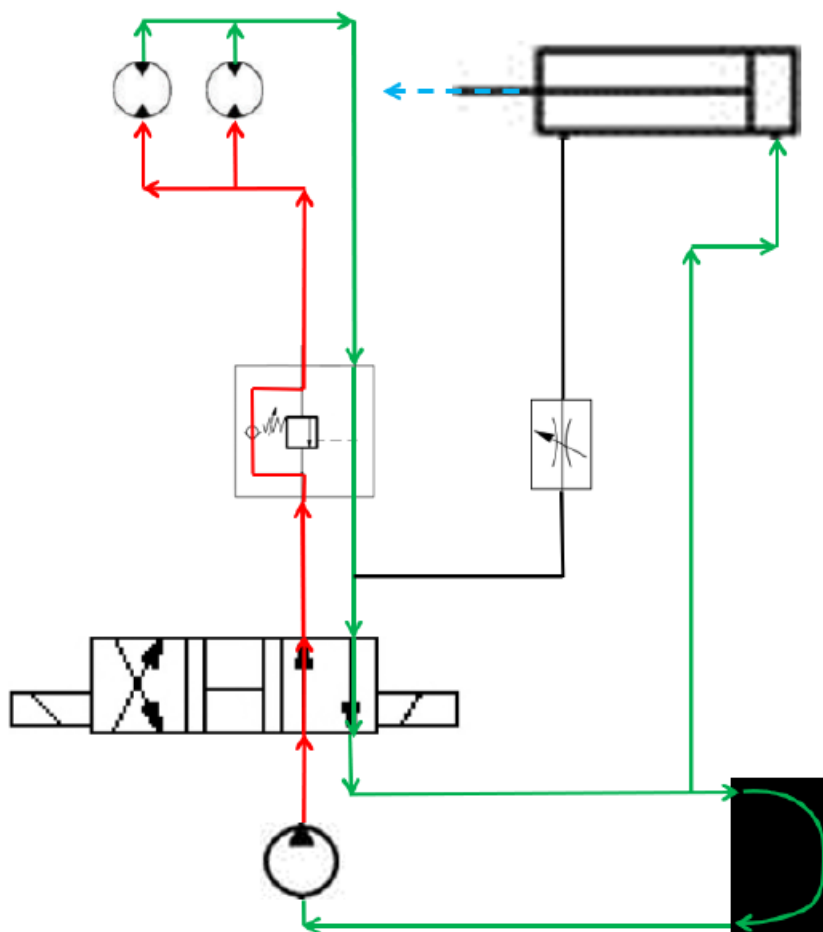
Figure 17: The solenoid valve during the hoist lift sequence.

The valve is a three-position, four-port valve that directs the flow of oil through the hydraulic system. The valve generally remains in the centre position and when the hoist bucket is activated to rise, the valve moves left, engaging the far right port with the up-down arrows (figure 17).

When this occurs, the hoist's hydraulic oil is being pumped, under pressure, through the system as shown in figure 17. When power is lost, the solenoid valve returns to the centre or rest position.

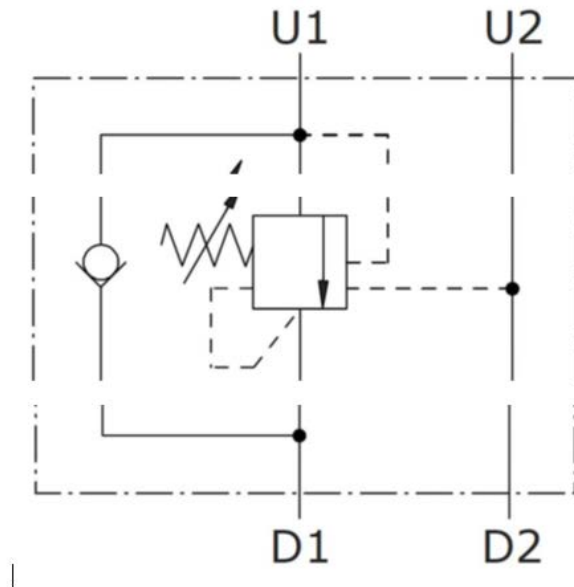
Figure 18: Schematic of the counter balance valve.

The valve on the Ag-Fab hoist's hydraulic system is a Walvoil 4 port- single acting counter balance valve (Single acting – allowing flow in one direction only with a spring-loaded return actuator), part No. VOS/SC 38/TR.S.p4.PG (figures 18 and 19). An example of the counter balance valve in its rest position, that is when the hoist is not in operation, is shown in figure 20.

The weight of the bucket then turns the motors (freewheeling) and because of the counter balance valve being single-acting (figure 18 and 22) there is no resistance to the motors pumping oil forward (figure 26) resulting in the motors turning and the bucket free-falling down the shaft.

The investigation identified several engineering controls that could have prevented the bucket from free falling. The simplest and most inexpensive of these involves fitting a dual acting counter balance valve to the hydraulic system (figure 28), which would have braked the hydraulic motors from turning (free-wheeling), in the event the bucket acted as a counter weight while the hoist is in an over-spool scenario during loss of power.

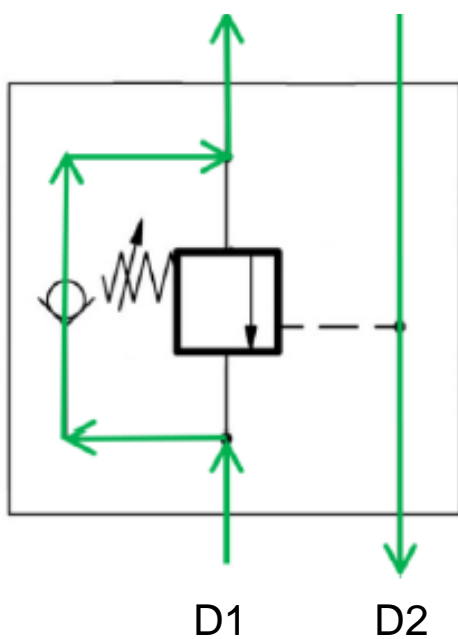
Figure 21: The counter balance valve forward flow of oil.

When the hoist's bucket is being operated in the raise sequence (that is, from the sump to above the ground) oil will flow forward through the counter balance valve via port D1 and U1, before entering the drive motor to turn to drum (raising the bucket) and return to the tank via ports U2 and D2 (figure 21).

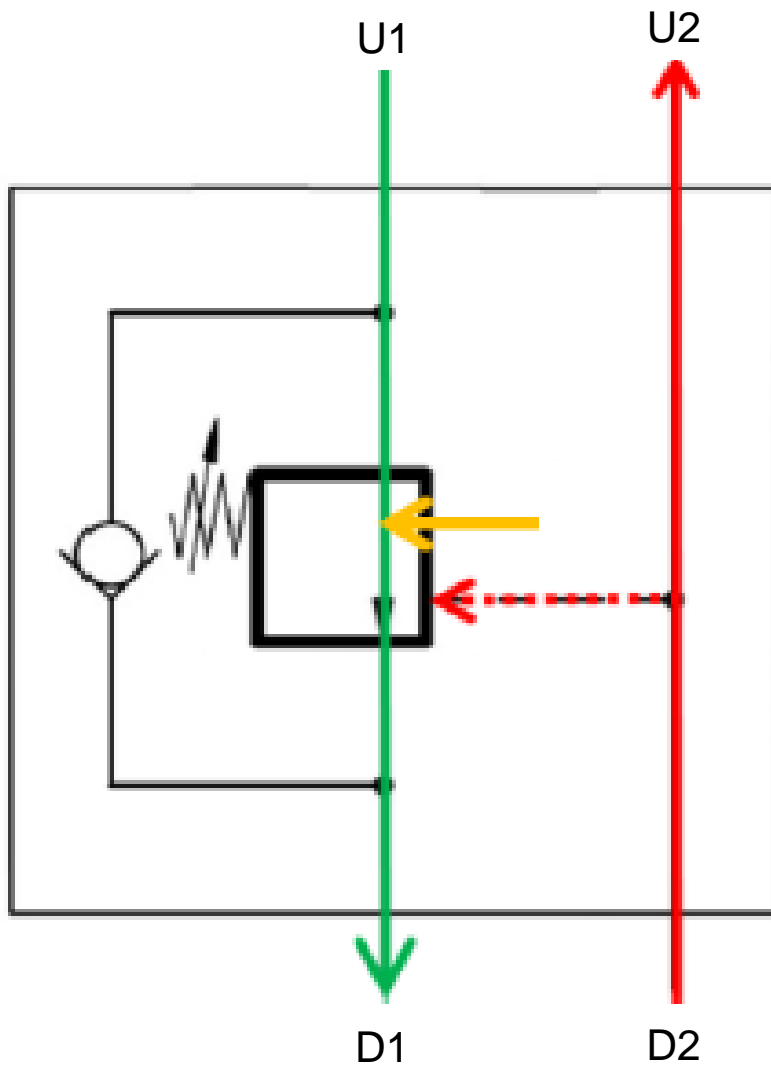
Figure 23: The counter balance valve pilot signal (green line) activated to allow the reverse flow of oil.

When the bucket is being operated in the lowering sequence, oil will flow through the counter balance valve in reverse, flowing through ports D2 and U2 and returning via ports U1 and D1. Reverse flow is generally prohibited due to a ball valve (figure 22). To achieve reverse flow a pilot signal, activated by the pressurised oil (figure 23 red lines), aligns the port to allow oil to return to the tank (figure 23). The operation of this valve was described as:

‘Freewheeling of the hydraulic motors is prevented in only one direction, the reverse direction, this type of counter balance is called a single acting counter balance valve.’
