Investigation report

Report into the death of Stephen Norman
at the Rix's Creek Coal Mine, Singleton, NSW,
on 13 December 2016

First published: November 2018

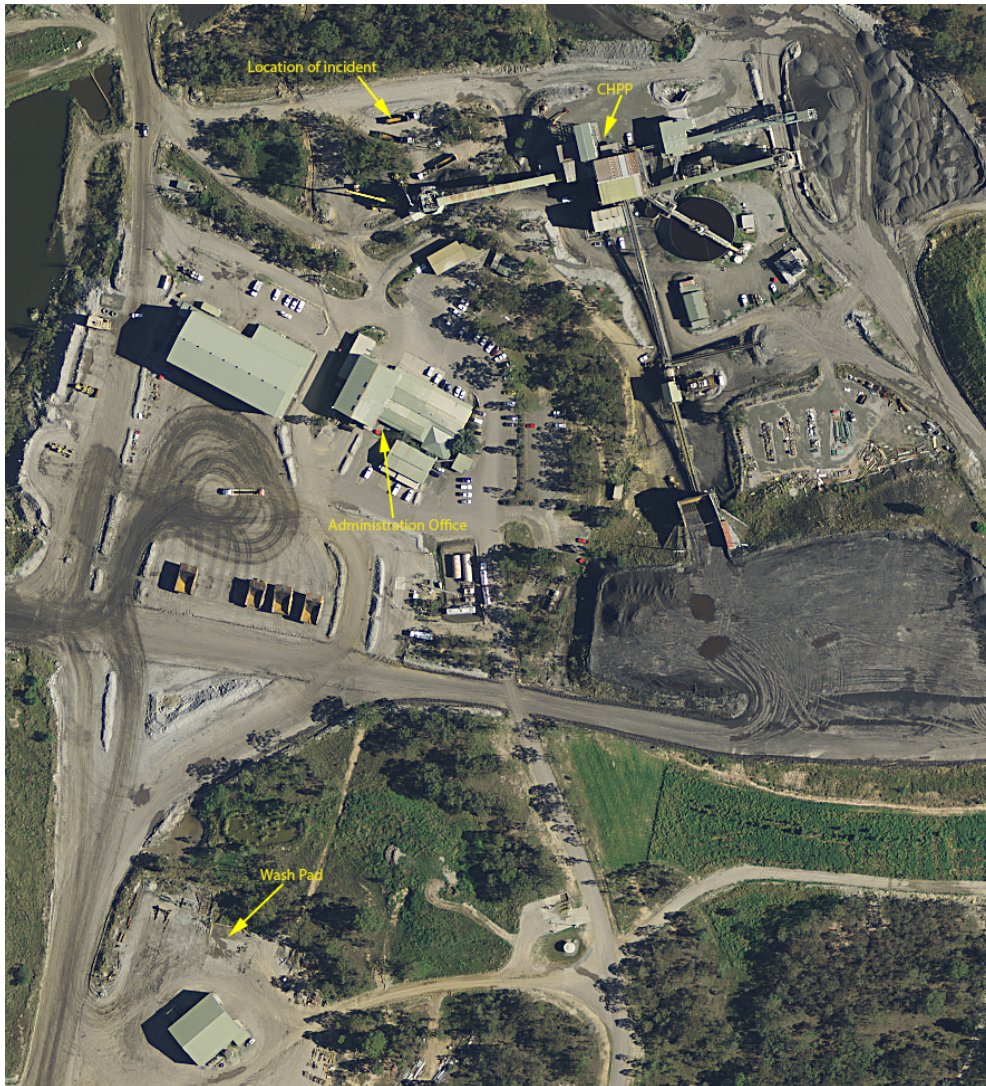
Figure 3 Location of the incident.

The incident occurred within the coal lease on an area near the coal handling preparation plant (CHPP) as shown in figure 3.
