REPORT | RESOURCES REGULATOR

Investigation report

**Report into the incident involving a worker at Ulan
West Operations on 26 November 2015**

First published: June 2017

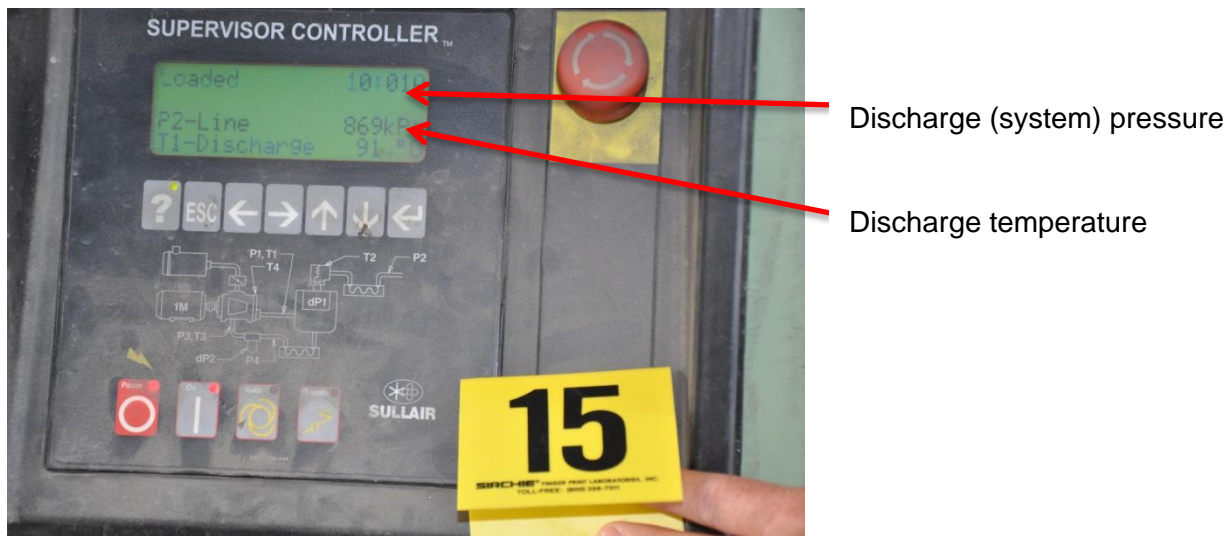
Figure 7- Control panel for Sullair compressor

- m) The system air pressure reading was taken from the surface compressor station on pressure recording devices.
- n) After the pressure manifold on pipe #52 had separated from the pipe end, both pressure manifold and pipe # 52 were found to be about 6 m apart.
