Investigation report

Investigation into the serious injury of a mine worker at the Perilya Broken Hill Southern Operations Mine, Broken Hill, NSW on 8 June 2012.

Report prepared by the NSW Mine Safety Investigation Unit

23 May 2014

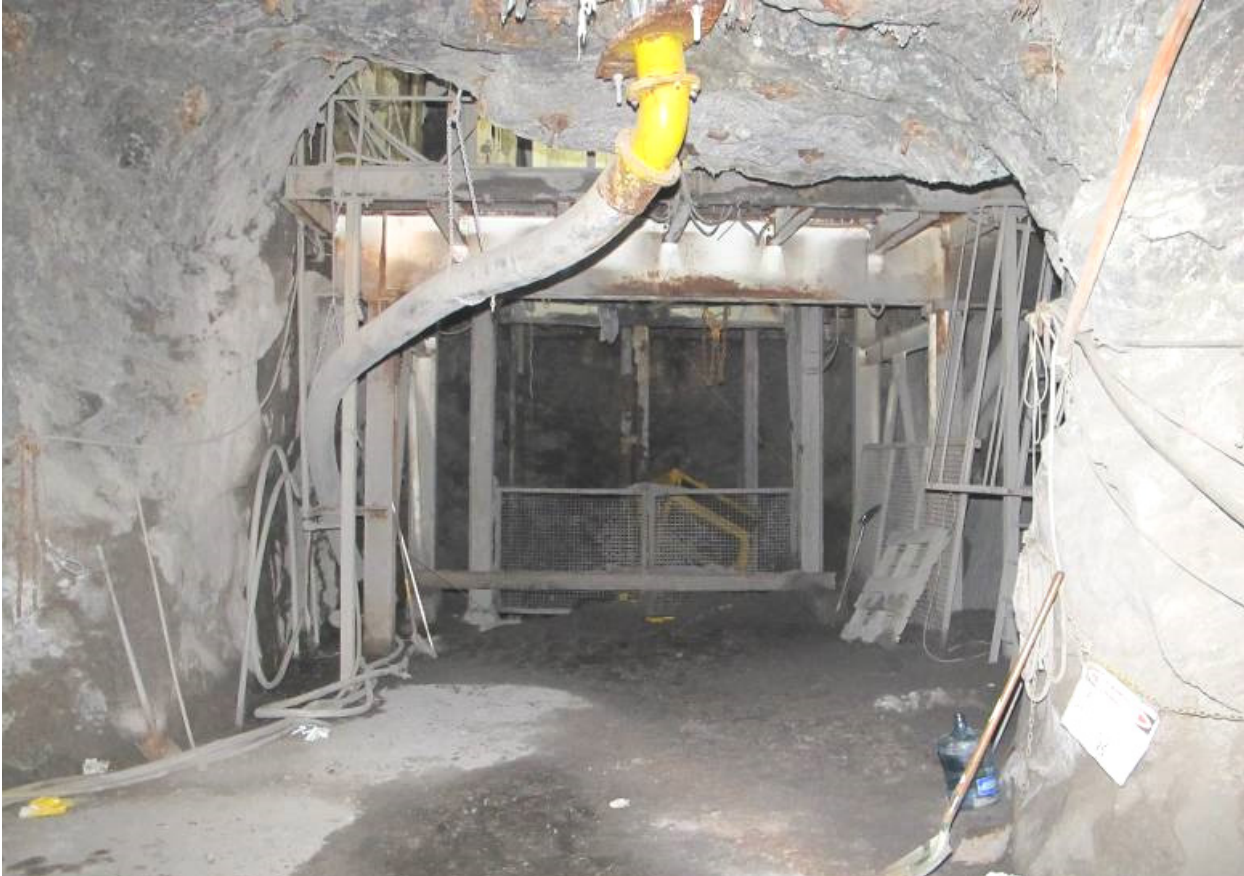
Figure 5: The 26 sub level access to the NBHC haulage shaft. This is the access into the base of the weigh flask above at the 26 level. Note the position of the horizontal steel RSJs and the closed steel mesh gate that formed the barriers across the front of the NBHC haulage shaft.¹¹

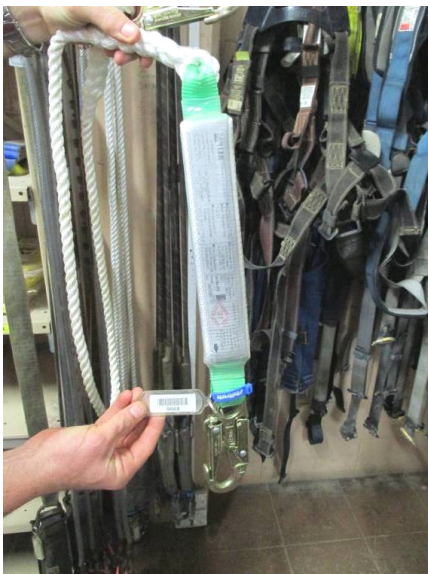
Figure 16: A rope lanyard with personal energy absorber device attached at the mine store room.

Neither mine workers used a personal energy absorber (deceleration device,²⁴ inertia reel,²⁵ karabiner²⁶) attachment to the lanyard at the time of the incident (see Figure 16).

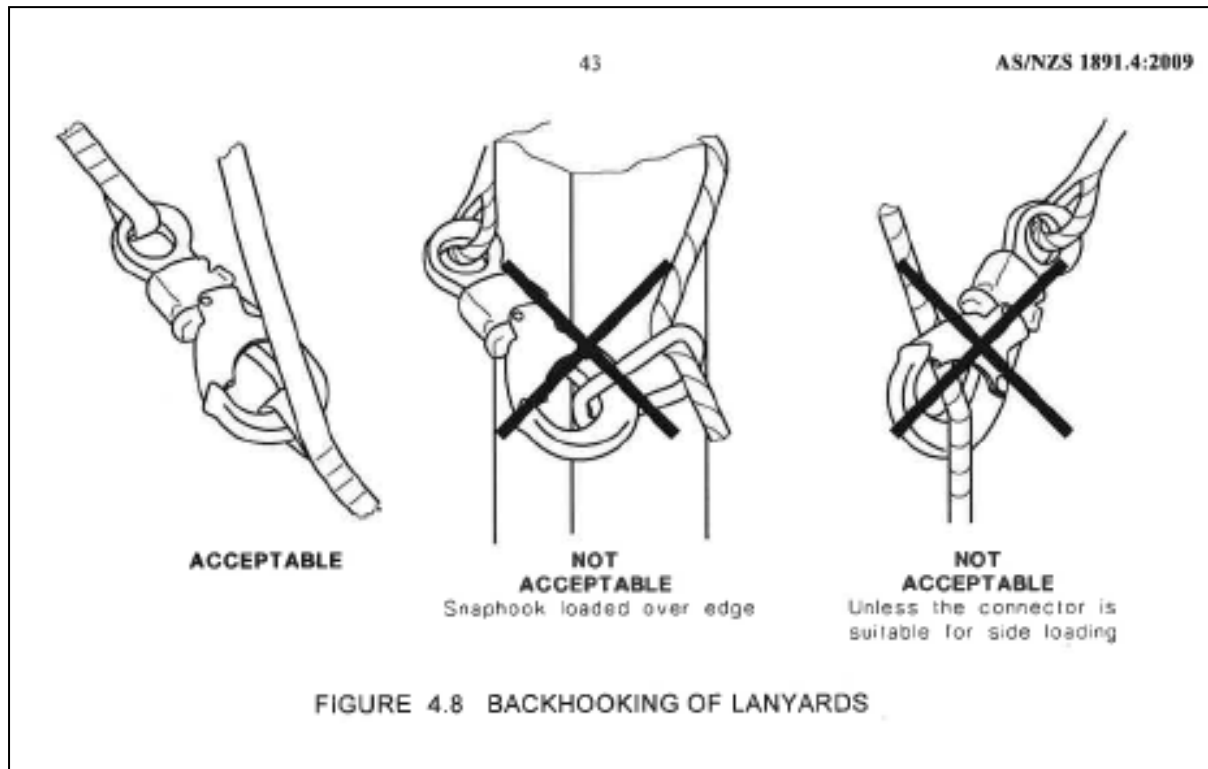
Figure 20: Extract from AS/NZS 1891.4.2009 Figure 4.8 Back hooking of lanyards.

The method that the rigger used of back hooking the lanyard to the bucket was not recommended by the published guidelines in AS/NZS 1891.4:2009 figure 4.8 back hooking of lanyards (Figure 20).³²

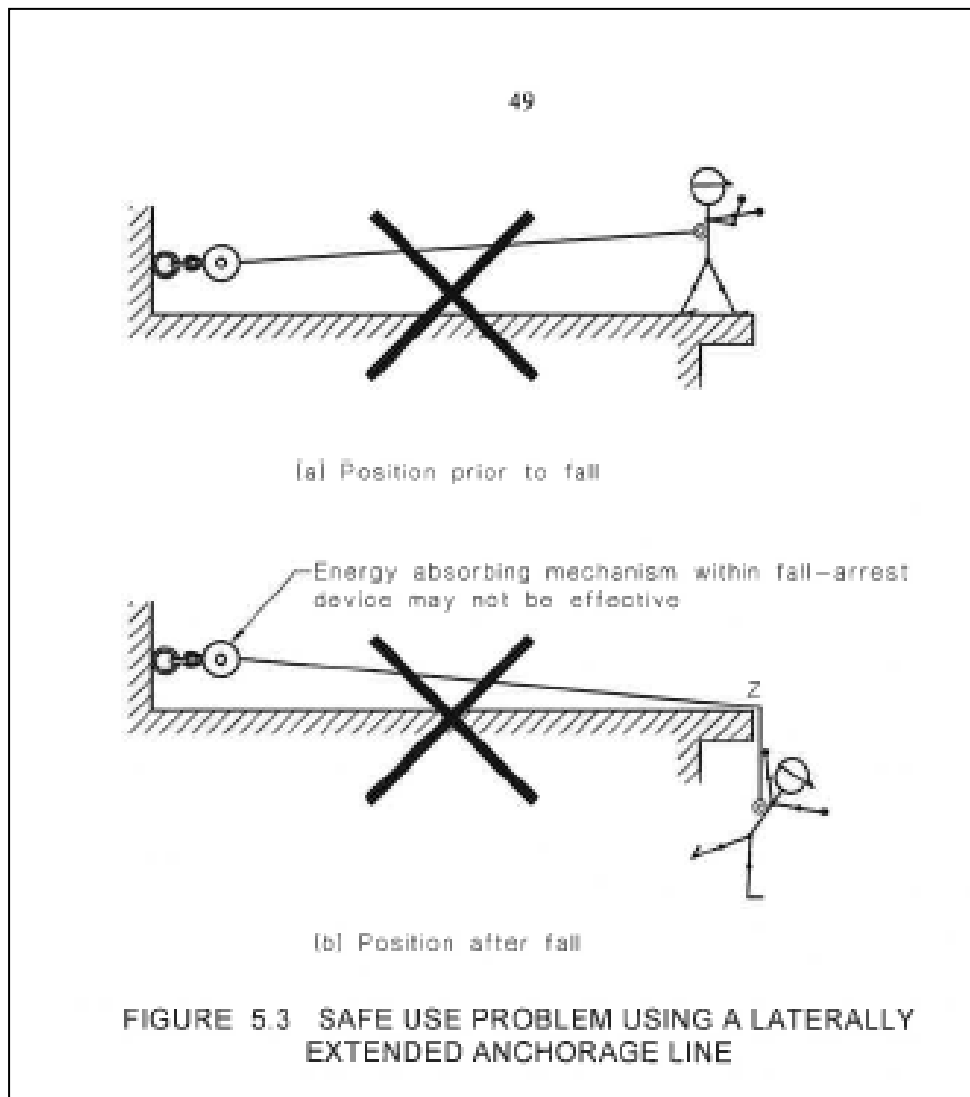
Figure 21: Extract from AS/NZS 1891.4.2009 Figure 5.3 - Safe use problems using a laterally extended anchorage lines.

Safe use problems are likely to arise if fall arrest devices are used in situations where the anchorage line is extended laterally from an anchorage point before reaching a point where the user is at risk of fall as illustrated in figure 5.3.' and;

Unless specific advice is given by the manufacturer of the fall arrest device that the particular equipment can be safely used in this way, it shall not be so used (see Figure 21).
