Investigation Report

Fatality involving
David Hurst Oldknow
Ravensworth Underground Mine
Coal Preparation Plant
Reject bin 802
18 February 2009

Mine Safety Investigation Unit

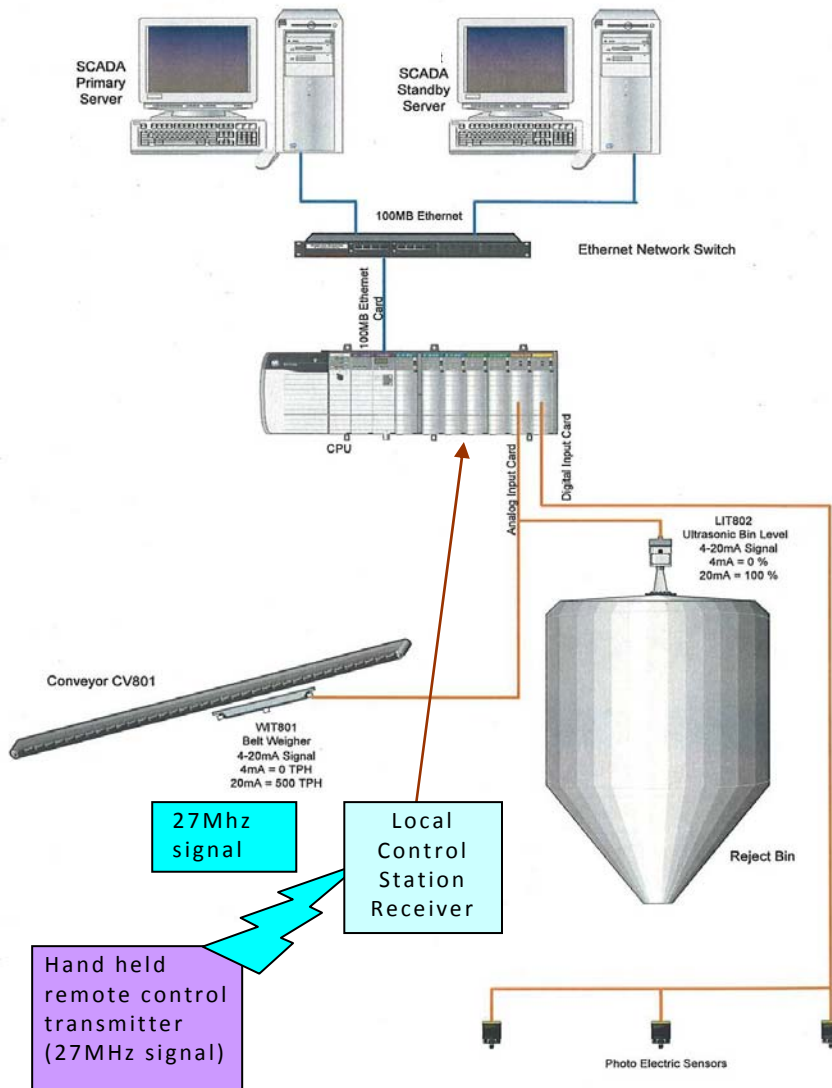
Ravensworth Reject Bin Control System Block Diagram

The following diagram is an indicative representation of the bin control system.
