**NSW  
Resources  
Regulator**

# **Quarterly safety report**

October to December 2020

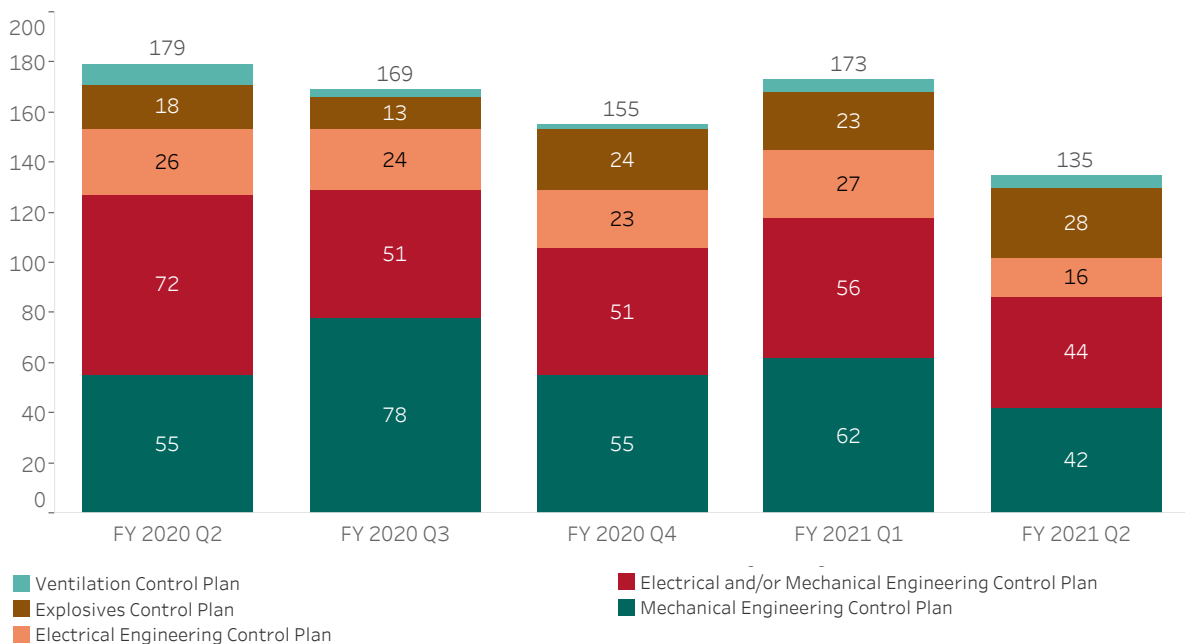
**FIGURE 10. INCIDENT NOTIFICATIONS RECEIVED BY PRINCIPAL CONTROL PLAN OCTOBER 2019 TO DECEMBER 2020**

The figure below presents a further breakdown of numbers of incident notifications received related to principal control plans as defined in clauses 3 and 26 of the regulation.
