# Weekly incident summary

## Week ending 8 September 2023

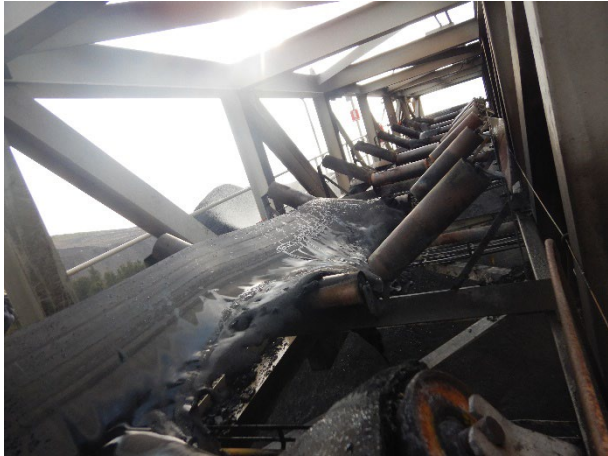
<p>A fire occurred on the boom conveyor of a stacker. The control room slewed the stacker away from the stockpile to assist fire-fighting. The fire was extinguished by site personnel using onsite fire hoses.</p> <p>The belt was shut down for about 2 hours before ignition.</p>

<p>The hazard of collapsed conveyor idler bearings must be considered in the fire and explosion risk assessment for surface mines.</p> <p>Defective idler management is not only a concern for underground mines. Every mine operating conveyors should have a defect management system for idlers.</p>
