Weekly incident summary

Week ending 24 May 2024

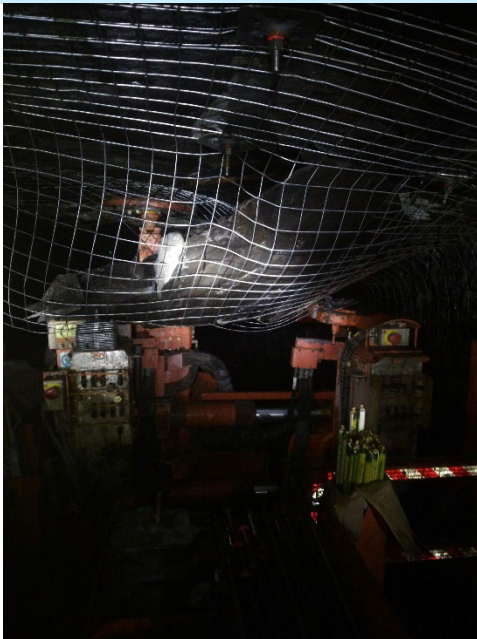
<p>A multi-bolter was being used to install rib mesh on the face following a plunge cut. Two workers held a sheet of mesh for the temporary roof support (TRS) to take to the roof. The workers stood back and shortly thereafter a piece of stone (1.8 m x 1.2 m x 150 mm) fell from the roof, slid on the mesh and landed on the timber jacks. There was one worker in the vicinity.</p>	<p>Workers must always be alert to the hazard of unsupported roof strata and must remain vigilant of their position relative to the risk of unsupported strata failure, which may occur without warning.</p> <p>Underground mine operators should review the adequacy of their strata monitoring arrangements and associated trigger action response plans (TARPs) to ensure that workers are not exposed to unacceptable risks associated with strata failure.</p>

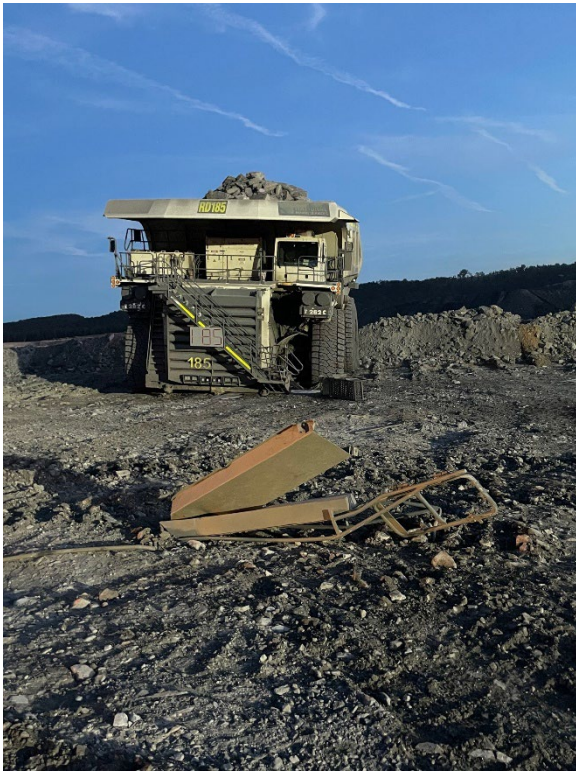
<p data-bbox="124 887 264 954">Dangerous incident</p> <p data-bbox="124 976 325 1010">IncNot0046975</p> <p data-bbox="124 1032 300 1066">Open cut coal</p>	<p data-bbox="392 887 951 1178">A haul truck was reversing to the tip head when the pos 1 tyre failed. The release of pressure caused damage to the truck and dislodged the access ladder. The emergency ladder was projected approximately 20 m in front of the truck and a fire extinguisher was projected approximately 95 m in front of the truck.</p>

<p data-bbox="999 887 1461 1032">Mine operators are reminded of the importance of undertaking a daily inspection routine for tyres to ensure they are fit-for-purpose.</p>

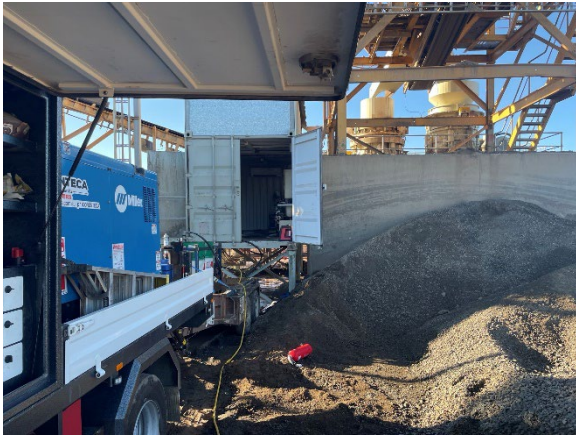
Incident type	Summary	Comments to industry
Serious injury IncNot0046833 Construction materials	<p>Two workers were in the crusher lube container when there was an explosion that caused a fire.</p> <p>The workers sustained burns to their upper chest and face.</p>

<p>This incident is under investigation by the Resources Regulator and further information will be published at a later date.</p>
