# Safety Bulletin

## Electric shocks in the mining industry

This safety bulletin provides safety advice for the NSW mining industry.

## Safety Bulletin SB25-04

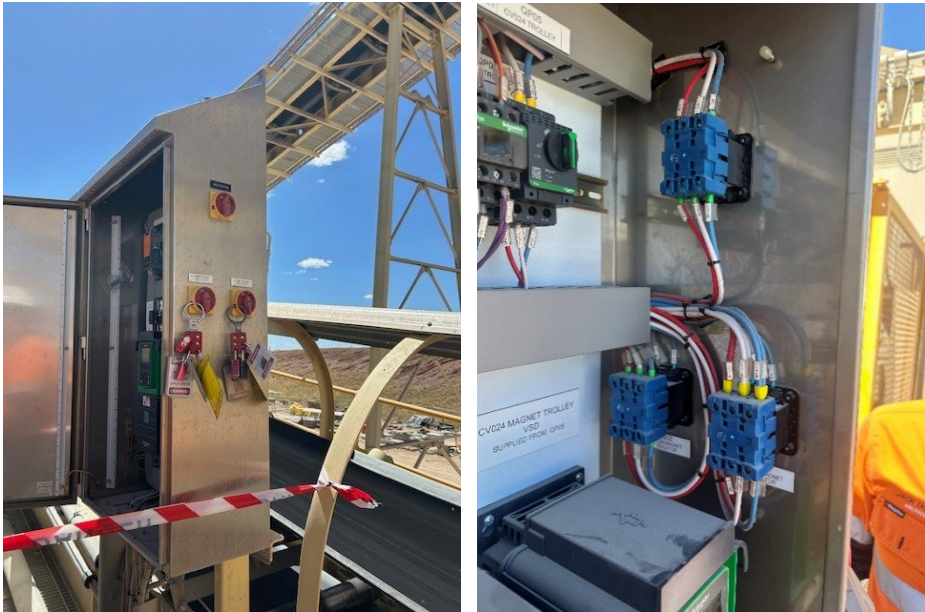
An electrician and an apprentice electrician were performing electrical maintenance when the apprentice suffered an electric shock. The task included tightening the terminals on a magnet starter with 2 panels side-by-side. The apprentice was in one panel and the electrician was in the other, tightening terminals. The apprentice made contact with the live side of the main isolator with a 1000 volt insulated screwdriver.

The isolations applied to the panel were incorrect (personal locks and tags applied to outgoing isolators, not the main isolator of the board).

Figure 3: Magnet starter cubicle

- **Energy isolation protocols:** ensuring they incorporate effective verification measures for potential energy sources and backfeeds, which may come from:

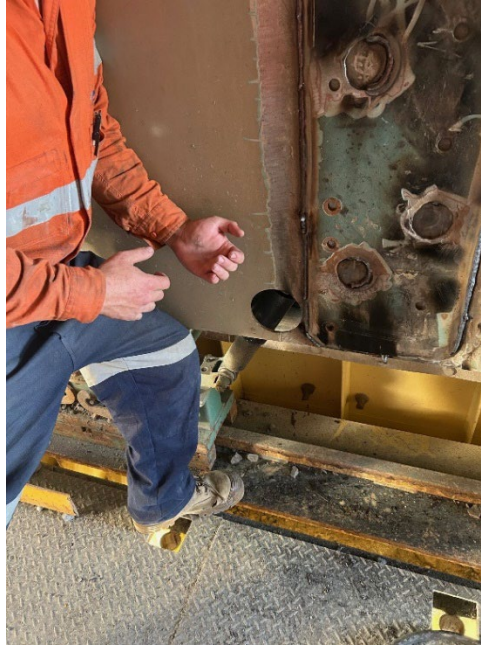
A boilermaker suffered an electric shock while operating a metal inert gas (MIG) welder at the screen building. The boilermaker was leaning against the screen while welding, creating an earth path from his elbow to the screen.

Figures 6 & 7: Earth clamp location on screen, and reenactment of boilermaker position while welding

- using extra-low voltage devices for field applications
  - preferring battery-operated or pneumatic tools over mains-powered alternatives, especially in wet or humid conditions

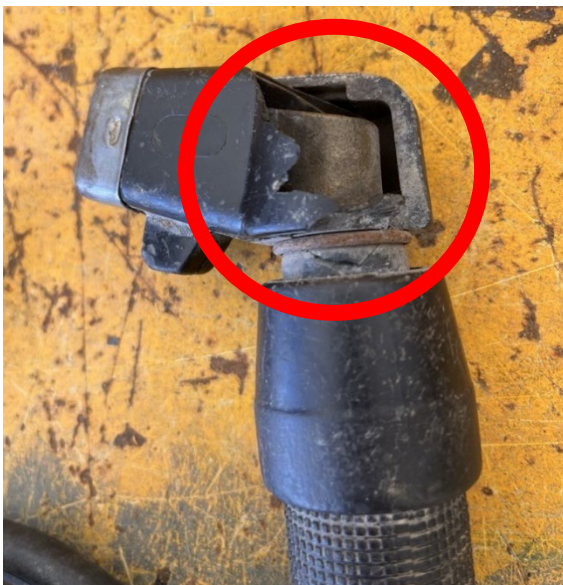
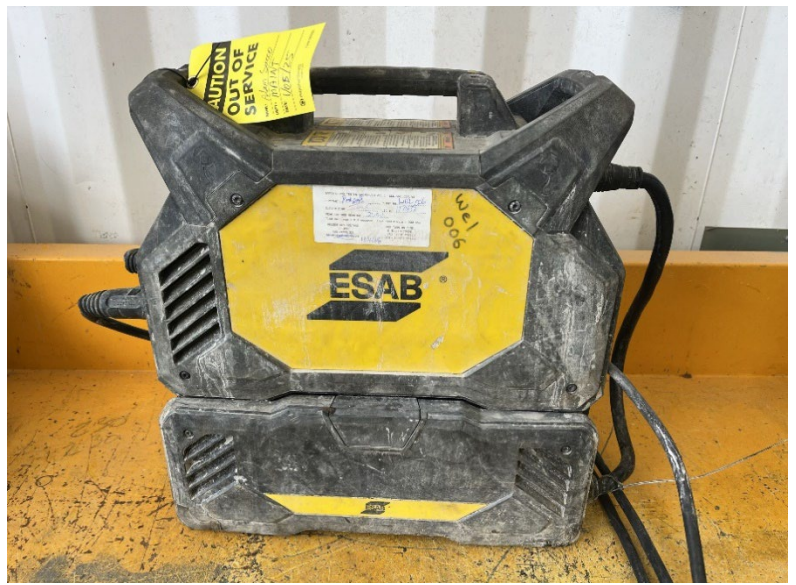
A boilermaker suffered an electric shock while welding in wet conditions in a ventilation shaft. The welding machine was fit-for-purpose for the task being undertaken. On inspection after the incident, the welding handpiece had clear evidence of damage allowing water ingress and transfer of the welding voltage to the boilermaker. The boilermaker suffered multiple electric shocks before ceasing work.

Figures 8 & 9: Damage to welding handpiece, and battery portable welder

- ensuring welding units are equipped with appropriate hazard reduction features and have a safe open circuit voltage for the intended environment.
- **Ongoing equipment maintenance:** to confirm built-in safety features remain effective. For example:

- maintaining correct ingress protection (IP) ratings to prevent exposure to dust and moisture.
- Workforce competence and supervision, making sure:
  - supervision levels match worker experience, with closer oversight for apprentices and trainees
