## Lightning Ridge compliance operation

### Compliance approach

### Inspection results

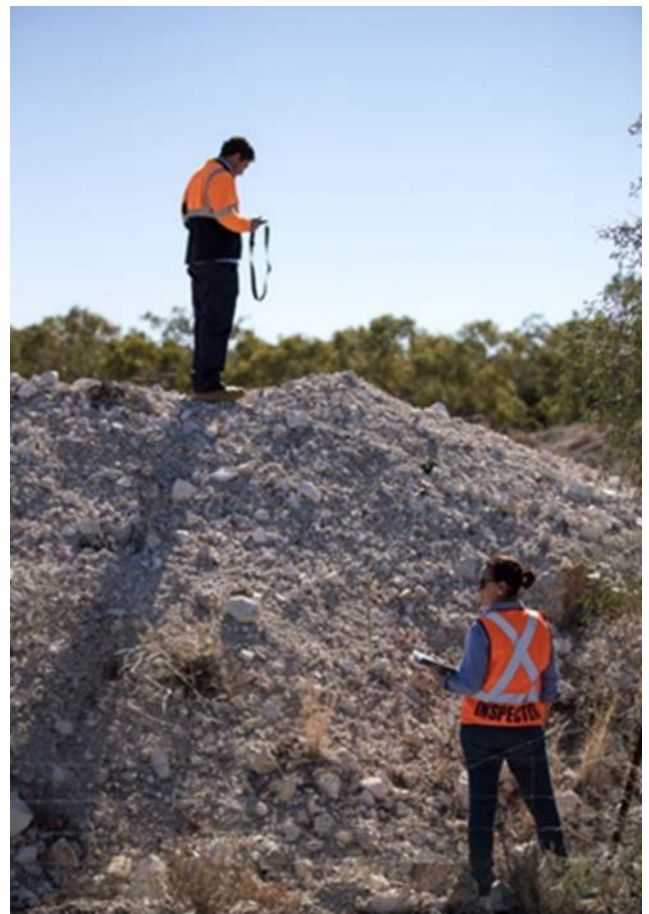
One of the most significant issues identified throughout the inspections was the inadequate securing of mine shafts. Such practices can pose significant safety risks and are unacceptable.

Claim holders must ensure that their shafts and auger holes are appropriately secured in accordance with the guidelines. Excess rubbish and mullock must also be removed from claims.

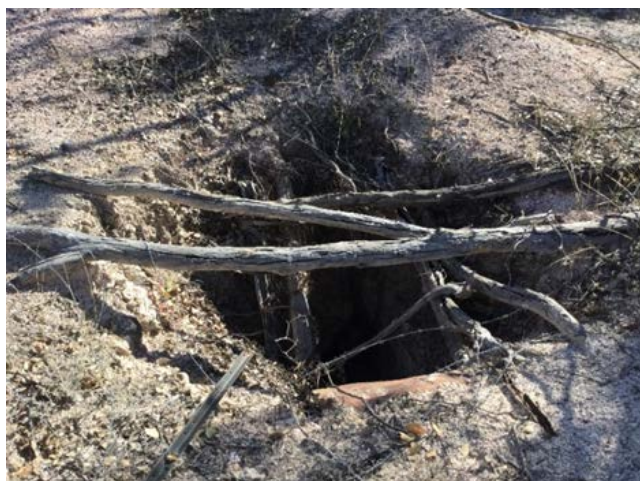
- 68 shaft/auger holes were not secured in accordance with the guidelines
- 16 claims had excessive waste/rubbish
- 10 claims had excessive mullock
- 23 claims were incorrectly marked out
- two claims failed to comply with environmental conditions
- one illegal use of machinery on claim
- one illegal mining allegation
- 11 inadequate guarding on machinery
- 10 electrical safety issues
- three insecure ladders in shafts
- one exhaust fumes potentially entering a shaft.

Plant and equipment must have appropriate guarding and electrical equipment must be safe to use and regularly tested.
