SAFETY ALERT

OPERATOR CRUSHED BY OVERTURNED FORKLIFT

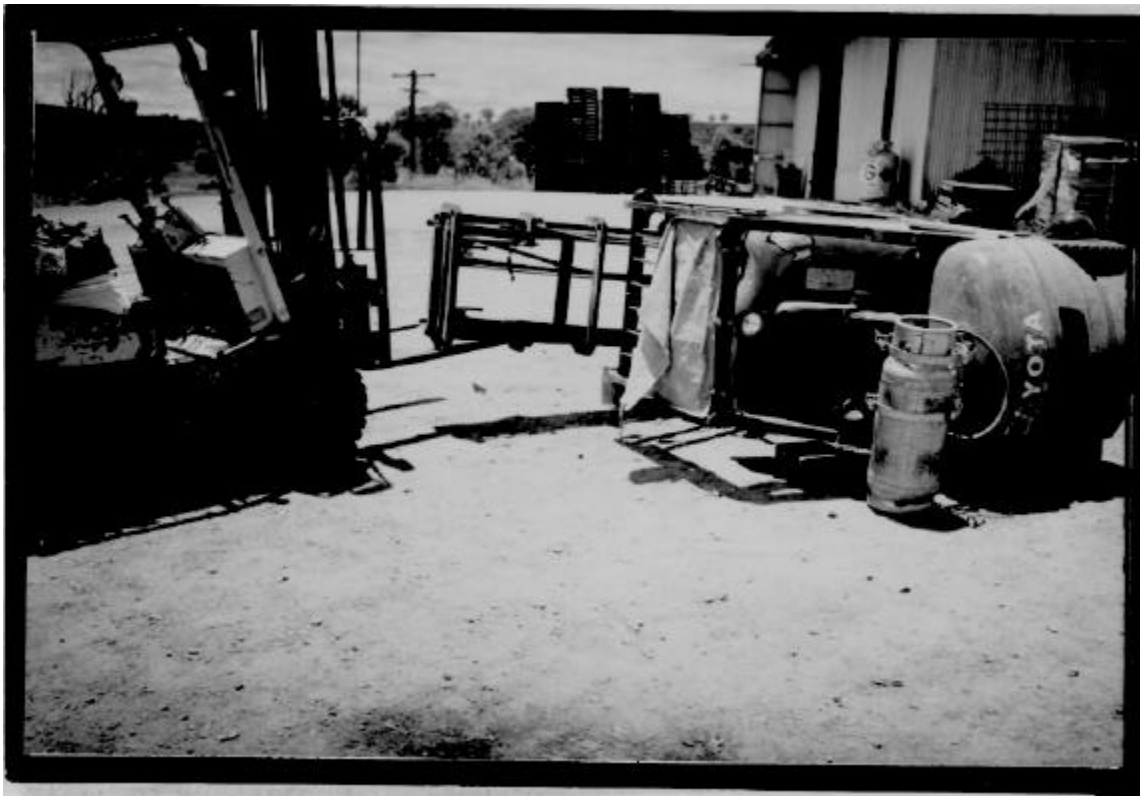
The driver was returning to the warehouse on his unloaded forklift and turned right on a sloping gravel surface. The right side of the machine lifted and travelled on its front and rear left hand wheels. The driver was not wearing the seat belt fitted to the machine and attempted to jump left to get clear. He was caught by the protective bar of the rollover cage which landed on his left hip and pinned him to the ground.

A forklift driver was seriously injured when this forklift overturned. His pelvis was fractured, crushed by the forklift.

- A risk assessment is conducted to identify all potential hazards associated with forklift operations.
- Areas and roadways where forklifts travel should be suitable for the specific equipment.
- Standard Operating Procedures and Job Safety Analysis should be available for forklift operators.
- Travel rules and routes should be established and sign posted.
- Competency of operators should be assessed.
- Heed safety advice and information provided by the supplier/manufacturer.
- Seat belts that comply with the forklift manufacturer's specifications should be worn.
- Acquire relevant training material/information and warning signage. These may be sourced from the manufacturer, service agent or WorkCover Authority.
